GMHA HOSPITAL ROOF AND ENVELOP UPGRADE PROJECT

PACKAGE A - 3RD & 4TH FLOOR ROOF AND ENVELOP (A,B, & E-WING)

GUAM MEMORIAL HOSPITAL AUTHORITY, TAMUNING, GUAM

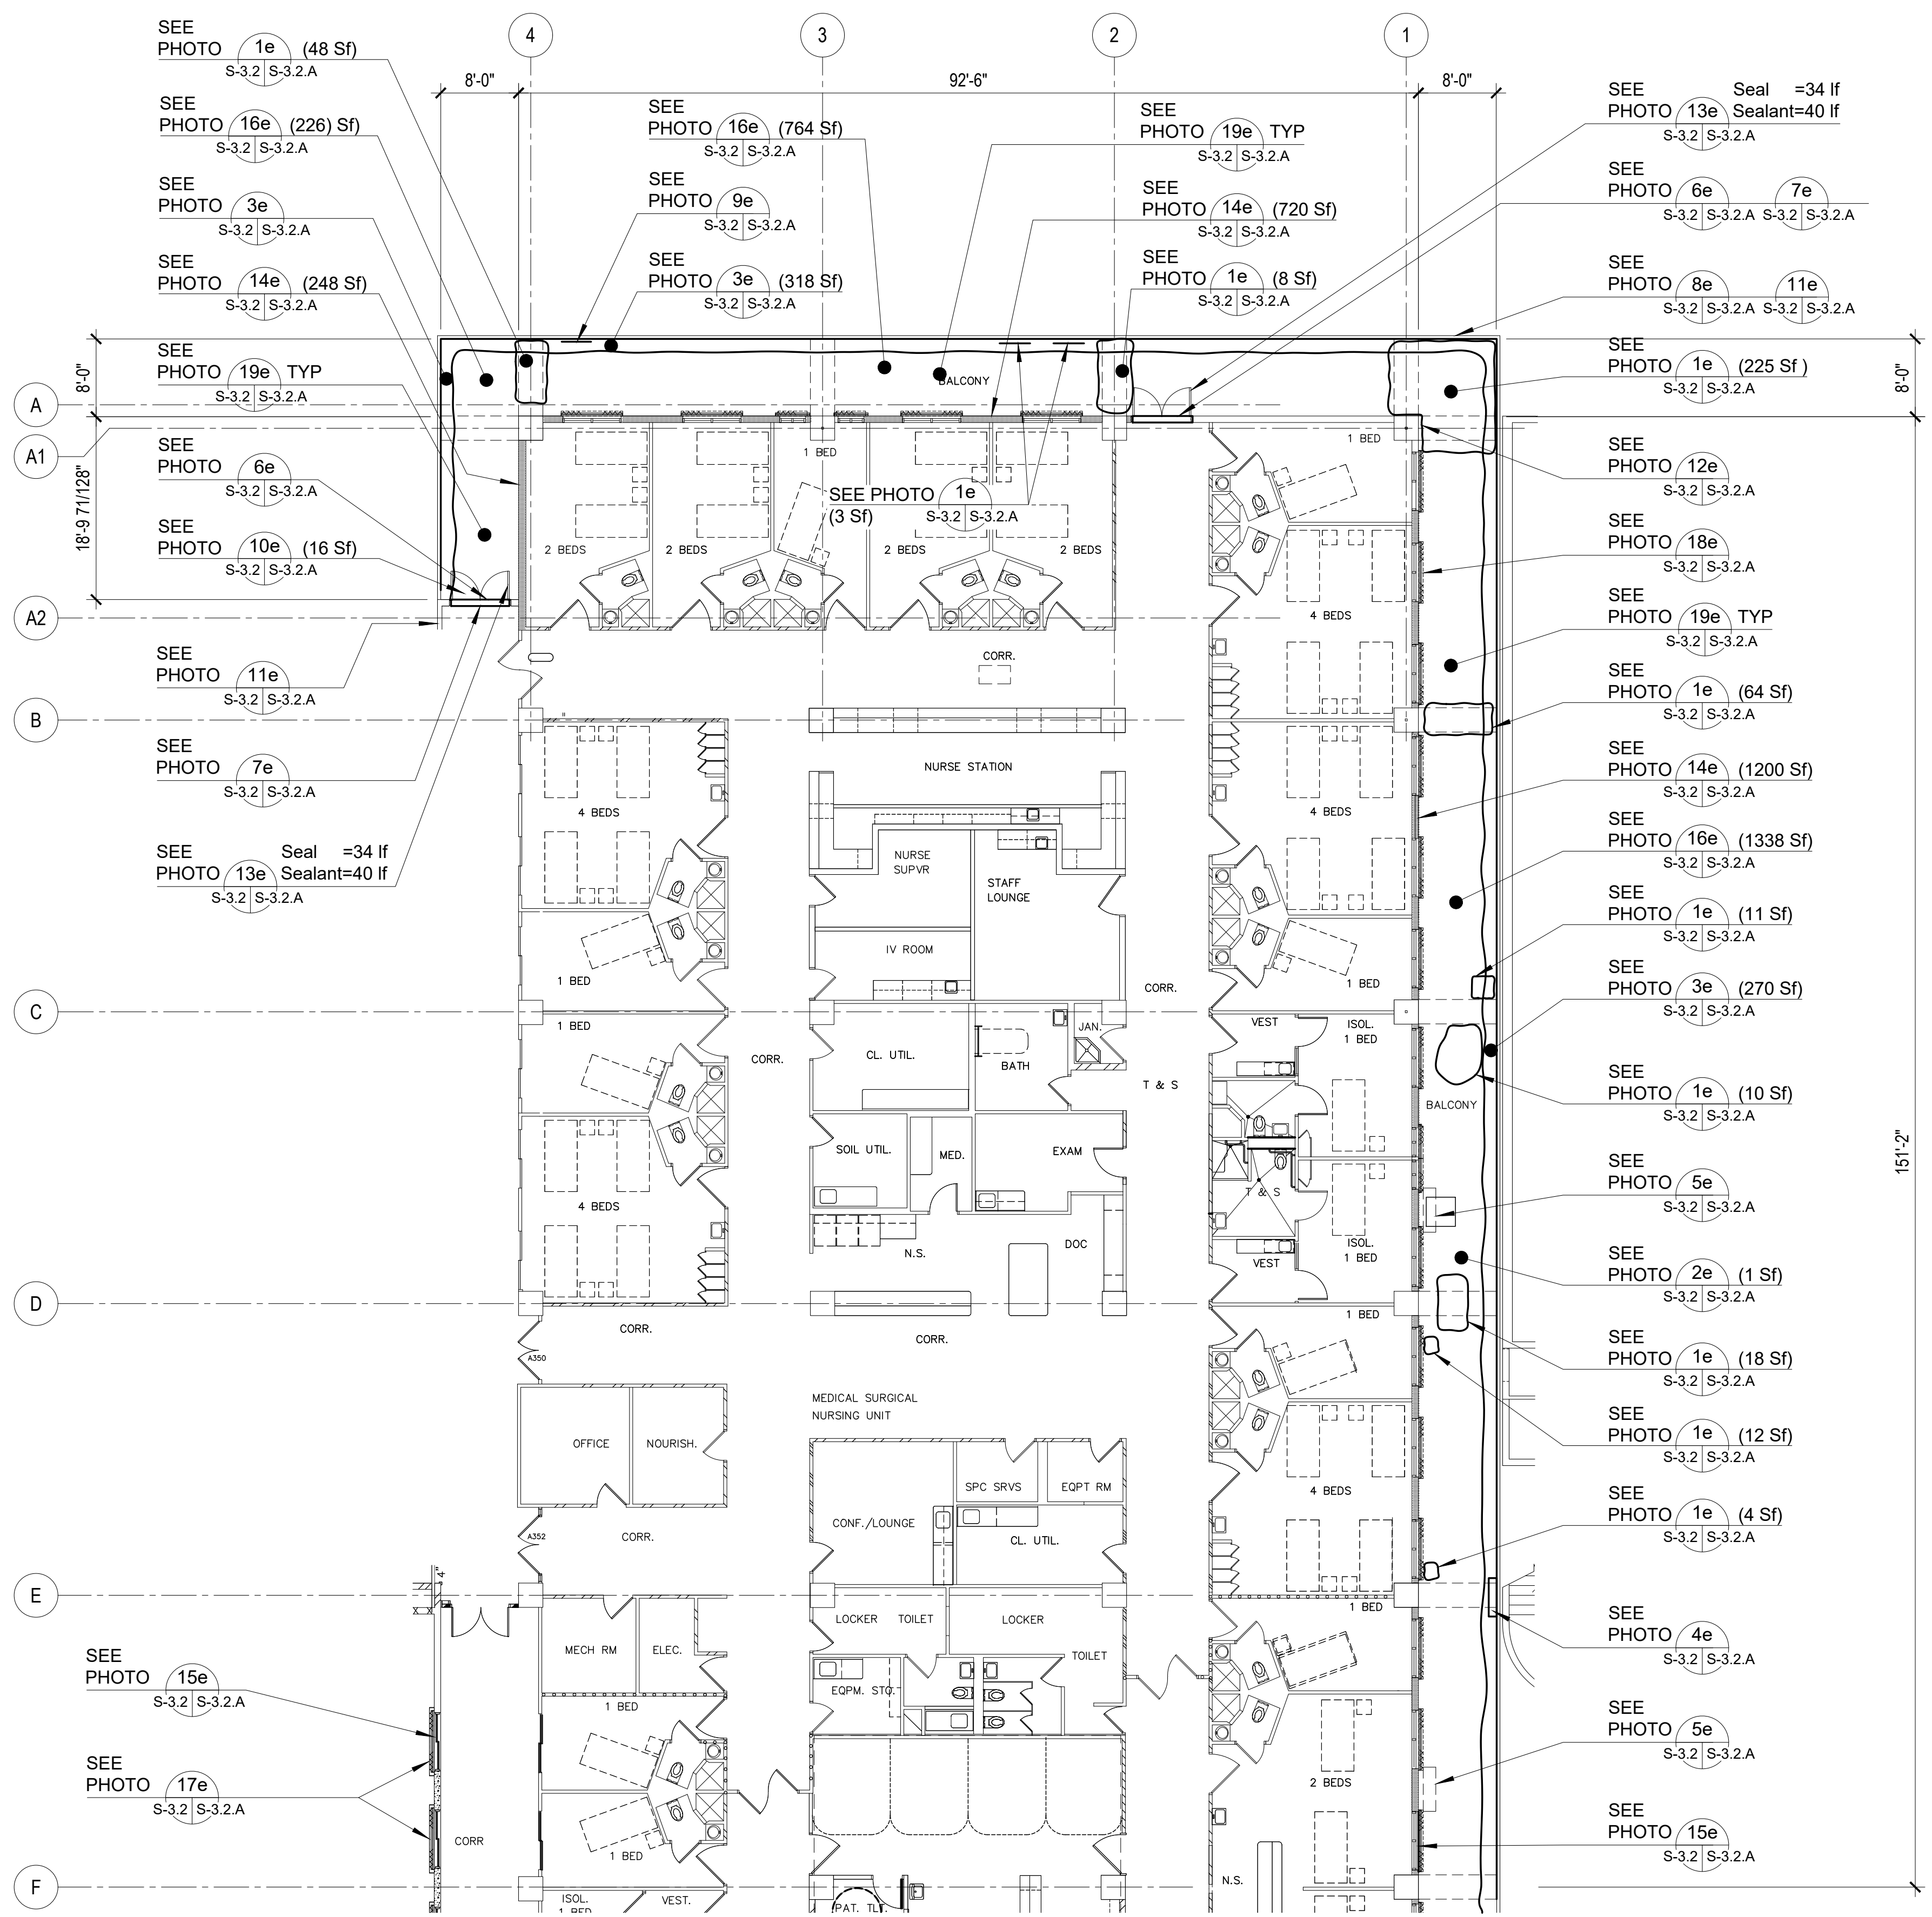
1 THIRD FLOOR PLAN _ A-WING: DAMAGED LOCATIONS
SCALE: 3/32" = 1' - 0"

PHOTO KEY NOTES:		SCOPE OF REPAIR WORKS:		
WING	PHOTO No.	DAMAGED DESCRIPTION	REPAIR METHODS	DETAIL SHOWN
A - WING THIRD FLOOR (EXTERIOR)	1e S-3.2 S-3.2.A	CONC FLOOR SPALLS (403 Sf).	SAWCUT DAMAGED SPALLS, CHIP OFF TO SOUND CONCRETE CLEAN & PATCH w/ EPOXY MORTAR, TYPICAL.	9 S-11.1 S-11.1
	2e S-3.2 S-3.2.A	CONC FLAKING (1 Sf).	SAWCUT DAMAGED SPALLS, CHIP OFF TO SOUND CONCRETE CLEAN & PATCH w/ EPOXY MORTAR, TYPICAL.	9 S-11.1 S-11.1
	3e S-3.2 S-3.2.A	WATER PONDING (602 Sf).	WATERBLAST EXIST AFFECTED AREAS, ROUGHEN SURFACES TO 1/4 AMPLITUDE, CLEAN & PROVIDE NEW CONCRETE CEMENT TOPPING. PROVIDE SLOPE ON NEW TOPPING TO DIRECT WATER TO EXISTING ROOF DRAIN OR SCUPPER DRAIN.	
	4e S-3.2 S-3.2.A	EXPOSED REBAR (2 LOC), 3 Sf.	SAWCUT DAMAGED SPALLS 1" MAX & CHIP OFF TO SOUND CONCRETE, GRIND REBAR TO FREE OF RUST & PATCH w/ EPOXY MORTAR, TYPICAL.	9 S-11.1 S-11.1
	5e S-3.2 S-3.2.A	DETERIORATED EXHAUST DUCT/HOOD (2 LOC).	REMOVE EXISTING WALL EXHAUST HOOD AND REPLACE WITH NEW, REFER TO MECHANICAL DRAWINGS.

6e S-3.2 S-3.2.A	DETERIORATED DOOR HEADER EXHAUST (2 LOC).	REMOVE EXISTING DOOR HEADER EXHAUST GRILLE AND REPLACE WITH NEW, REFER TO MECHANICAL DRAWINGS.	
	7e S-3.2 S-3.2.A	DETERIORATED DOOR THRESHOLD (12 Lf).	REMOVE EXISTING DOOR THRESHOLD AND REPLACE WITH NEW.	3 S-8.1 S-8.1
	8e S-3.2 S-3.2.A	CURB SPALLS WITH EXPOSED REBAR (15 Sf).	SAWCUT DAMAGED SPALLS 1" MAX & CHIP OFF TO SOUND CONCRETE, GRIND REBAR TO FREE OF RUST & PATCH w/ EPOXY MORTAR, TYPICAL.	9 S-11.1 S-11.1
	9e S-3.2 S-3.2.A	DETERIORATED PAINT AND PAINT FLAKING ON CONCRETE RAILINGS, TYPE.	WATERBLAST EXISTING ENTIRE CONCRETE RAILINGS, SCRAPE OFF PAINT FLAKING, REPAIR ANY DAMAGES, CLEAN AND PROVIDE NEW PAINT, PER GMHA STANDARD.	
	10e S-3.2 S-3.2.A	DETERIORATED FLOOR TOPPING (16 Sf).	SAWCUT DAMAGED CONCRETE TOPPING, CHIP OFF TO SOUND CONCRETE CLEAN & PATCH w/ EPOXY CEMENT MORTAR, TYPICAL.	
	11e S-3.2 S-3.2.A	CONC FASCIA SPALLS WITH EXPOSE REB (12 Sf).	SAWCUT DAMAGED SPALLS 1" MAX & CHIP OFF TO SOUND CONCRETE, GRIND REBAR TO FREE OF RUST & PATCH w/ EPOXY MORTAR, TYPICAL.	9 S-11.1 S-11.1

12e S-3.2 S-3.2.A	SPALLS ON CEILING (4 Sf).	SAWCUT DAMAGED SPALLS, CHIP OFF TO SOUND CONCRETE CLEAN & PATCH w/ EPOXY MORTAR, TYPICAL.	10 S-11.1 S-11.1
	13e S-3.2 S-3.2.A	DETERIORATED DOOR SEAL & SEALANT (68 SEAL, 80 SEALANT).	REMOVE EXISTING DOOR SEAL / SEALANT AND REPLACE WITH NEW.	
	14e S-3.2 S-3.2.A	DETERIORATED WALL PAINT (1200+720+248 Sf) = 2168 Sf.	PRESSURE-WASH EXISTING WALL TO REMOVE DIRT, STAIN, MILDEW, ALGAE AND REPAIR ANY AREAS WITH MINOR DAMAGED AND PATCH WITH EPOXY MORTAR. PROVIDE NEW PAINT ON ALL WALL, CONC RAILINGS SURFACES, PER GMHA FACILITY STANDARD, TYPICAL.	
	15e S-3.2 S-3.2.A	DETERIORATED WINDOW SEALANT (840 Lf).	REMOVE EXISTING WINDOW SEAL / SEALANT AND REPLACE WITH NEW.	
	16e S-3.2 S-3.2.A	DETERIORATED CORRIDOR FLOOR COATING (2328 Sf).	WATERBLAST EXISTING ENTIRE CORRIDOR AREAS, CLEAN AND PROVIDE NEW 60 MIL POLYURETHANE FLOOR COATING, PER GMHA STANDARD.	
	17e S-3.2 S-3.2.A	DETERIORATED EXISTING TYPHOON SHUTTERS (TYP 2 PLACES).	REMOVE EXISTING WINDOW SHUTTERS AND ITS ACCESSORIES AND REPLACE WITH NEW EXTERIOR MOUNTED TYPHOON RATED INTERLOCKING ALUMINUM SLATS ROLLER SHUTTERS WITH MANUAL OPERATING SYSTEM. VERIFY WIDTH AND HEIGHT OF EXISTING WALL OPENING.	1 S-9.1 S-9.1

18e S-3.2 S-3.2.A	DETERIORATED WINDOW SHUTTERS (TYP 21 PLACES).	REMOVE EXISTING WINDOW ACCORDION SHUTTERS AND ITS ACCESSORIES AND REPLACE WITH NEW ALUMINUM ACCORDION SHUTTER, TYPICAL AT EXTERIOR CORRIDORS. REFER TO GMHA FOR COLOR SELECTION.	
	19e S-3.2 S-3.2.A	BIRDS DROPPINGS FROM LIGHT TO HEAVILY INFESTED NARROW TO EXTRA WIDE AREAS.	PROVIDE STAINLESS STEEL ANTI BIRD SPIKES ON ALL LEDGES SUCH AS PIPES, SPRINKLER SYSTEMS, STEEL BEAMS, WINDOW SHUTTERS HEAD, HVAC EXHAUST HOODS, AC UNITS, ETC. and PVC AviAngle LEDGE SHIELD ON CONCRETE BEAM LEDGES. SEE SHEET S-9.1 FOR PVC AviAngle LEDGE SHIELD and ANTI BIRD SPIKES SPECIFICATIONS.	5 S-9.1 S-9.1

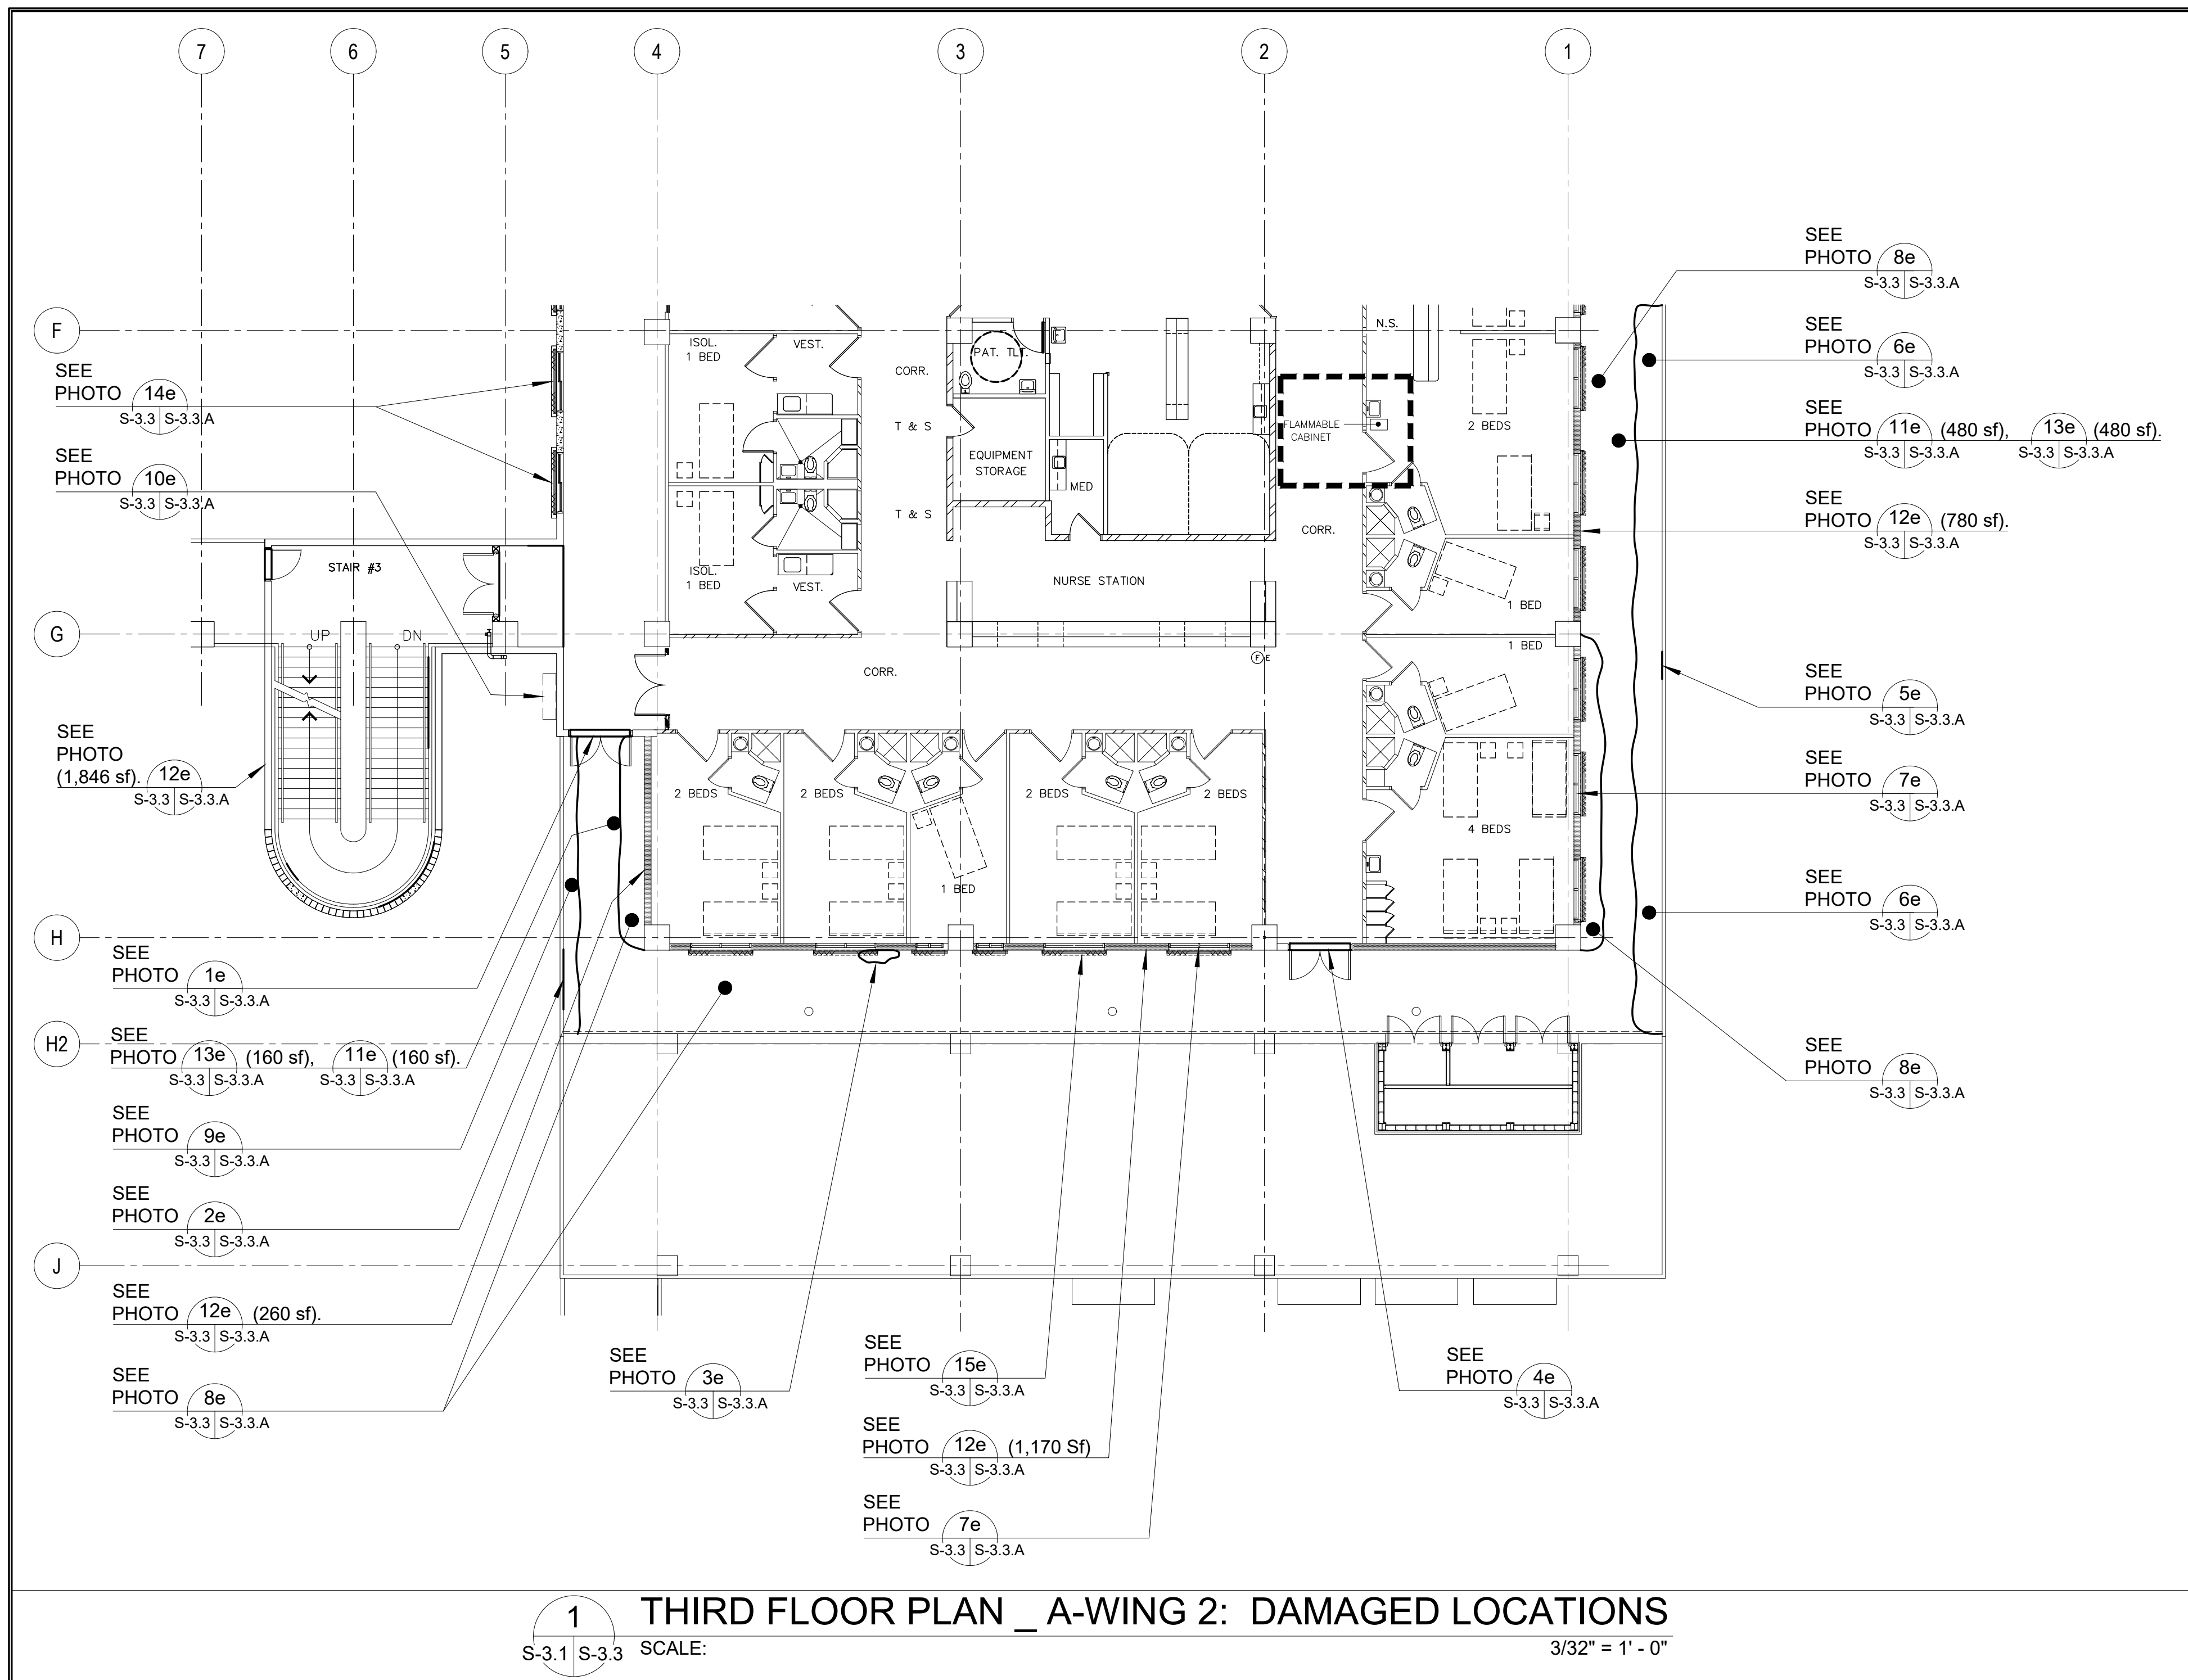
PHOTO KEY NOTES:		SCOPE OF REPAIR WORKS:		
WING	PHOTO No.	DAMAGED DESCRIPTION	REPAIR METHODS	DETAIL SHOWN
A-WING 2 THIRD FLOOR (EXTERIOR)	1e S-3.3 S-3.3.A	DETERIORATED DOOR THRESHOLD (12 Lf)	REMOVE EXISTING DOOR THRESHOLD AND REPLACE WITH NEW	3 S-8.1 S-8.1
	2e S-3.3 S-3.3.A	CONC FASCIA PALLS (9 Sf)	SAWCUT AND CHIP-OFF DAMAGED AREA TO A SOUND CONCRETE AND PATCH WITH EPOXY MOTAR. PROVIDE NEW PAINT FINISH.	7 S-11.1 S-11.1
	3e S-3.3 S-3.3.A	CONC SPALLS ON FLOORS (4 Sf)	SAWCUT DAMAGED SPALLS, CHIP OFF TO SOUND CONCRETE CLEAN & PATCH w/ EPOXY MORTAR, TYPICAL.	9 S-11.1 S-11.1
	4e S-3.3 S-3.3.A	DETERIORATED DOOR HDR EXHAUST GRILLE (1 ea).	REMOVE EXISTING DOOR HEADER EXHAUST GRILLE AND REPLACE WITH NEW, REFER TO MECHANICAL DRAWINGS.	
	5e S-3.3 S-3.3.A	CONC FLAKING ON RAILING (2 Sf)	CHIP OFF EXISTING DAMAGED AREA TO SOUND CONCRETE AND PATCH WITH EPOXY MORTAR.	
	6e S-3.3 S-3.3.A	PONDING ON CORRIDOR (188 Sf)	WATERBLAST EXIST AFFECTED AREAS, ROUGHEN SURFACES TO 1/4 AMPLITUDE, CLEAN & PROVIDE NEW CONCRETE CEMENT TOPPING. PROVIDE SLOPE ON NEW TOPPING TO DIRECT WATER TO EXISTING ROOF DRAIN OR SCUPPER DRAIN.

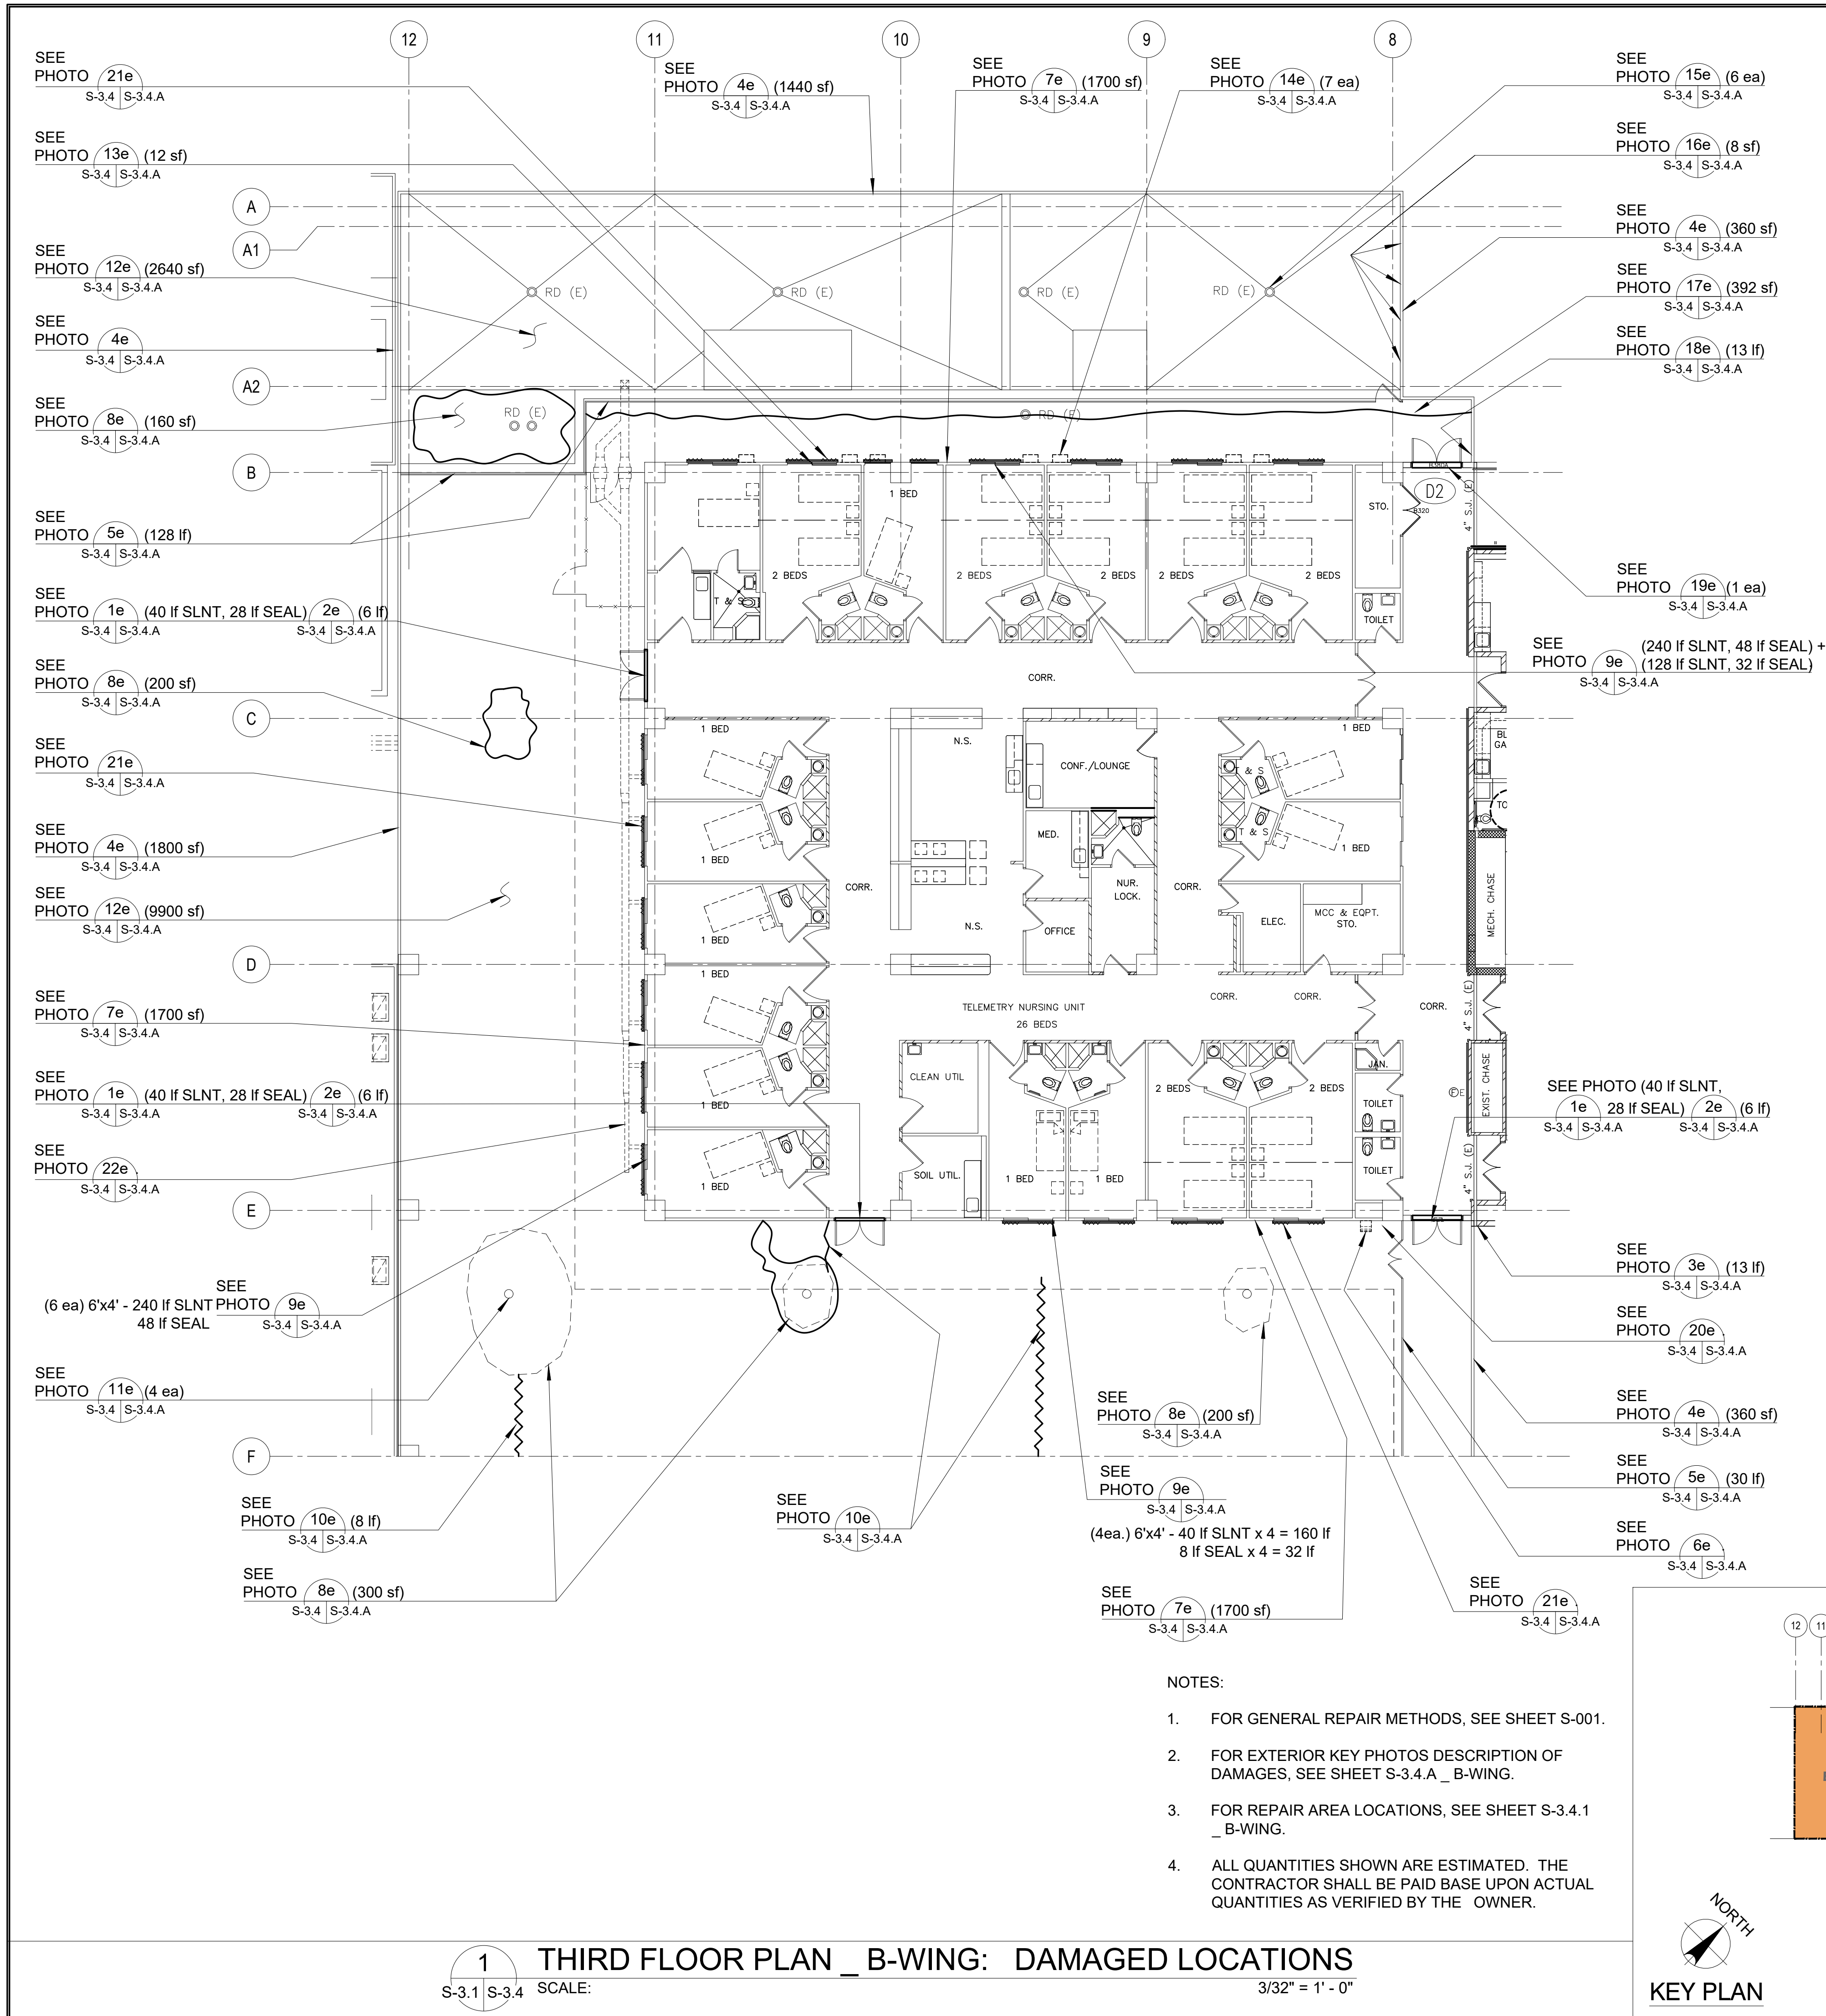
PHOTO KEY NOTES:		SCOPE OF REPAIR WORKS:		
WING	PHOTO No.	DAMAGED DESCRIPTION	REPAIR METHODS	DETAIL SHOWN
B - WING - 3RD FLOOR (EXTERIOR)	1e	DETERIORATED DOOR SEALANT & SEAL (40 lf SLNT) (28 lf SEAL).	REMOVE EXISTING DOOR SEAL / SEALANT AND REPLACE WITH NEW.	
	2e	DOOR THRESHOLD FAILED (6 lf).	REMOVE EXISTING DOOR THRESHOLD AND REPLACE WITH NEW	3 S-8.1 S-8.1
	3e	SEVERE CRACKS ON PILASTER WALL (13 lf).	GRIND TRACES OF CRACKS, CLEAN AND INJECT WITH EPOXY MORTAR, SEE DETAIL.	6 S-11.1 S-11.1
	4e	DETERIORATED PARAPET WALL PAINTS (1440 sf).	WATERBLAST TO CLEAN EXISTING PARAPET WALL AND PROVIDE NEW PAINT, PER GMHA FACILITY STANDARD.	
	5e	DETERIORATED CHAIN LINK & PIPE RAILING & ITS ACCESSORIES (158 sf).	REMOVE EXISTING CHAINLINK GUARD RAILS AND REPLACE WITH NEW. SEE DETAIL.	2,3 S-3.4 S-13.1
	6e	WALL MOUNTED EXHAUST HOOD RUSTED WITH BIRD DROPPING.	REMOVE EXIST WALL MOUNTED HOOD & REPLACE WITH NEW. REFER TO MECHANICAL DRAWINGS.	2A S-3.4 S-14.1

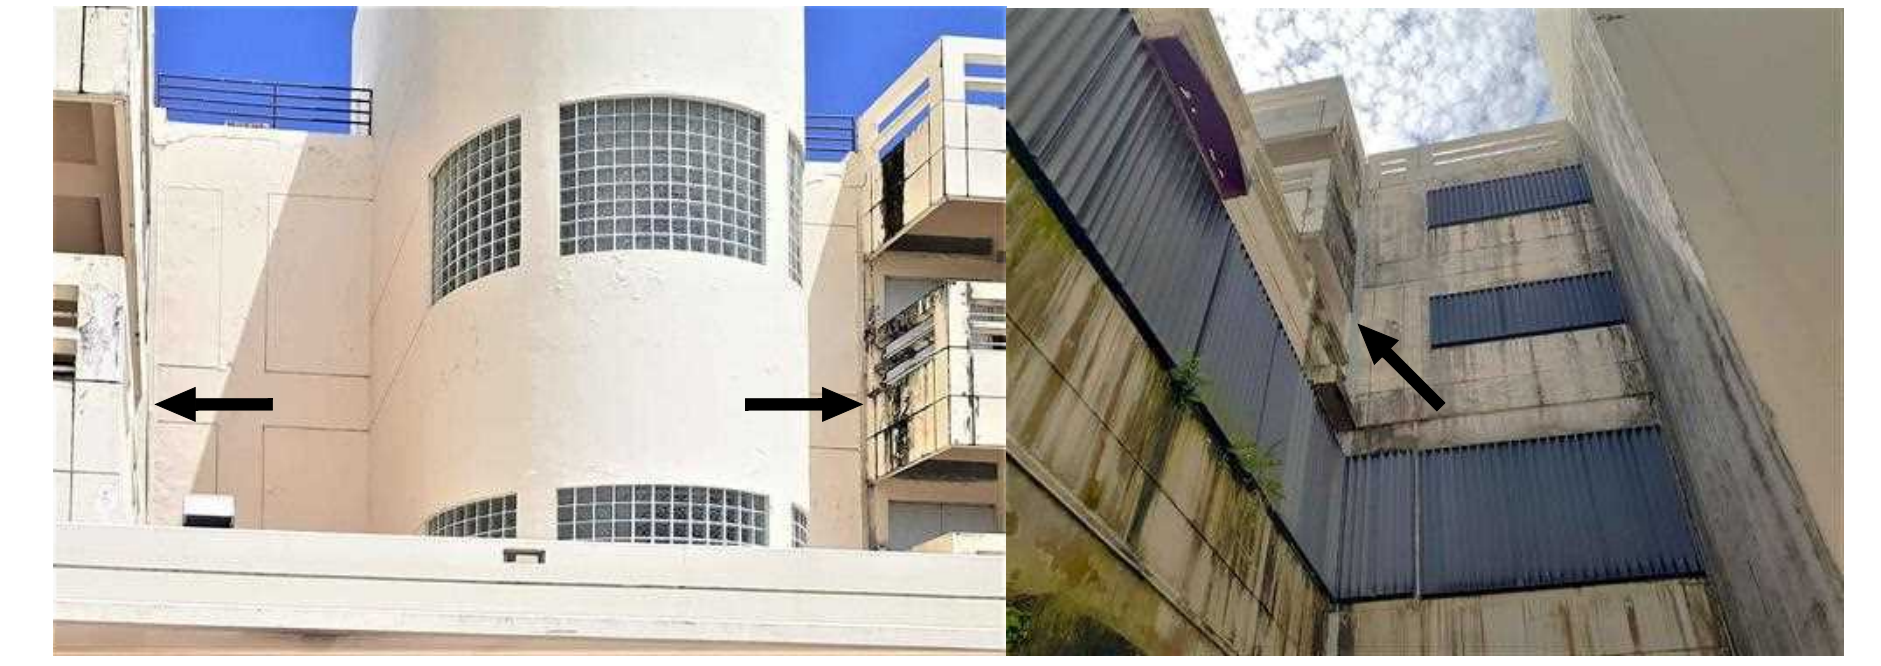
3e PHOTO
S-3.5 S-3.5.A

DETERIORATED VERTICAL SEISMIC JOINT, TYPICAL 4 PLACES (52 Lf)

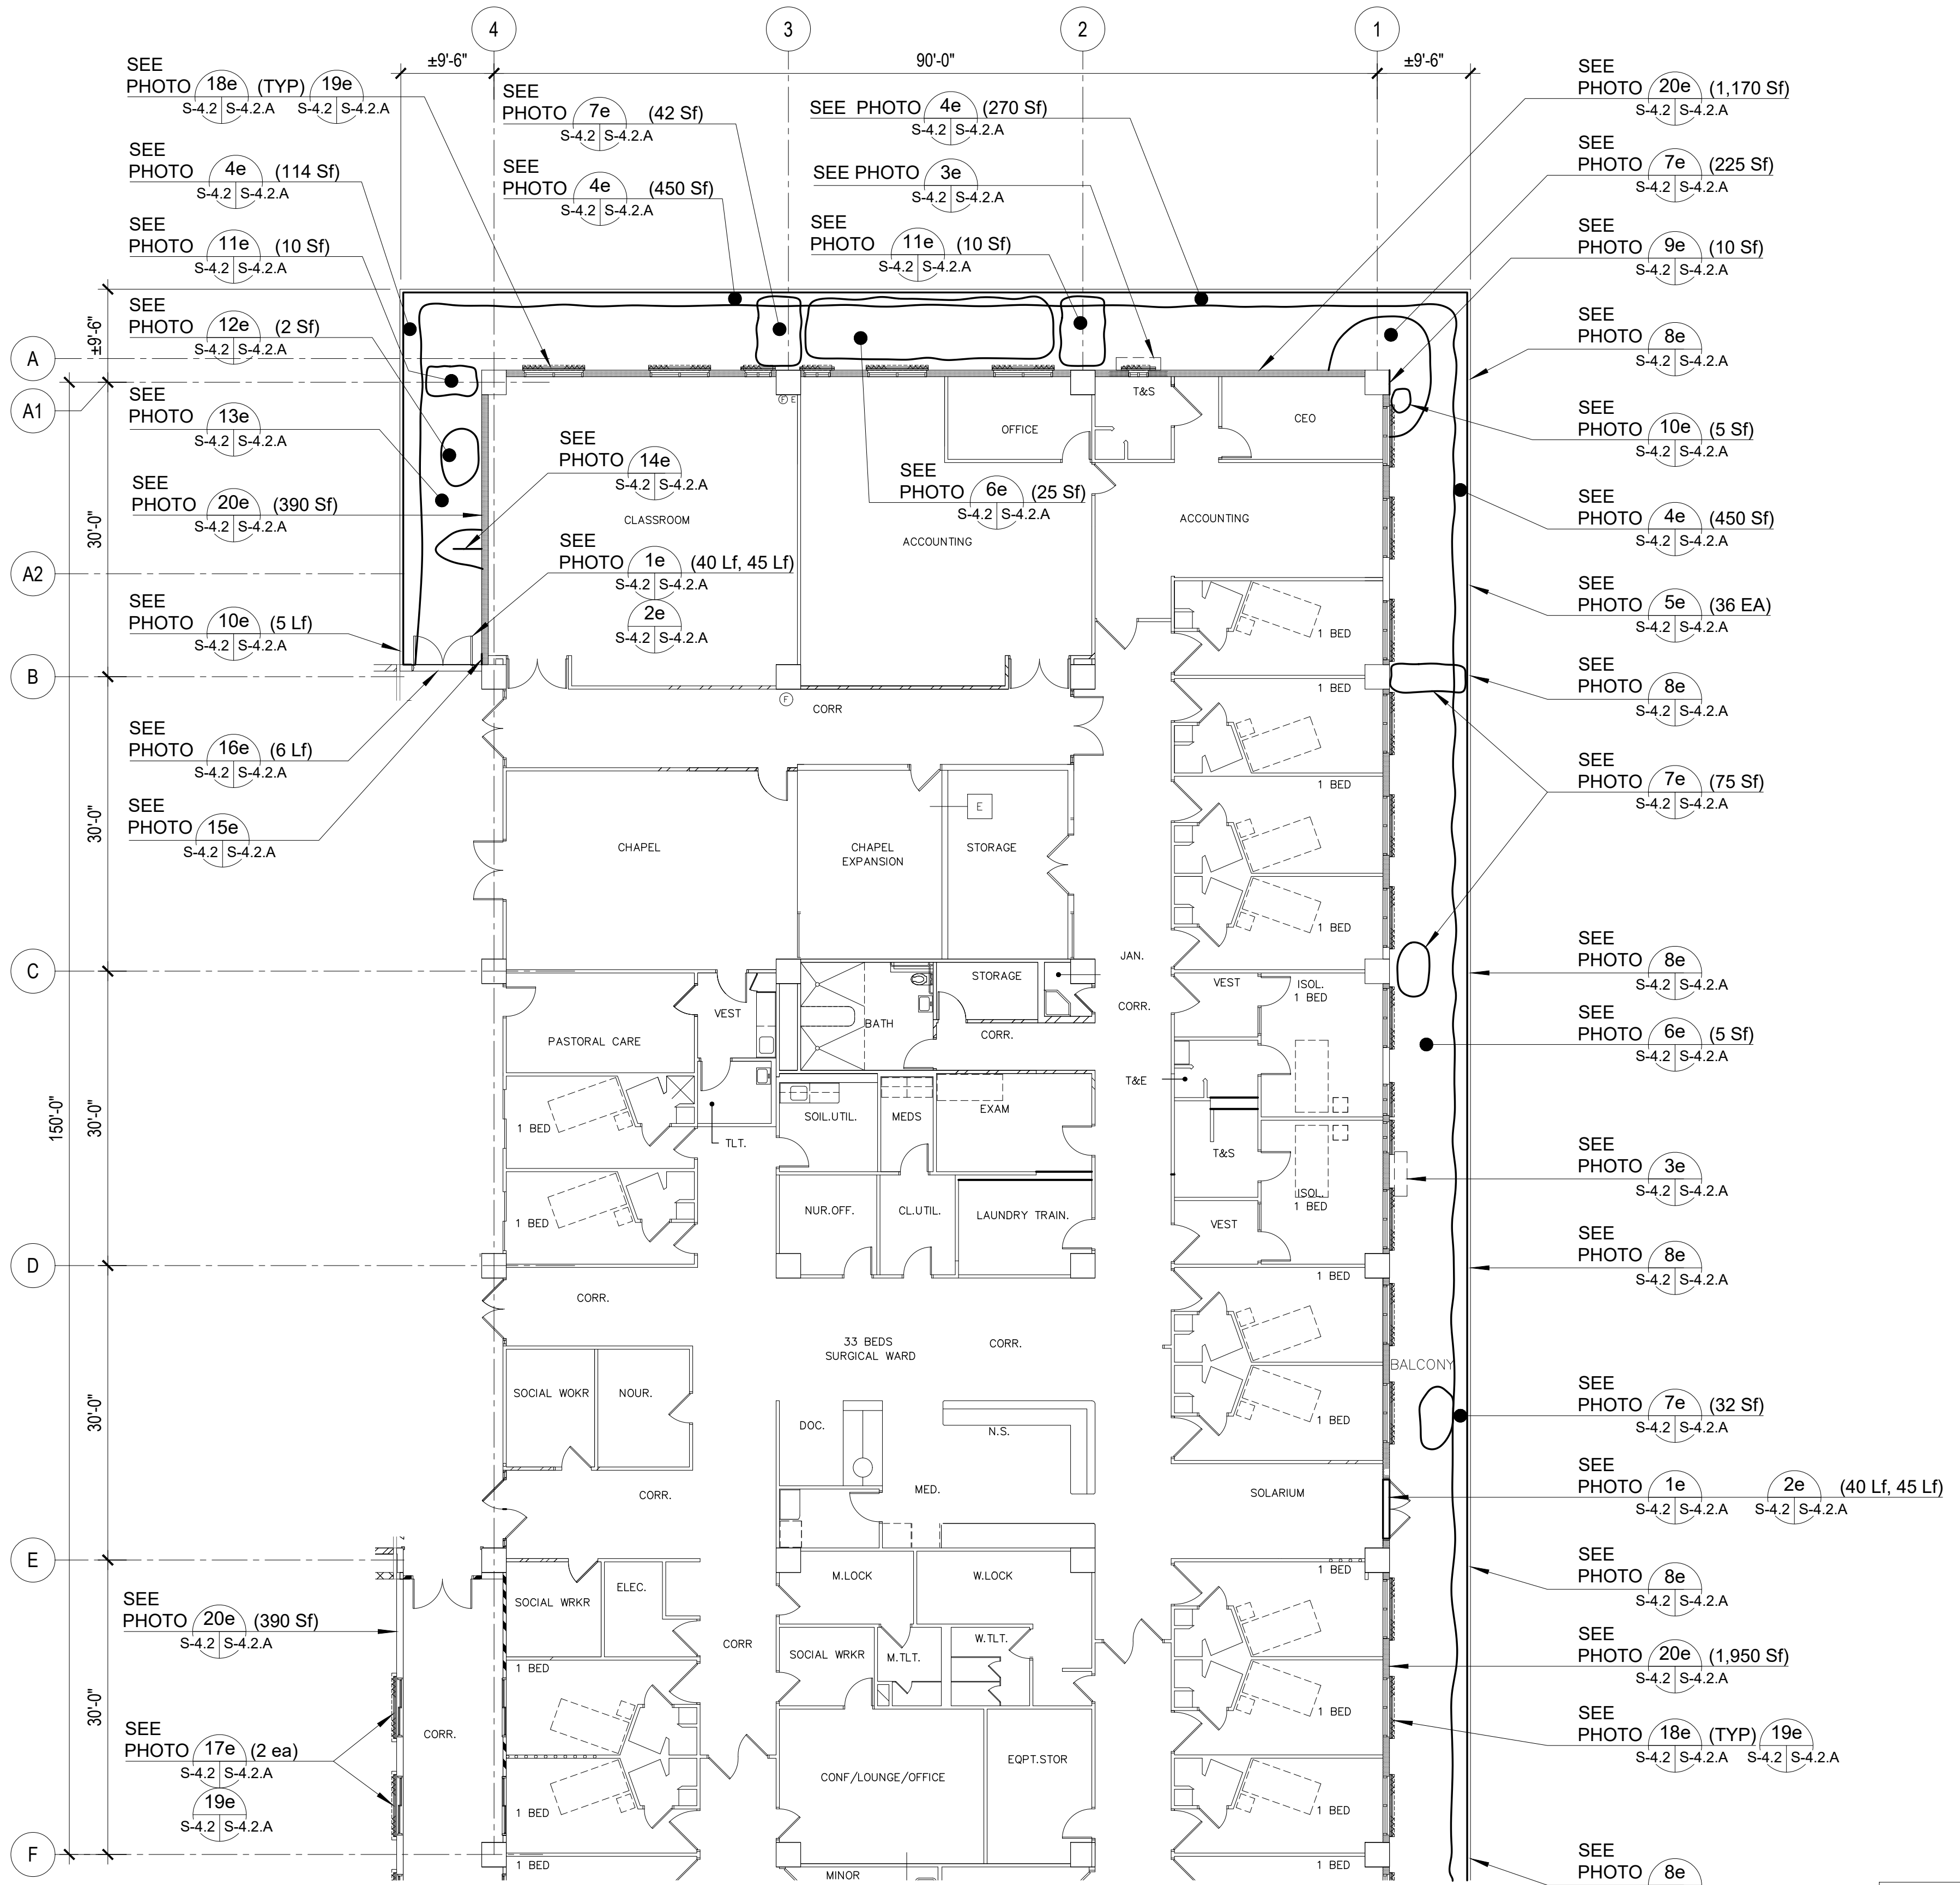
1 FOURTH FLOOR PLAN _ A-WING: DAMAGED LOCATIONS
 S-4.1 S-4.2 SCALE: 3/32" = 1' - 0"

PHOTO KEY NOTES:		SCOPE OF REPAIR WORKS:		
WING	PHOTO No.	DAMAGED DESCRIPTION	REPAIR METHODS	DETAIL SHOWN
A - WING FOURTH FLOOR (EXTERIOR)	1e S-4.2 S-4.2.A	DETERIORATED DOOR SEALANT & SEAL (40 Lf, 45 Lf)	REMOVE EXISTING DOOR SEAL / SEALANT AND REPLACE WITH NEW.	
	2e S-4.2 S-4.2.A	BROKEN OVERHEAD DOOR AIR INTAKE	REMOVE EXISTING DOOR HEADER EXHAUST GRILLE AND REPLACE WITH NEW, REFER TO MECHANICAL DRAWINGS.	
	3e S-4.2 S-4.2.A	DETERIORATED WALL EXHAUST HOOD	REMOVE EXISTING WALL EXHAUST HOOD AND REPLACE WITH NEW, REFER TO MECHANICAL DRAWINGS.	
	4e S-4.2 S-4.2.A	FLOOR WATER PONDING (450 Sf, 270 Sf, 114 Sf)	WATERBLAST EXIST AFFECTED AREAS, ROUGHEN SURFACES TO 1/4 AMPLITUDE, CLEAN & PROVIDE NEW CONCRETE CEMENT TOPPING. PROVIDE SLOPE ON NEW TOPPING TO DIRECT WATER TO EXISTING ROOF DRAIN OR SCUPPER DRAIN.	
	5e S-4.2 S-4.2.A	CORRODED BOLTS AT SOFFIT FASCIA (36 EA)	REMOVE EXISTING CORRODED BOLTS AND PATCH HOLES WITH EPOXY MORTAR.

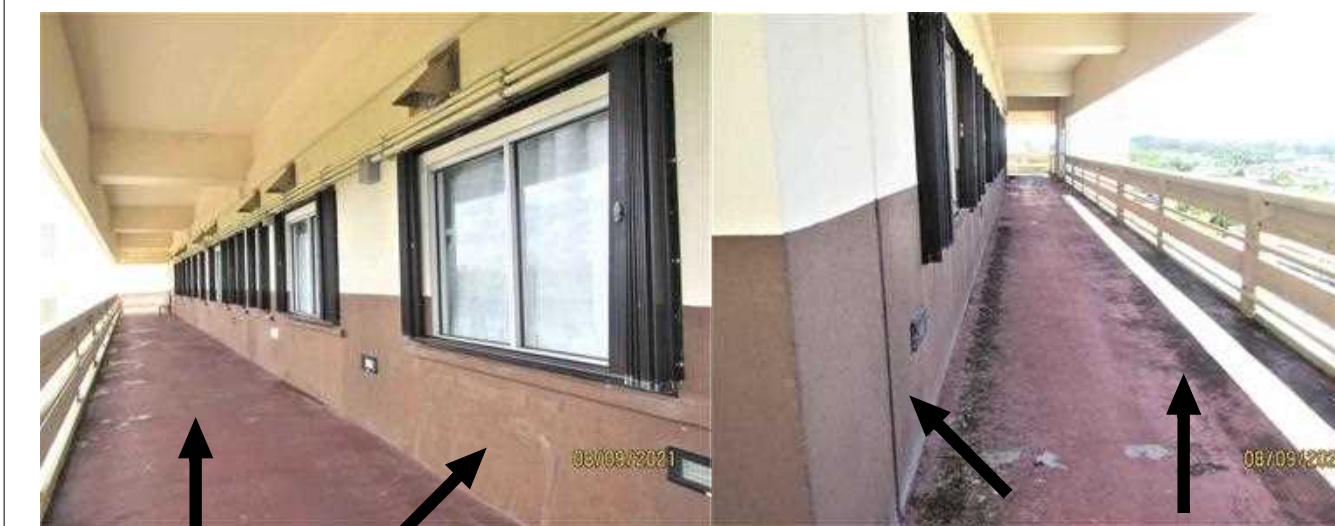
21e PHOTO
S-4.3 S-4.3.A

DETERIORATED WALL PAINT (3,510 Sf)
DETERIORATED CORRIDOR FLOOR COATING MEMBRANE (1,496 Sf)

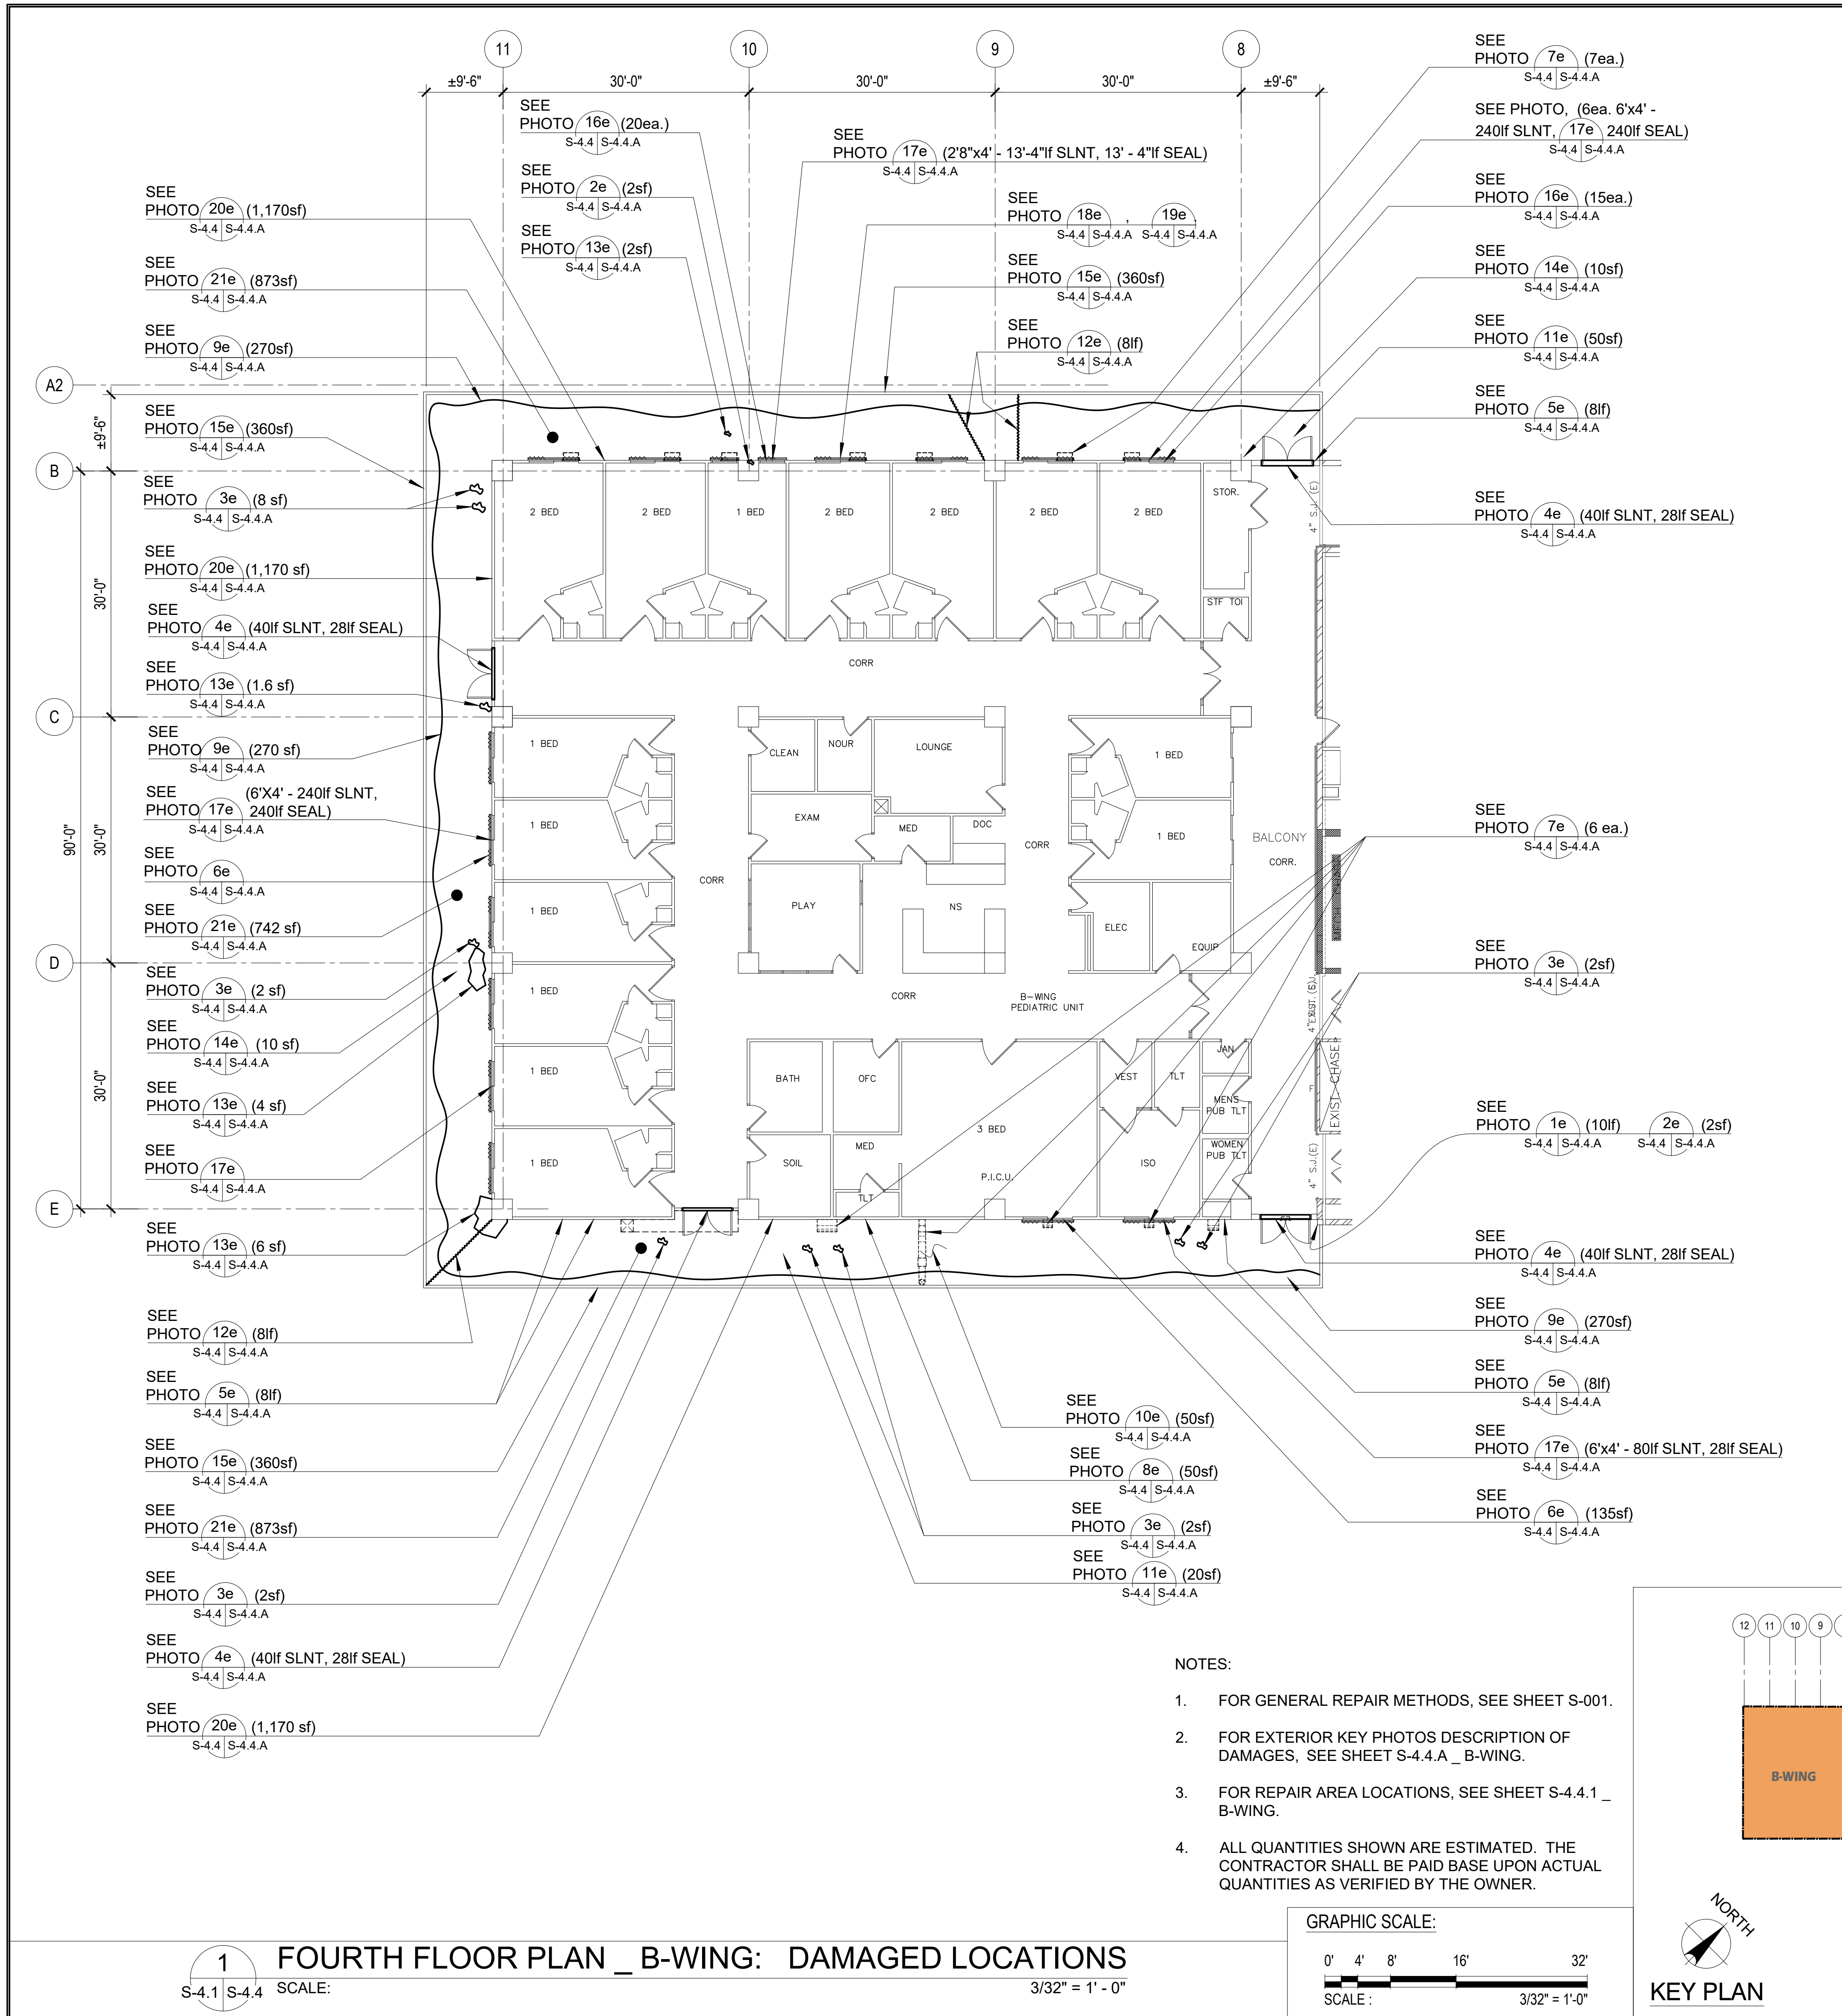
PHOTO KEY NOTES:		SCOPE OF REPAIR WORKS:		
WING	PHOTO No.	DAMAGED DESCRIPTION	REPAIR METHODS	DETAIL SHOWN
B - WING _ 4TH FLOOR (EXTERIOR)	1e	DETERIORATED STEEL PILASTER (10 lf).	WIRE BRUSH OR GRIND EXISTING STEEL PILASTER, CLEAN AND PROVIDE NEW EPOXY MORTAR PATCH, PAINTED.	
	2e	COLUMN SPALLS (2 sf).	SAWCUT DAMAGED SPALLS, CHIP OFF TO SOUND CONCRETE CLEAN & PATCH w/ EPOXY MORTAR, TYPICAL.	10 S-11.1 S-11.1
	3e	SPALLS ON CEILING (14sf).	SAWCUT DAMAGED SPALLS, CHIP OFF TO SOUND CONCRETE CLEAN & PATCH w/ EPOXY MORTAR, TYPICAL.	10 S-11.1 S-11.1
	4e	DETERIORATED DOOR SEALANT & SEAL (160lf SLNT, 112lf SEAL).	REMOVE EXISTING DOOR SEAL / SEALANT AND REPLACE WITH NEW.	
	5e	WALL CRACKS (16lf).	GRIND TRACES OF CRACKS, CLEAN AND INJECT WITH EPOXY MORTAR, SEE DETAIL.	8 S-11.1 S-11.1
	6e	BIRD DROPPINGS (135sf).	WATERBLAST EXISTING AFFECTED FLOOR AREAS, CLEAN AND PROVIDE NEW POLYURETHANE FLOOR COATING, TYPICAL.
