GMHA HOSPITAL ROOF AND ENVELOP UPGRADE PROJECT

PACKAGE A - 3RD & 4TH FLOOR ROOF AND ENVELOP (A,B, & E-WING)

GUAM MEMORIAL HOSPITAL AUTHORITY, TAMUNING, GUAM

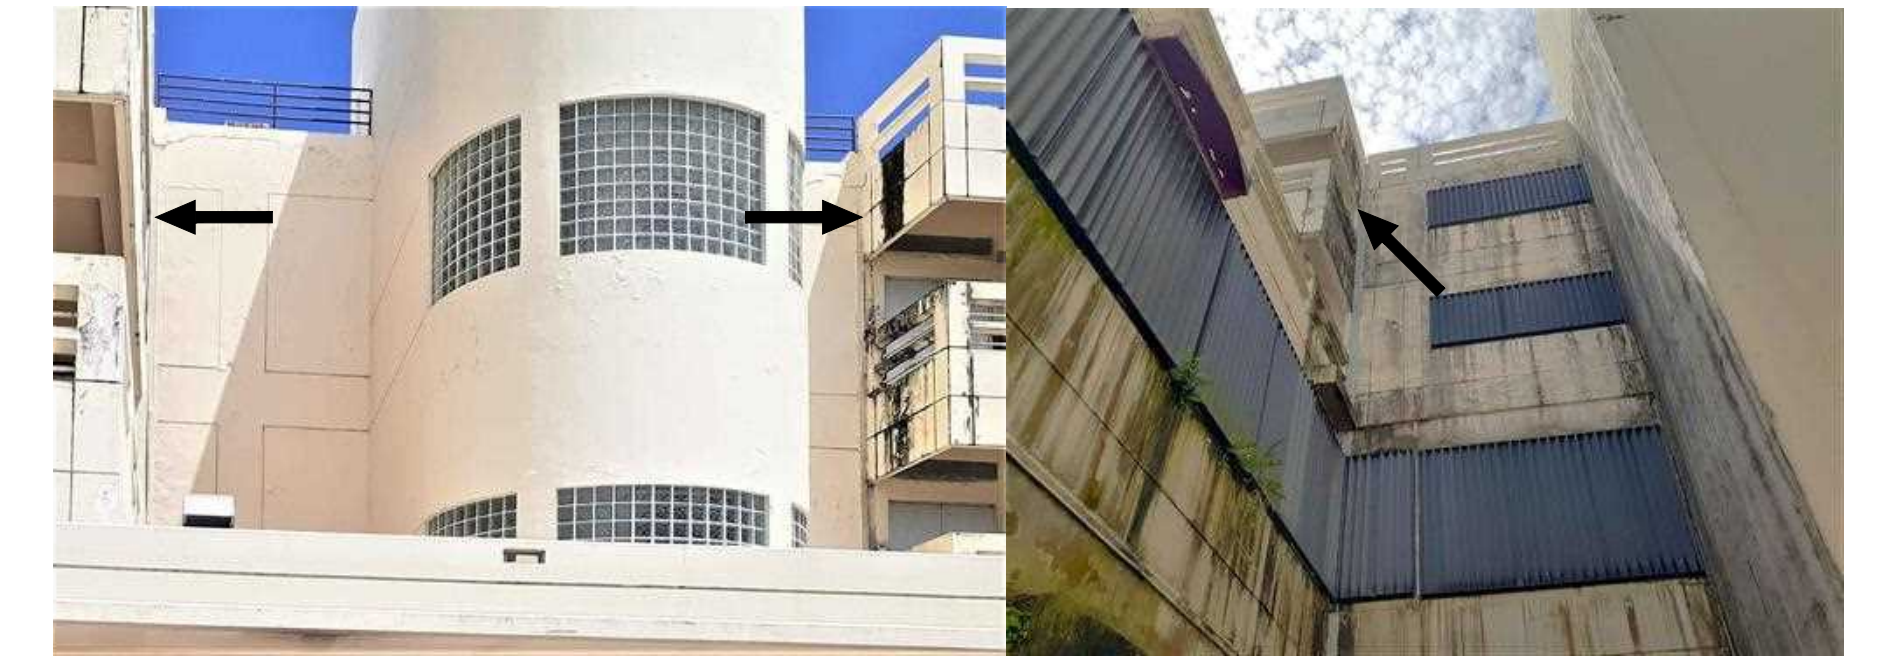
DETERIORATED VERTICAL SEISMIC JOINT, TYPICAL 4 PLACES (52 Lf)

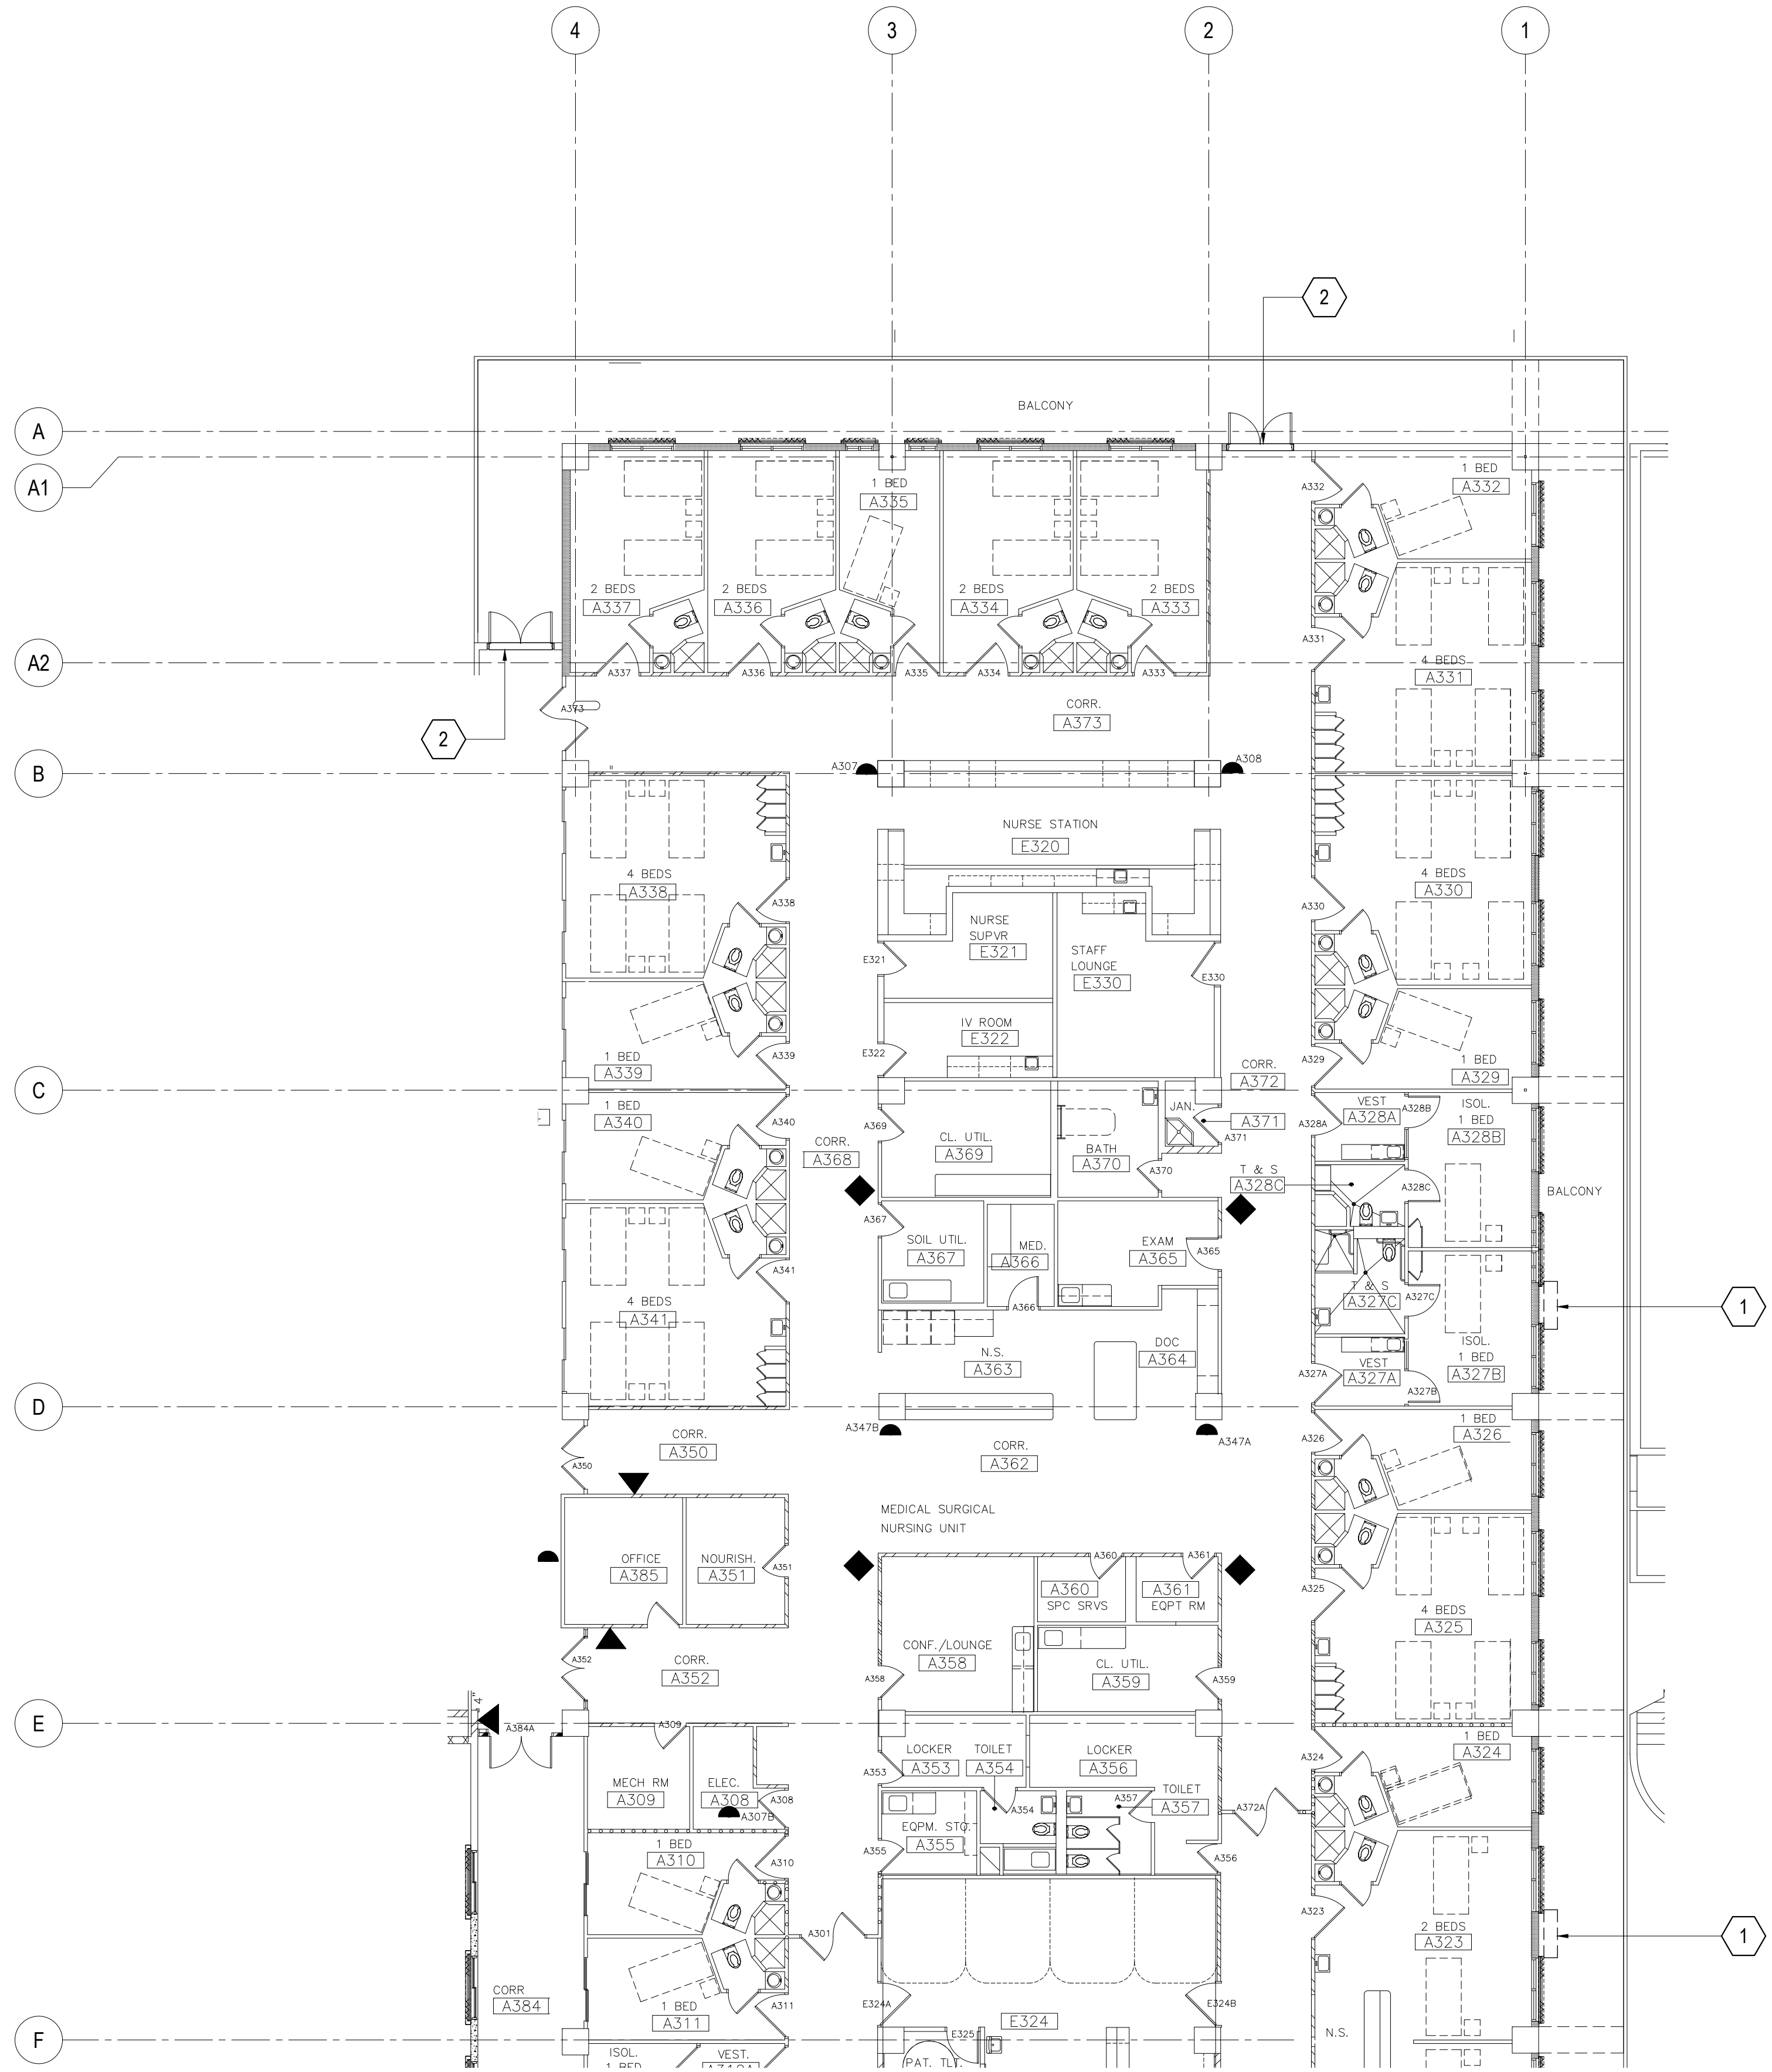
DEMO KEY NOTES:			
WING	MARK	DESCRIPTION	DETAIL SHOWN
A - WING THIRD FLOOR (EXTERIOR)	1	DETERIORATED EXHAUST DUCT/HOOD (2 LOC). REMOVE EXISTING WALL EXHAUST HOOD AND REPLACE WITH NEW.	
	2	DETERIORATED DOOR HEADER EXHAUST (2 LOC). REMOVE EXISTING DOOR HEADER EXHAUST GRILLE AND REPLACE WITH NEW.

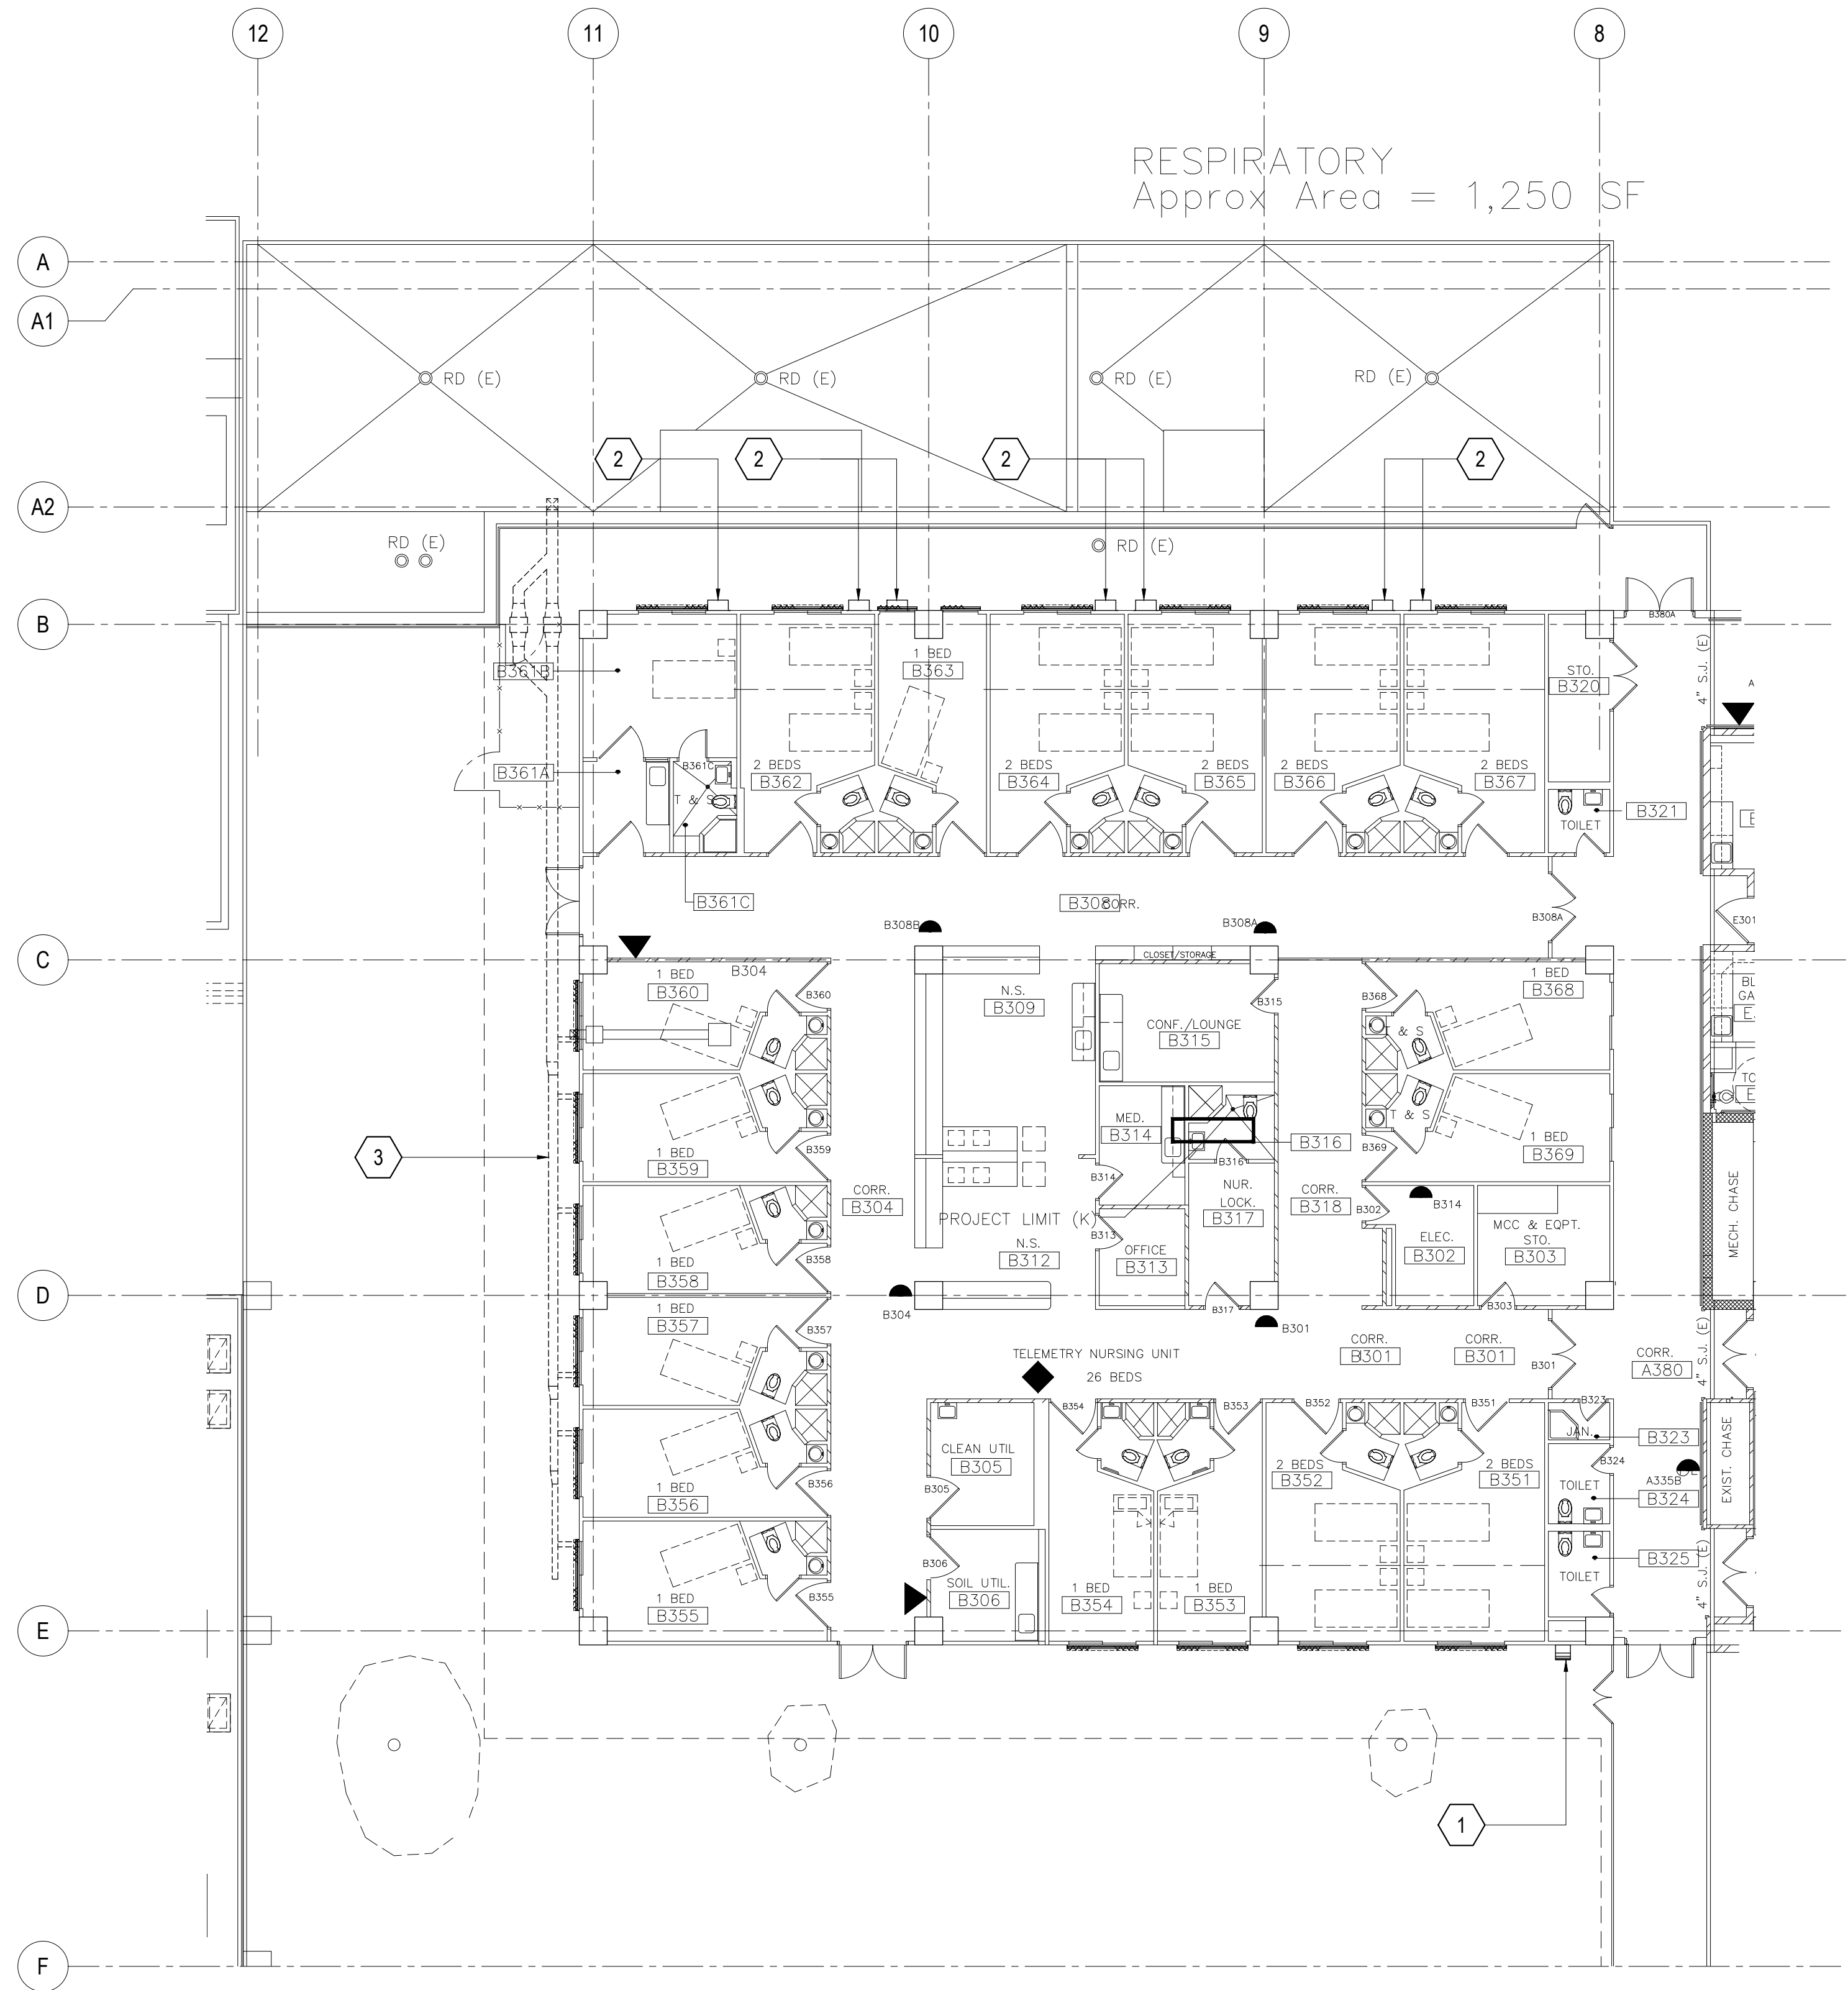
DEMO KEY NOTES:			
WING	MARK	DESCRIPTION	DETAIL SHOWN
B - WING_ 3RD FLOOR (EXTERIOR)	1	WALL MOUNTED EXHAUST HOOD RUSTED WITH BIRD DROPPING. REMOVE EXIST WALL MOUNTED HOOD & REPLACE WITH NEW.	
	2	DETERIORATED EXHAUST HOOD (7 ea). REMOVE EXIST WALL MOUNTED HOOD & REPLACE WITH NEW.	
	3	EXISTING EXTERIOR SUSPENDED AC DUCTING. PROVIDE STAINLESS STEEL ANTI BIRD SPIES ON ALL LEDGES SUCH AS PIPES, SPRINKLER SYSTEMS, STEEL BEAMS, BEAM LEDGES, WINDOW SHUTTERS HEAD, HVAC EXHAUST HOODS, AC UNITS, ETC. SEE 2 / S-10.1 FOR ANTI BIRD SPIES SPECIFICATIONS.

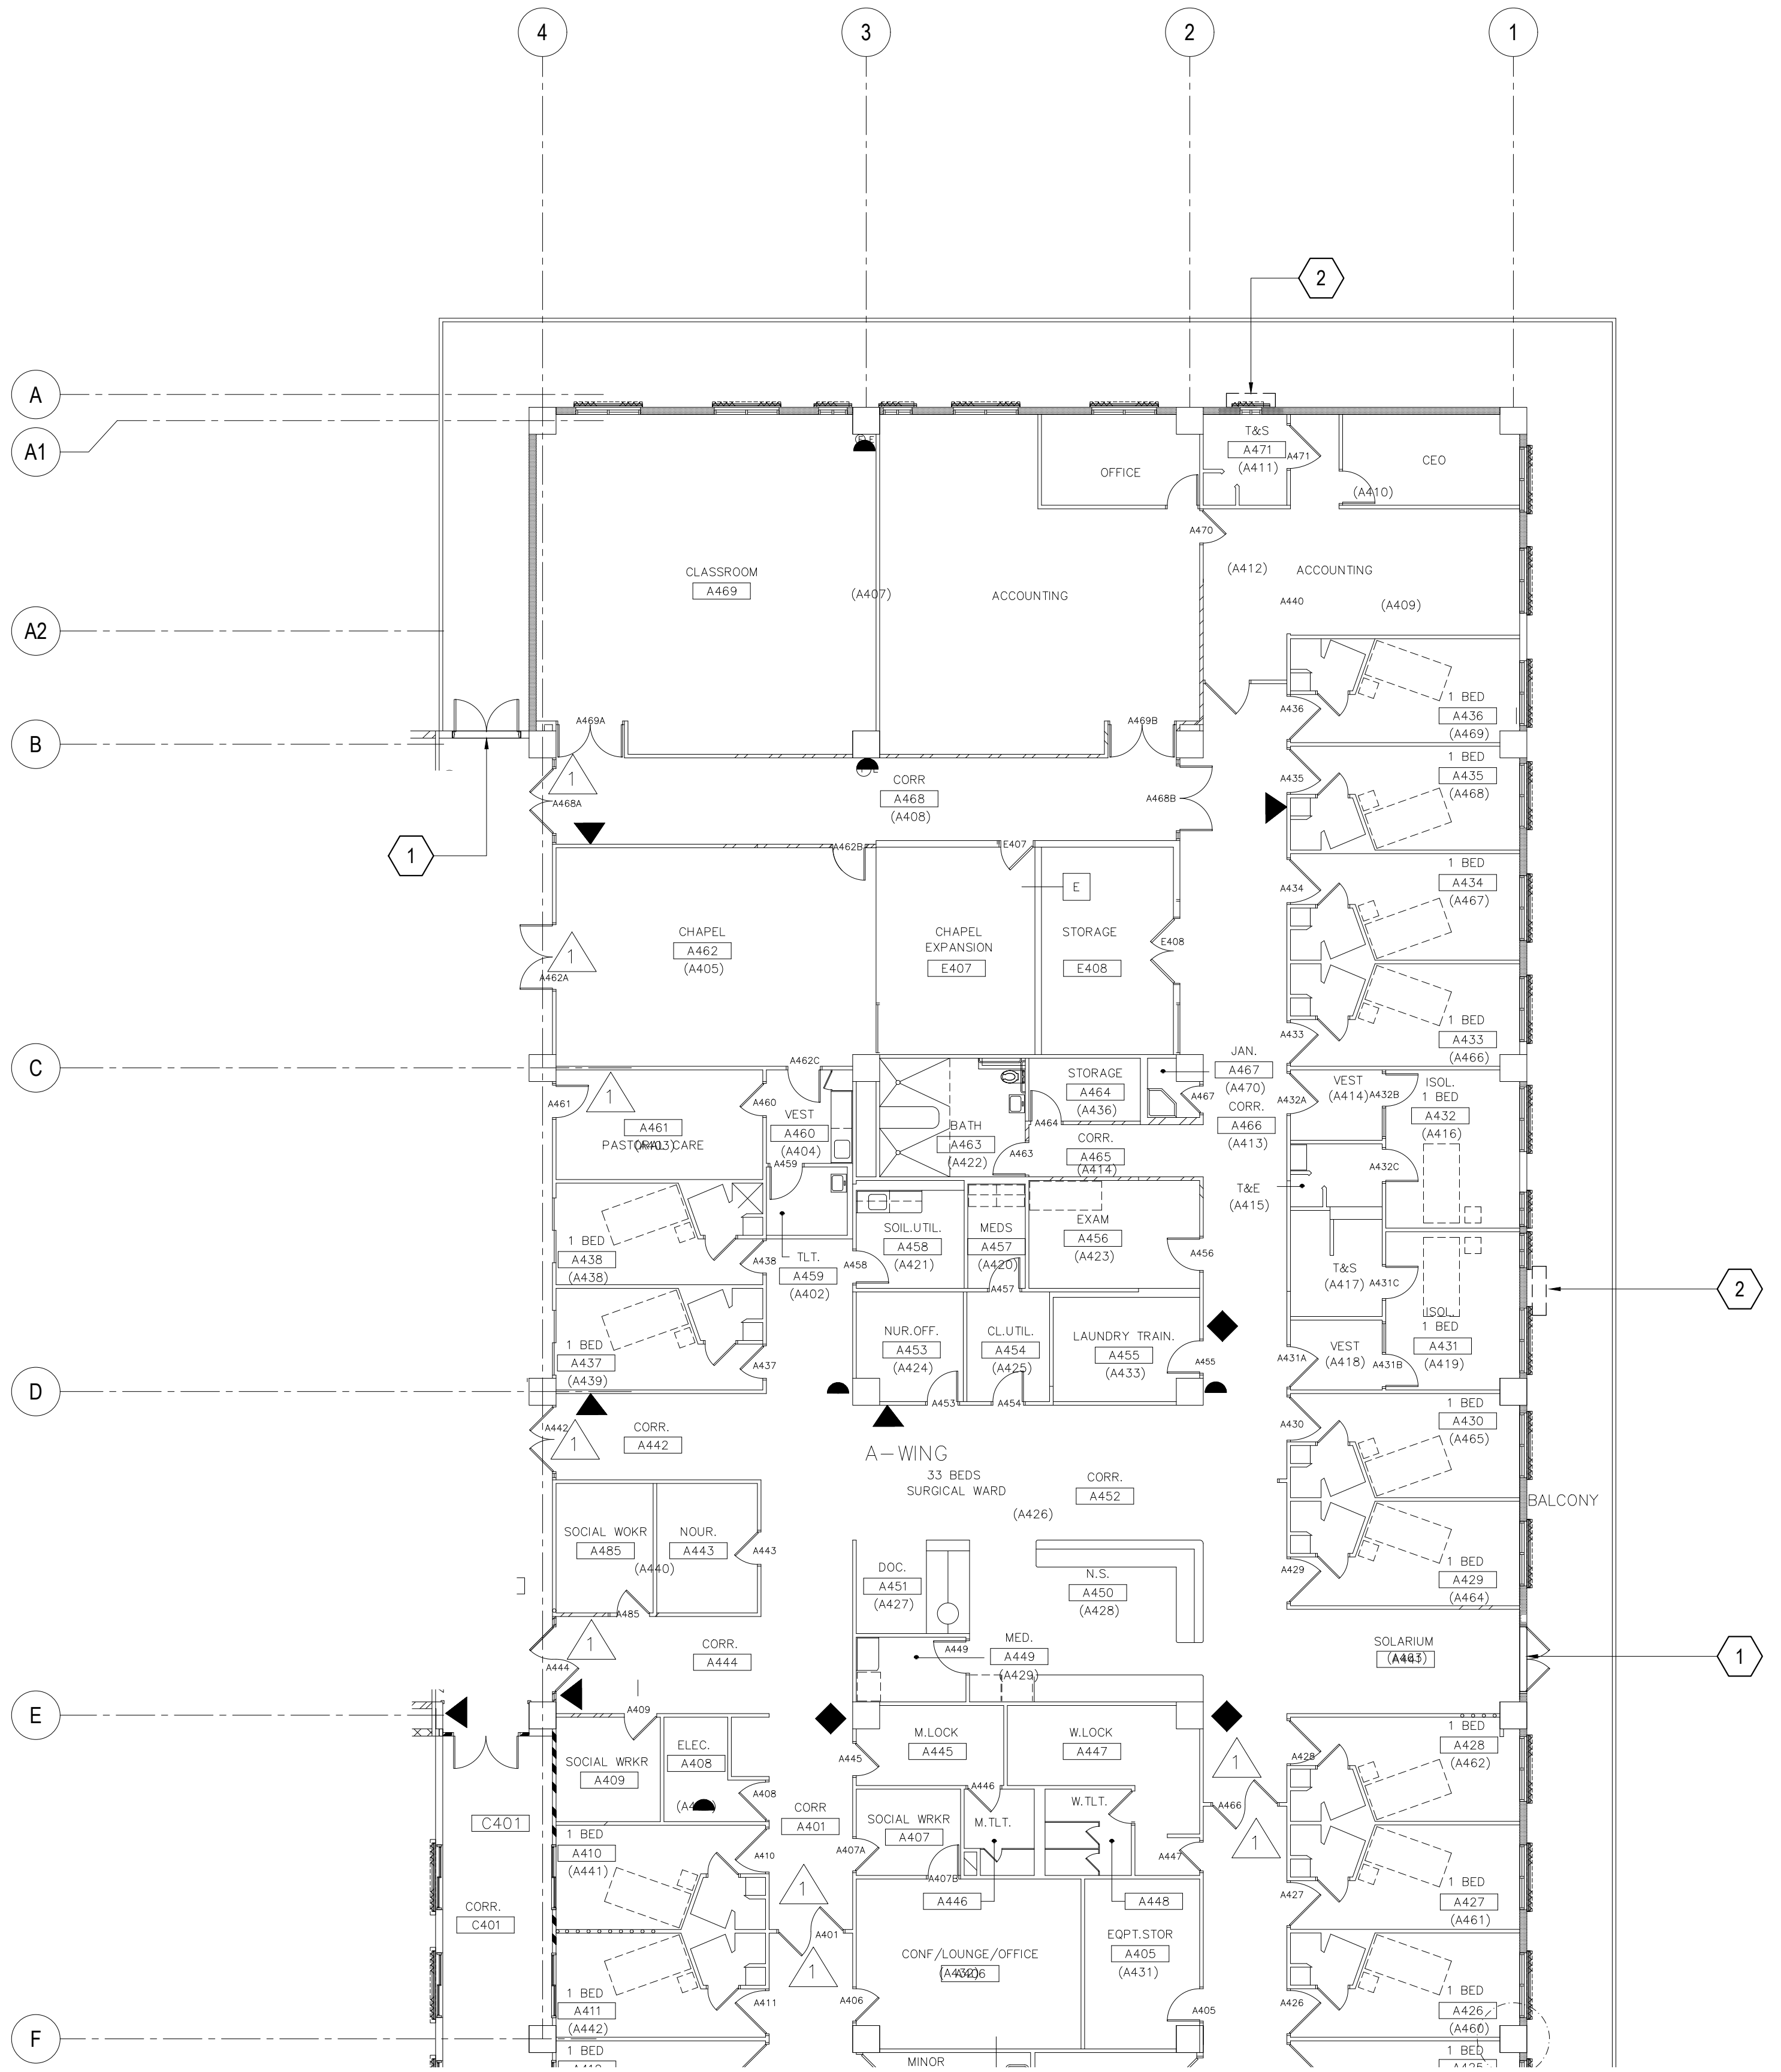
DEMO KEY NOTES:			
WING	MARK	DESCRIPTION	DETAIL SHOWN
A - WING FOURTH FLOOR (EXTERIOR)	1	BRO EN OVERHEAD DOOR AIR INTAKE REMOVE EXISTING DOOR HEADER EXHAUST GRILLE AND REPLACE WITH NEW.	
	2	DETERIORATED WALL EXHAUST HOOD REMOVE EXISTING WALL EXHAUST HOOD AND REPLACE WITH NEW.

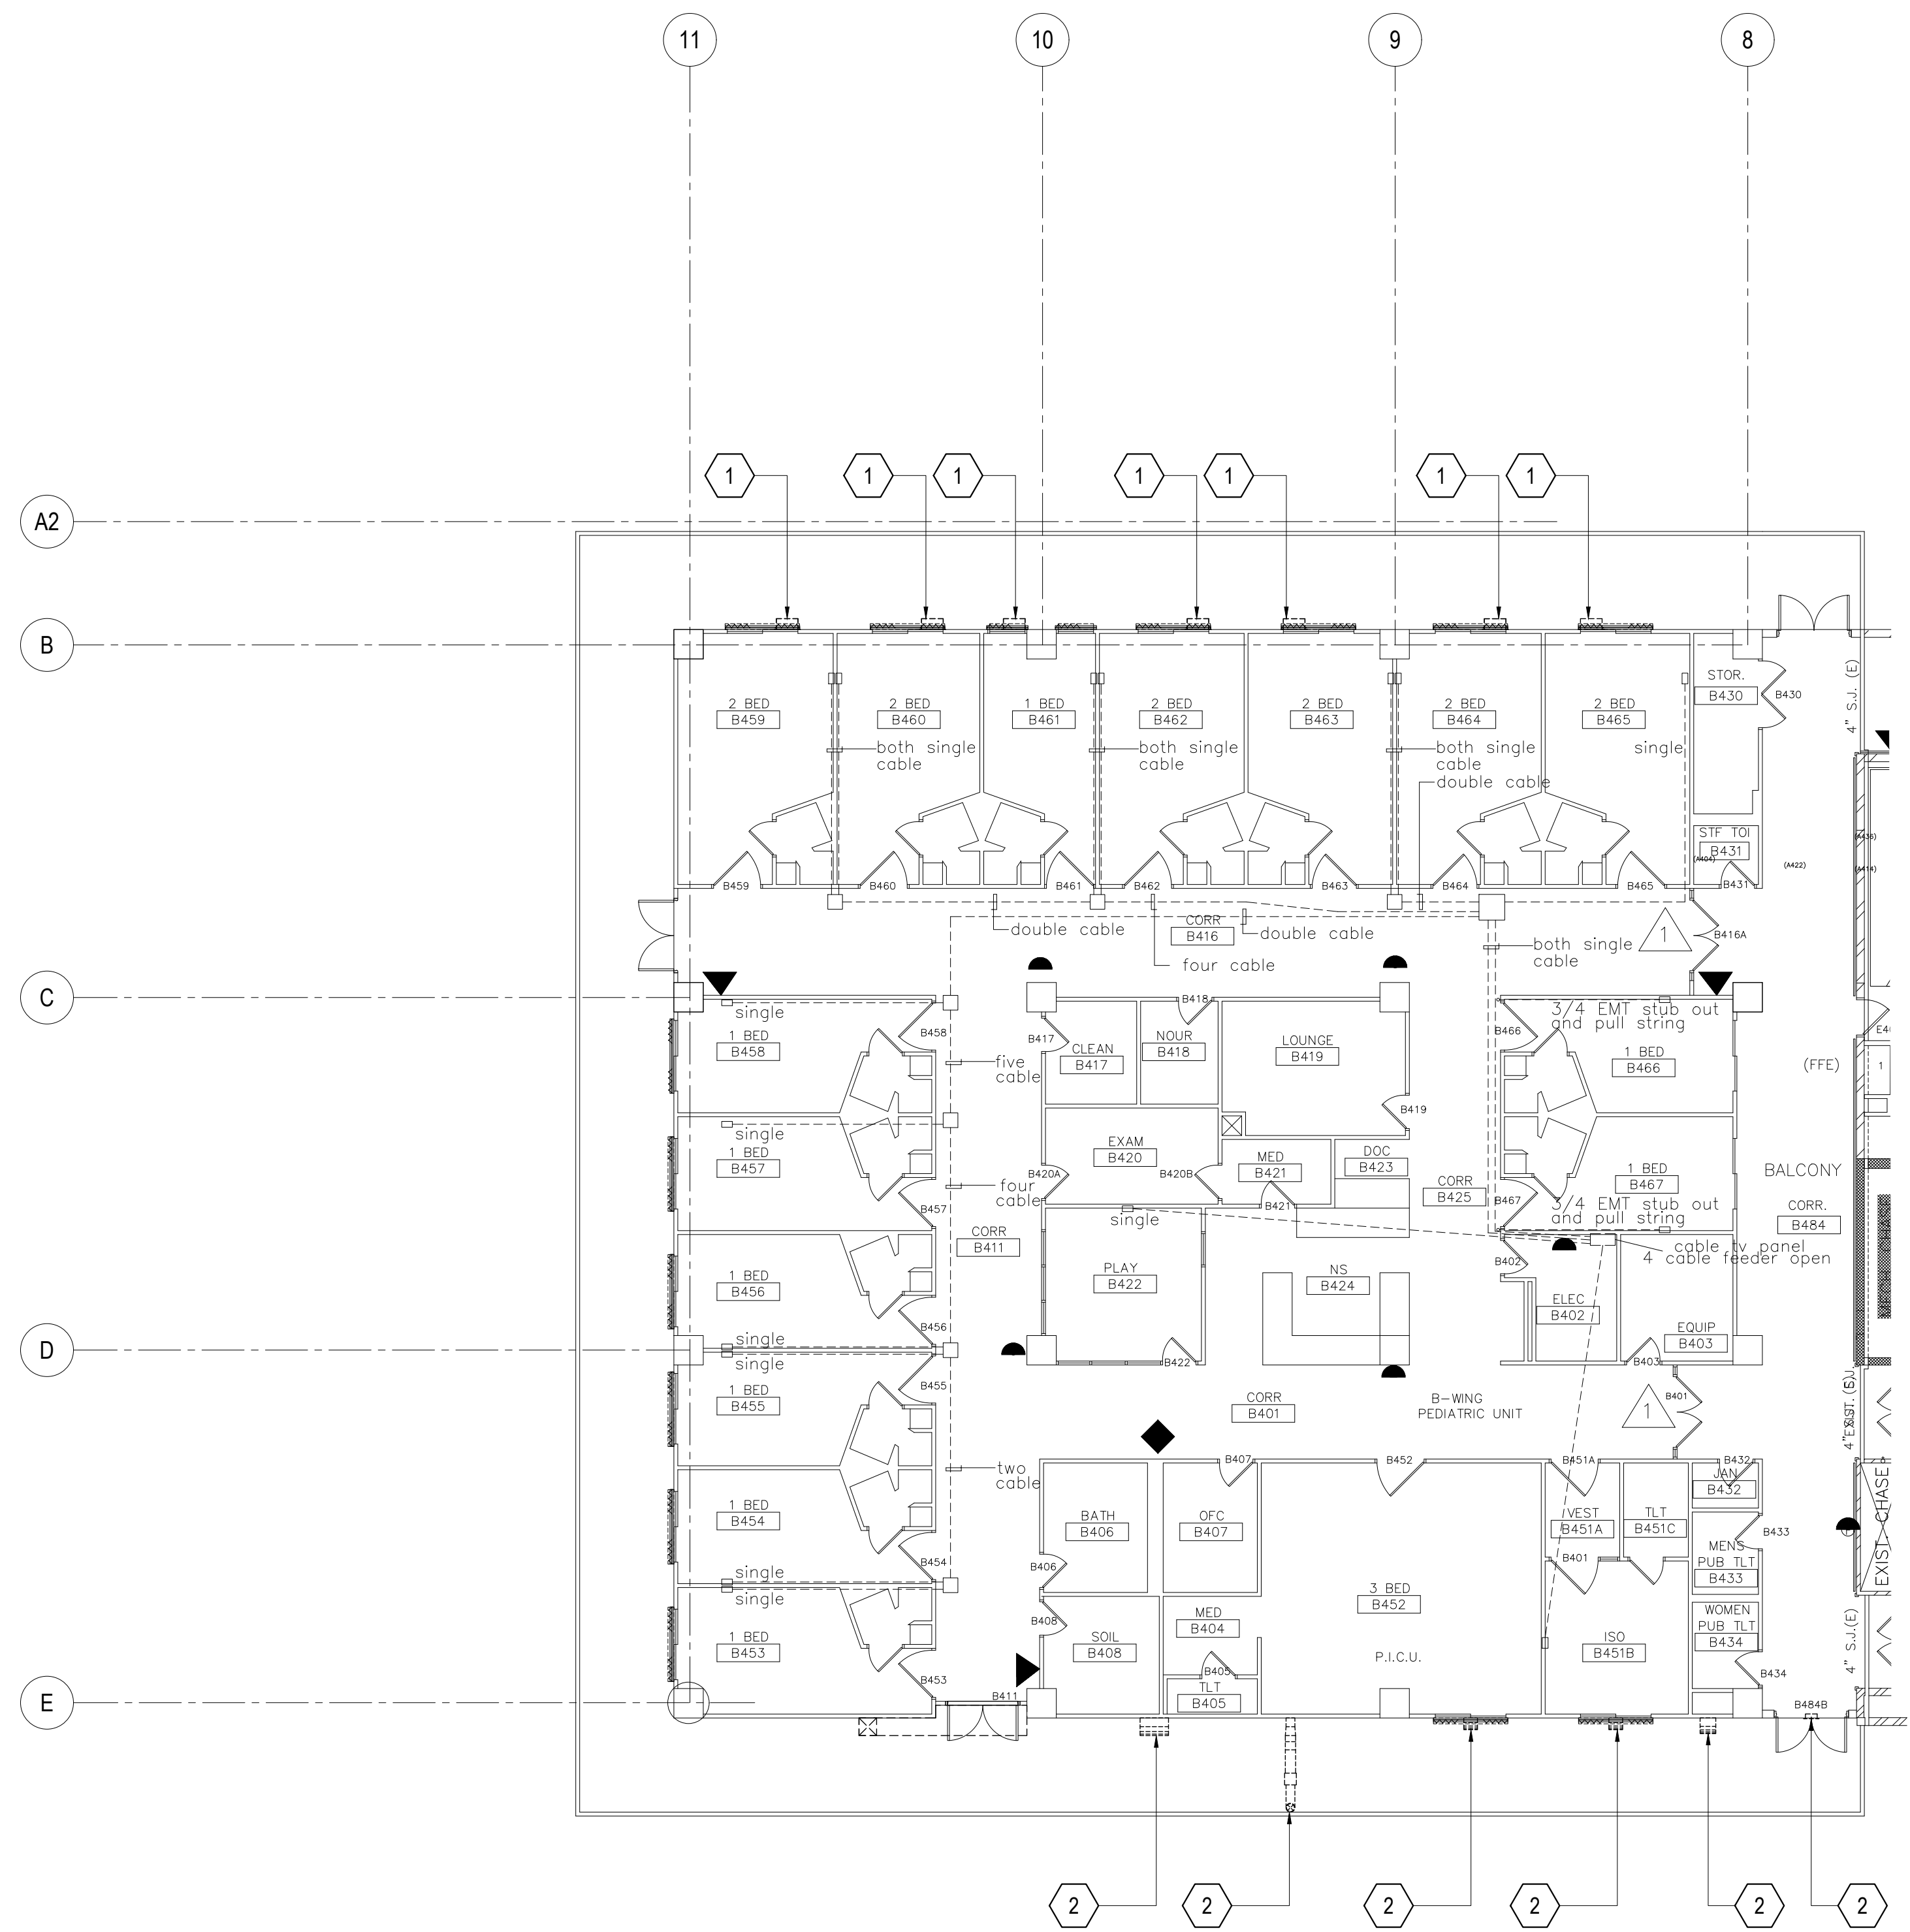
DEMO KEY NOTES:			
WING	MARK	DESCRIPTION	DETAIL SHOWN
B - WING - 4TH FLOOR (EXTERIOR)	1	DETERIORATED WALL EXHAUST HOOD (7 ea.). REMOVE EXISTING WALL EXHAUST HOOD AND REPLACE WITH NEW.	
	2	DETERIORATED WALL EXHAUST HOOD (6 ea.). REMOVE EXISTING WALL EXHAUST HOOD AND REPLACE WITH NEW.
