DRAWING INDEX

REV	DATE	BY	DESCRIPTION
GMHA NO. _____ GRANT ID NO. _____ CONTRACT NO. _____ PROJECT NO. _____		PROJECT: GMHA HOSPITAL AND ENVELOPE UPGRADE PROJECT	
DES. BY: kje DRN. BY: jl CHK. BY: rmca		CHIEF ENGR: - ENGR. SUP: - PROJ. ENGR: -	
I HEREBY CERTIFY THAT THIS PLAN WAS PREPARED BY ME OR UNDER MY DIRECT SUPERVISION DATE: 07-31-2024		CONTENTS: FIRST FLOOR PLAN _ A-WING: DAMAGED LOCATIONS, PHOTO KEY NOTES, SCOPE OF REPAIR WORKS, NOTES, and KEY PLAN	
DRAWING NO. S-1.2.1		SH. 07 OF 60

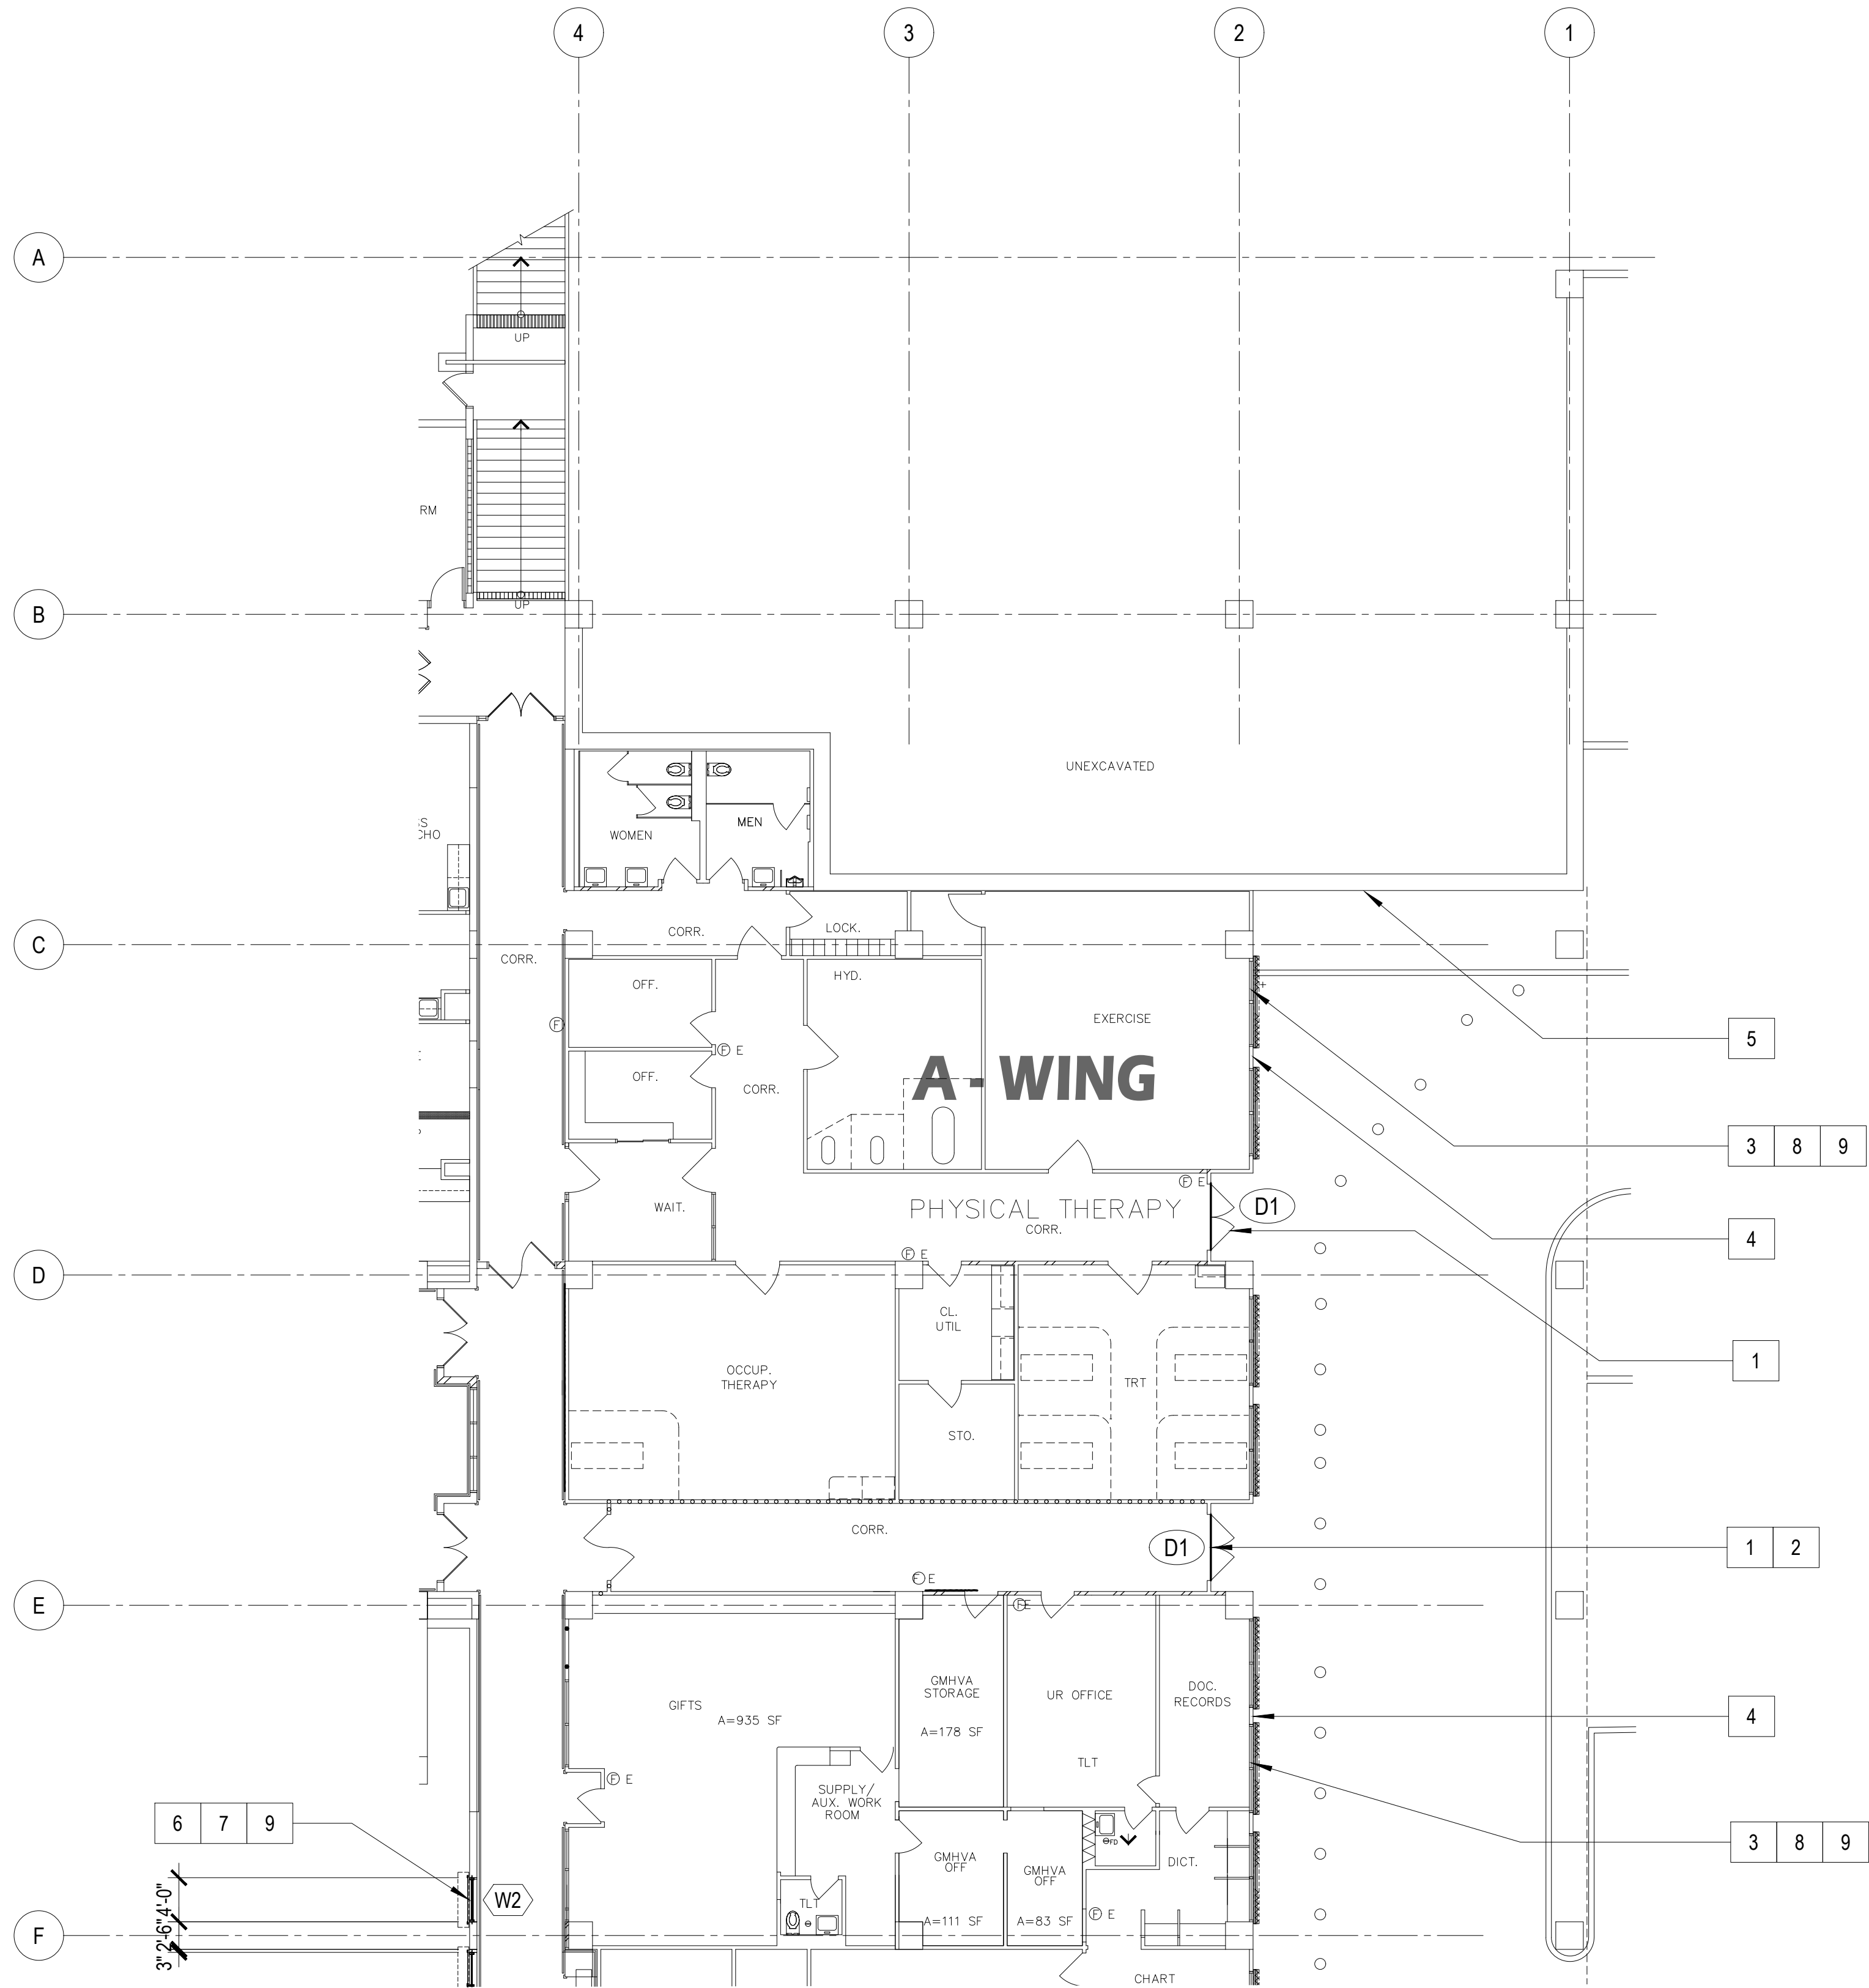
1 FIRST FLOOR PLAN _ A-WING: DAMAGED LOCATIONS
S-1.1 | S-1.2 SCALE: 3/32" = 1' - 0"

PHOTO KEY NOTES:			SCOPE of REPAIR WORKS:	
WING	PHOTO No.	DAMAGED DESCRIPTION	REPAIR METHODS	DETAIL SHOWN
A-WING _ FIRST FLOOR (EXTERIOR)	1e S-1.2 S-1.2.A	DETERIORATED DOOR SEALANT (80 Lf), SEAL (56 Lf) & DOOR THRESHOLD (12 Lf).	REMOVE EXISTING DOOR, SEALANT & SEAL, DOOR THRESHOLD and REPLACE WITH NEW, SEE DOOR SCHEDULE ON SHEET S-7.1.	1,2,3 S-9.1 S-9.1
	2e S-1.2 S-1.2.A	DETERIORATED WALL EXHAUST.	REMOVE EXISTING WALL SHEET METAL COVER and PROVIDE with NEW STAINLESS STEEL AIR INTAKE GRILL, TYPICAL. SEE MECHANICAL PLAN and DETAIL.	
	3e S-1.2 S-1.2.A	DETERIORATED WINDOW SEAL 7EA-2'x8' WIDE (280 Lf).	REMOVE EXISTING WINDOW SEAL and REPLACE WITH NEW, TYPICAL.	
	4e S-1.2 S-1.2.A	DETERIORATED WALL PAINT with MILDEW and STAINS.	WATERBLAST EXISTING WALL and PROVIDE NEW PAINT PER GMHA FACILITY STANDARD.	
	5e S-1.2 S-1.2.A	UNDERSLAB FLOOR & WALL JOINT CRACK (120 Lf).	GRIND TRACES OF WALL JOINT CRACKS, CLEAN and INJECT WITH EPOXY MORTAR, SEE DETAIL.	8 S-10.1 S-10.1

6e S-1.2 S-1.2.A	DETERIORATED FIXED GLASS WINDOW CURTAIN WALL.	REMOVE FIXED GLASS WINDOW CURTAIN WALLS and ITS ACCESSORIES and REPLACE with NEW FIXED GLASS WINDOW.	1,2,3 S-9.1 S-9.1
	7e S-1.2 S-1.2.A	DETERIORATED WINDOW SHUTTERS.	REMOVE EXISTING WINDOW SHUTTERS and ITS ACCESSORIES and REPLACE WITH NEW EXTERIOR MOUNTED TYPHOON RATED INTERLOCKING ALUMINUM SLATS ROLL-UP SHUTTERS WITH MANUAL OPERATING SYSTEM. VERIFY WIDTH and HEIGHT OF EXISTING WALL OPENING.	4 S-11.1 S-11.1
	8e S-1.2 S-1.2.A	DETERIORATED WINDOW ACCORDION SHUTTERS	REMOVE EXISTING WINDOW ACCORDION SHUTTERS and ITS ACCESSORIES and REPLACE WITH NEW ALUMINUM ACCORDION SHUTTER, TYPICAL AT EXTERIOR CORRIDORS. REFER TO GMHA FOR COLOR SELECTION.	
	9e S-1.2 S-1.2.A	BIRDS DROPPINGS PRESENT ON BEAM, HOODS, PIPES, DUCT WORK, SHUTTER HEAD, ETC. FROM LIGHT TO HEAVILY INFESTED NARROW TO EXTRA WIDE AREAS.	PROVIDE STAINLESS STEEL ANTI BIRD SPIKES ON ALL LEDGES SUCH AS PIPES, SPRINKLER SYSTEMS, STEEL BEAMS, WINDOW SHUTTERS HEAD, HVAC EXHAUST HOODS, AC UNITS, ETC. and PVC AviAngle LEDGE SHIELD ON CONCRETE BEAM LEDGES. SEE SHEET S-9.1 FOR PVC AviAngle LEDGE SHIELD and ANTI BIRD SPIKES SPECIFICATIONS.	5 S-11.1 S-11.1

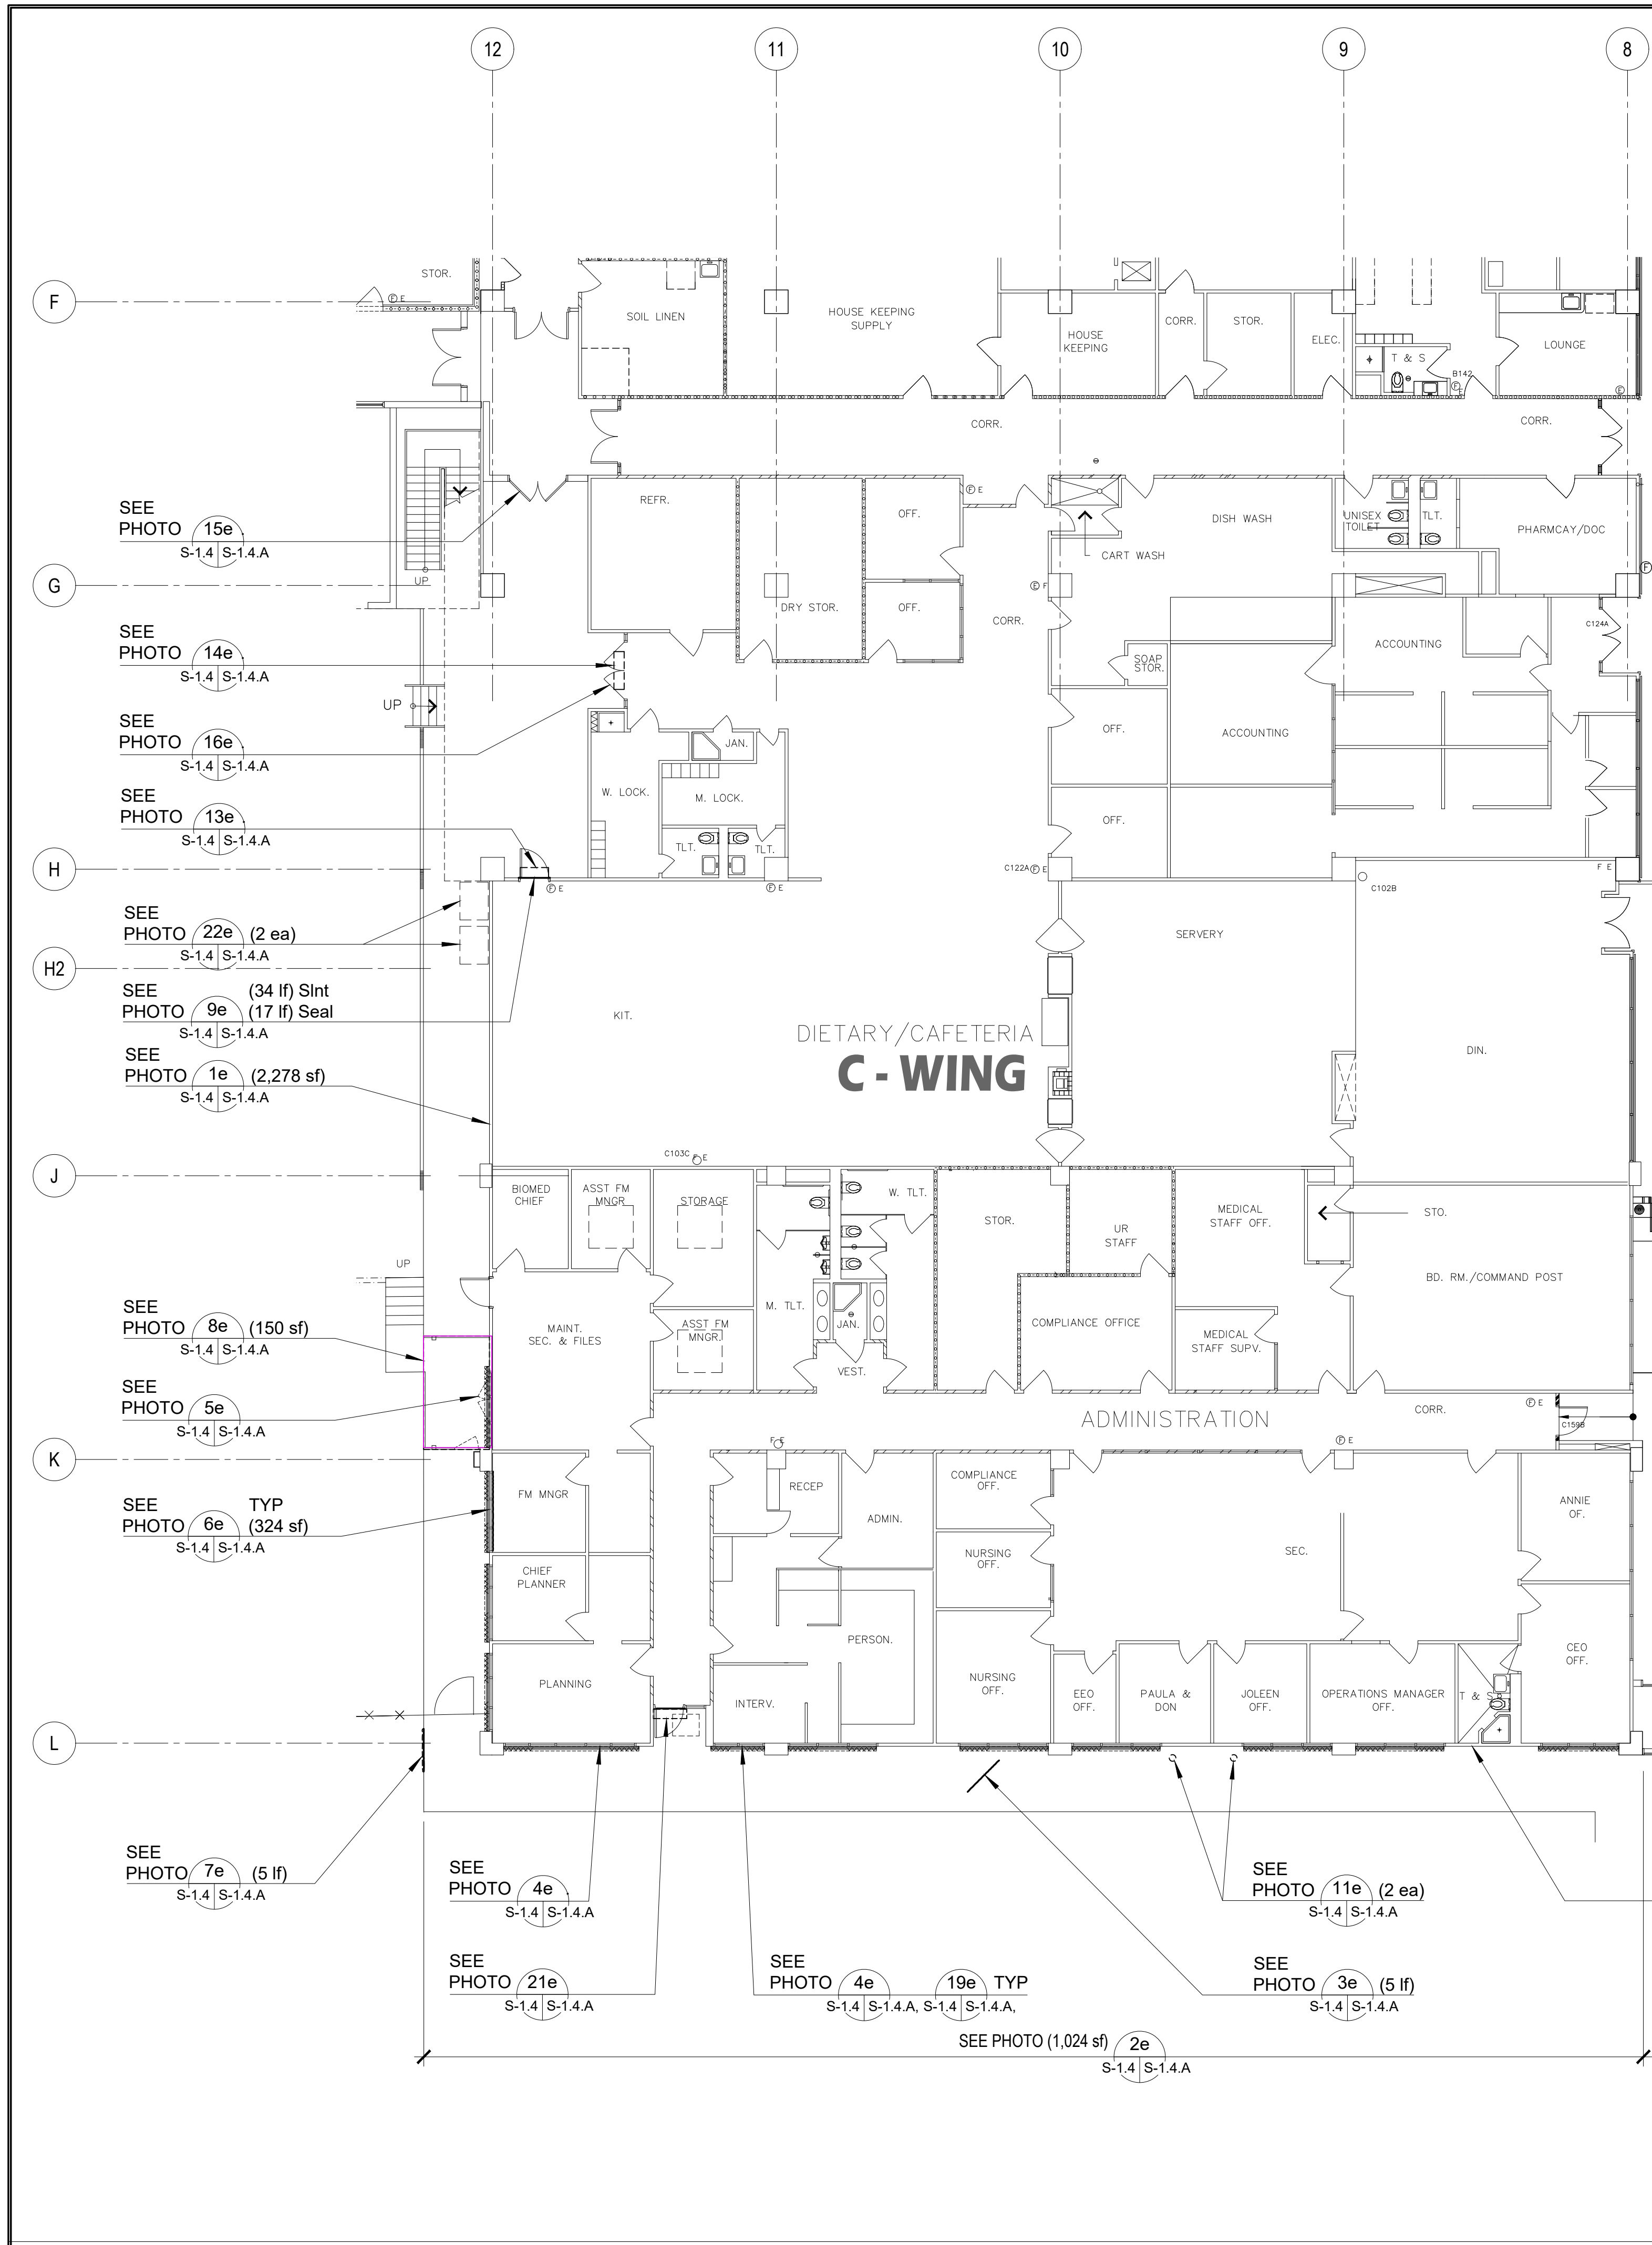
1 FIRST FLOOR PLAN _ C-WING; DAMAGED LOCATIONS
S-1.1 | S-1.4 SCALE: 3/32" = 1' - 0"

PHOTO KEY NOTES:		SCOPE of REPAIR WORKS:		
WING	PHOTO No.	DAMAGED DESCRIPTION	REPAIR METHODS	DETAIL SHOWN
C-WING FIRST FLOOR (EXTERIOR)	1e S-1.4 S-1.4.A	CONCRETE WALL PAINT DETERIORATED (6,239 sf).	WATERBLAST EXISTING OF WALL, GRIND TRACES OF CRACKS, CLEAN and INJECT WITH EPOXY MORTAR, and PROVIDE NEW PAINT PER GMHA FACILITY STANDARD.	3 S-12.1 S-12.1
	2e S-1.4 S-1.4.A	MOLD AND MILDEW ON FASCIA (1024 SF).	WATERBLAST TO CLEAN EXISTING FASCIA and PROVIDE NEW PAINT PER GMHA FACILITY STANDARD.	
	3e S-1.4 S-1.4.A	CEILING CRACKS (5 lf).	GRIND TRACES OF CRACKS, CLEAN and INJECT WITH EPOXY MORTAR, SEE DETAIL.	5 S-12.1 S-12.1
	4e S-1.4 S-1.4.A	DETERIORATED WINDOW SEAL (644 lf).	REMOVE and REPLACE EXISTING WINDOW SEAL, TYPICAL.	
	5e S-1.4 S-1.4.A	MECHANICAL EQUIPMENT DOOR BROKEN and RUSTED 2 ea).	REMOVE EXISTING DOOR and ITS ACCESSORIES and REPLACE WITH NEW INSULATED STEEL DOOR.	5,6 S-8.1 S-8.1
	6e S-1.4 S-1.4.A	WINDOW STAINED and MILDEW (324 sf).	REMOVE EXISTING GLASS WINDOWS & REPLACE w/ NEW, TYPICAL

7e S-1.4 S-1.4.A	DETERIORATED CONCRETE PARAPET (5 lf).	REMOVE DAMAGED AREAS PAINT FLAKING, STAIN and MILDEW, CLEAN and PATCH WITH CEMENT GROUT and PROVIDE NEW PAINT.	
	8e S-1.4 S-1.4.A	DETERIORATED MEZZANINE FLOOR GRATING (150 sf).	REMOVE EXISTING GRATINGS and REPLACE WITH NEW.	
	9e S-1.4 S-1.4.A	FAILED DOOR SEAL (17 lf), THRESHOLD (3 lf) and SEALANT (34 lf).	REMOVE EXISTING DOOR SEAL, SEALANT, THRESHOLD and REPLACE WITH NEW, TYPICAL.	
	10e S-1.4 S-1.4.A	DETERIORATED MECHANICAL AIR INTAKE GRILLE on WALL.	REMOVE EXISTING AIR INTAKE GRILLE and REPLACE w/ NEW to MATCH EXISTING, SEE MECHANICAL PLAN and DETAIL.	
	11e S-1.4 S-1.4.A	CONCRETE FLOOR HOLE ABOVE (2 ea).	PATCH HOLE WITH CEMENT GROUT and PROVIDE NEW PAINT.	
	12e S-1.4 S-1.4.A	DETERIORATED EXHAUST HOOD.	REMOVE EXISTING WALL EXHAUST HOOD and REPLACE w/ NEW STAINLESS STEEL to MATCH EXISTING, SEE MECHANICAL PLAN and DETAIL.	
	13e S-1.4 S-1.4.A	DETERIORATED DOOR HEAD BLOWER.	REMOVE and REPLACE EXISTING DOOR HEAD BLOWER with NEW to MATCH EXISTING, SEE MECHANICAL PLAN and DETAIL.

14e S-1.4 S-1.4.A	DETERIORATED DOOR HEAD BLOWER.	REMOVE and REPLACE EXISTING DOOR HEAD BLOWER with NEW to MATCH EXISTING, SEE MECHANICAL PLAN and DETAIL.	
	15e S-1.4 S-1.4.A	DETERIORATED DOOR with VISION PANEL.	REMOVE EXISTING DOOR with VISION PANEL and ITS ACCESSORIES and REPLACE with NEW to MATCH EXISTING.	1,2,3,9 S-8.1 S-8.1
	16e S-1.4 S-1.4.A	DETERIORATED DOOR with FIXED WINDOW SIDE PANEL.	REMOVE EXISTING DOOR with WINDOW SIDE PANEL and ITS ACCESSORIES and REPLACE with NEW to MATCH EXISTING.	1,2,3,10 S-8.1 S-8.1
	17e S-1.4 S-1.4.A	DETERIORATED FIXED GLASS WINDOW CURTAIN WALL.	REMOVE FIXED GLASS WINDOW CURTAIN WALLS and ITS ACCESSORIES and REPLACE with NEW FIXED GLASS WINDOW.	1,2,3,7 S-9.1 S-9.1
	18e S-1.4 S-1.4.A	DETERIORATED WINDOW SHUTTERS.	REMOVE EXISTING WINDOW SHUTTERS and ITS ACCESSORIES and REPLACE WITH NEW EXTERIOR MOUNTED TYPHOON RATED INTERLOCKING ALUMINUM SLATS-UP SHUTTERS WITH MANUAL OPERATING SYSTEM. VERIFY WIDTH and HEIGHT OF EXISTING WALL OPENING.	4 S-11.1 S-11.1

19e S-1.4 S-1.4.A	DETERIORATED WINDOW ACCORDION SHUTTERS	REMOVE EXISTING WINDOW ACCORDION SHUTTERS and ITS ACCESSORIES and REPLACE WITH NEW ALUMINUM ACCORDION SHUTTER, TYPICAL AT EXTERIOR CORRIDORS. REFER TO GMHA FOR COLOR SELECTION.	
	20e S-1.4 S-1.4.A	BIRDS DROPPINGS PRESENT ON BEAM, HOODS, PIPES, DUCT WORK, SHUTTER HEAD, ETC. FROM LIGHT TO HEAVILY INFESTED NARROW TO EXTRA WIDE AREAS.	PROVIDE STAINLESS STEEL ANTI BIRD SPIKES ON ALL LEDGES SUCH AS PIPES, SPRINKLER SYSTEMS, STEEL BEAMS, WINDOW SHUTTERS HEAD, HVAC EXHAUST HOODS, AC UNITS, ETC. and PVC AviAngle LEDGE SHIELD ON CONCRETE BEAM LEDGES. SEE SHEET S-9.1 FOR PVC AviAngle LEDGE SHIELD and ANTI BIRD SPIKES SPECIFICATIONS.	5 S-11.1 S-11.1
	21e S-1.4 S-1.4.A	DETERIORATED DOOR HEAD BLOWER, and CEILING ACCESS DOOR HATCH.	REMOVE and REPLACE EXISTING DOOR HEAD BLOWER with NEW to MATCH EXISTING, SEE MECHANICAL PLAN and DETAIL.	
	22e S-1.4 S-1.4.A	DETERIORATED EXHAUST HOOD.	REMOVE EXISTING WALL EXHAUST HOOD and REPLACE w/ NEW STAINLESS STEEL to MATCH EXISTING, SEE MECHANICAL PLAN and DETAIL.

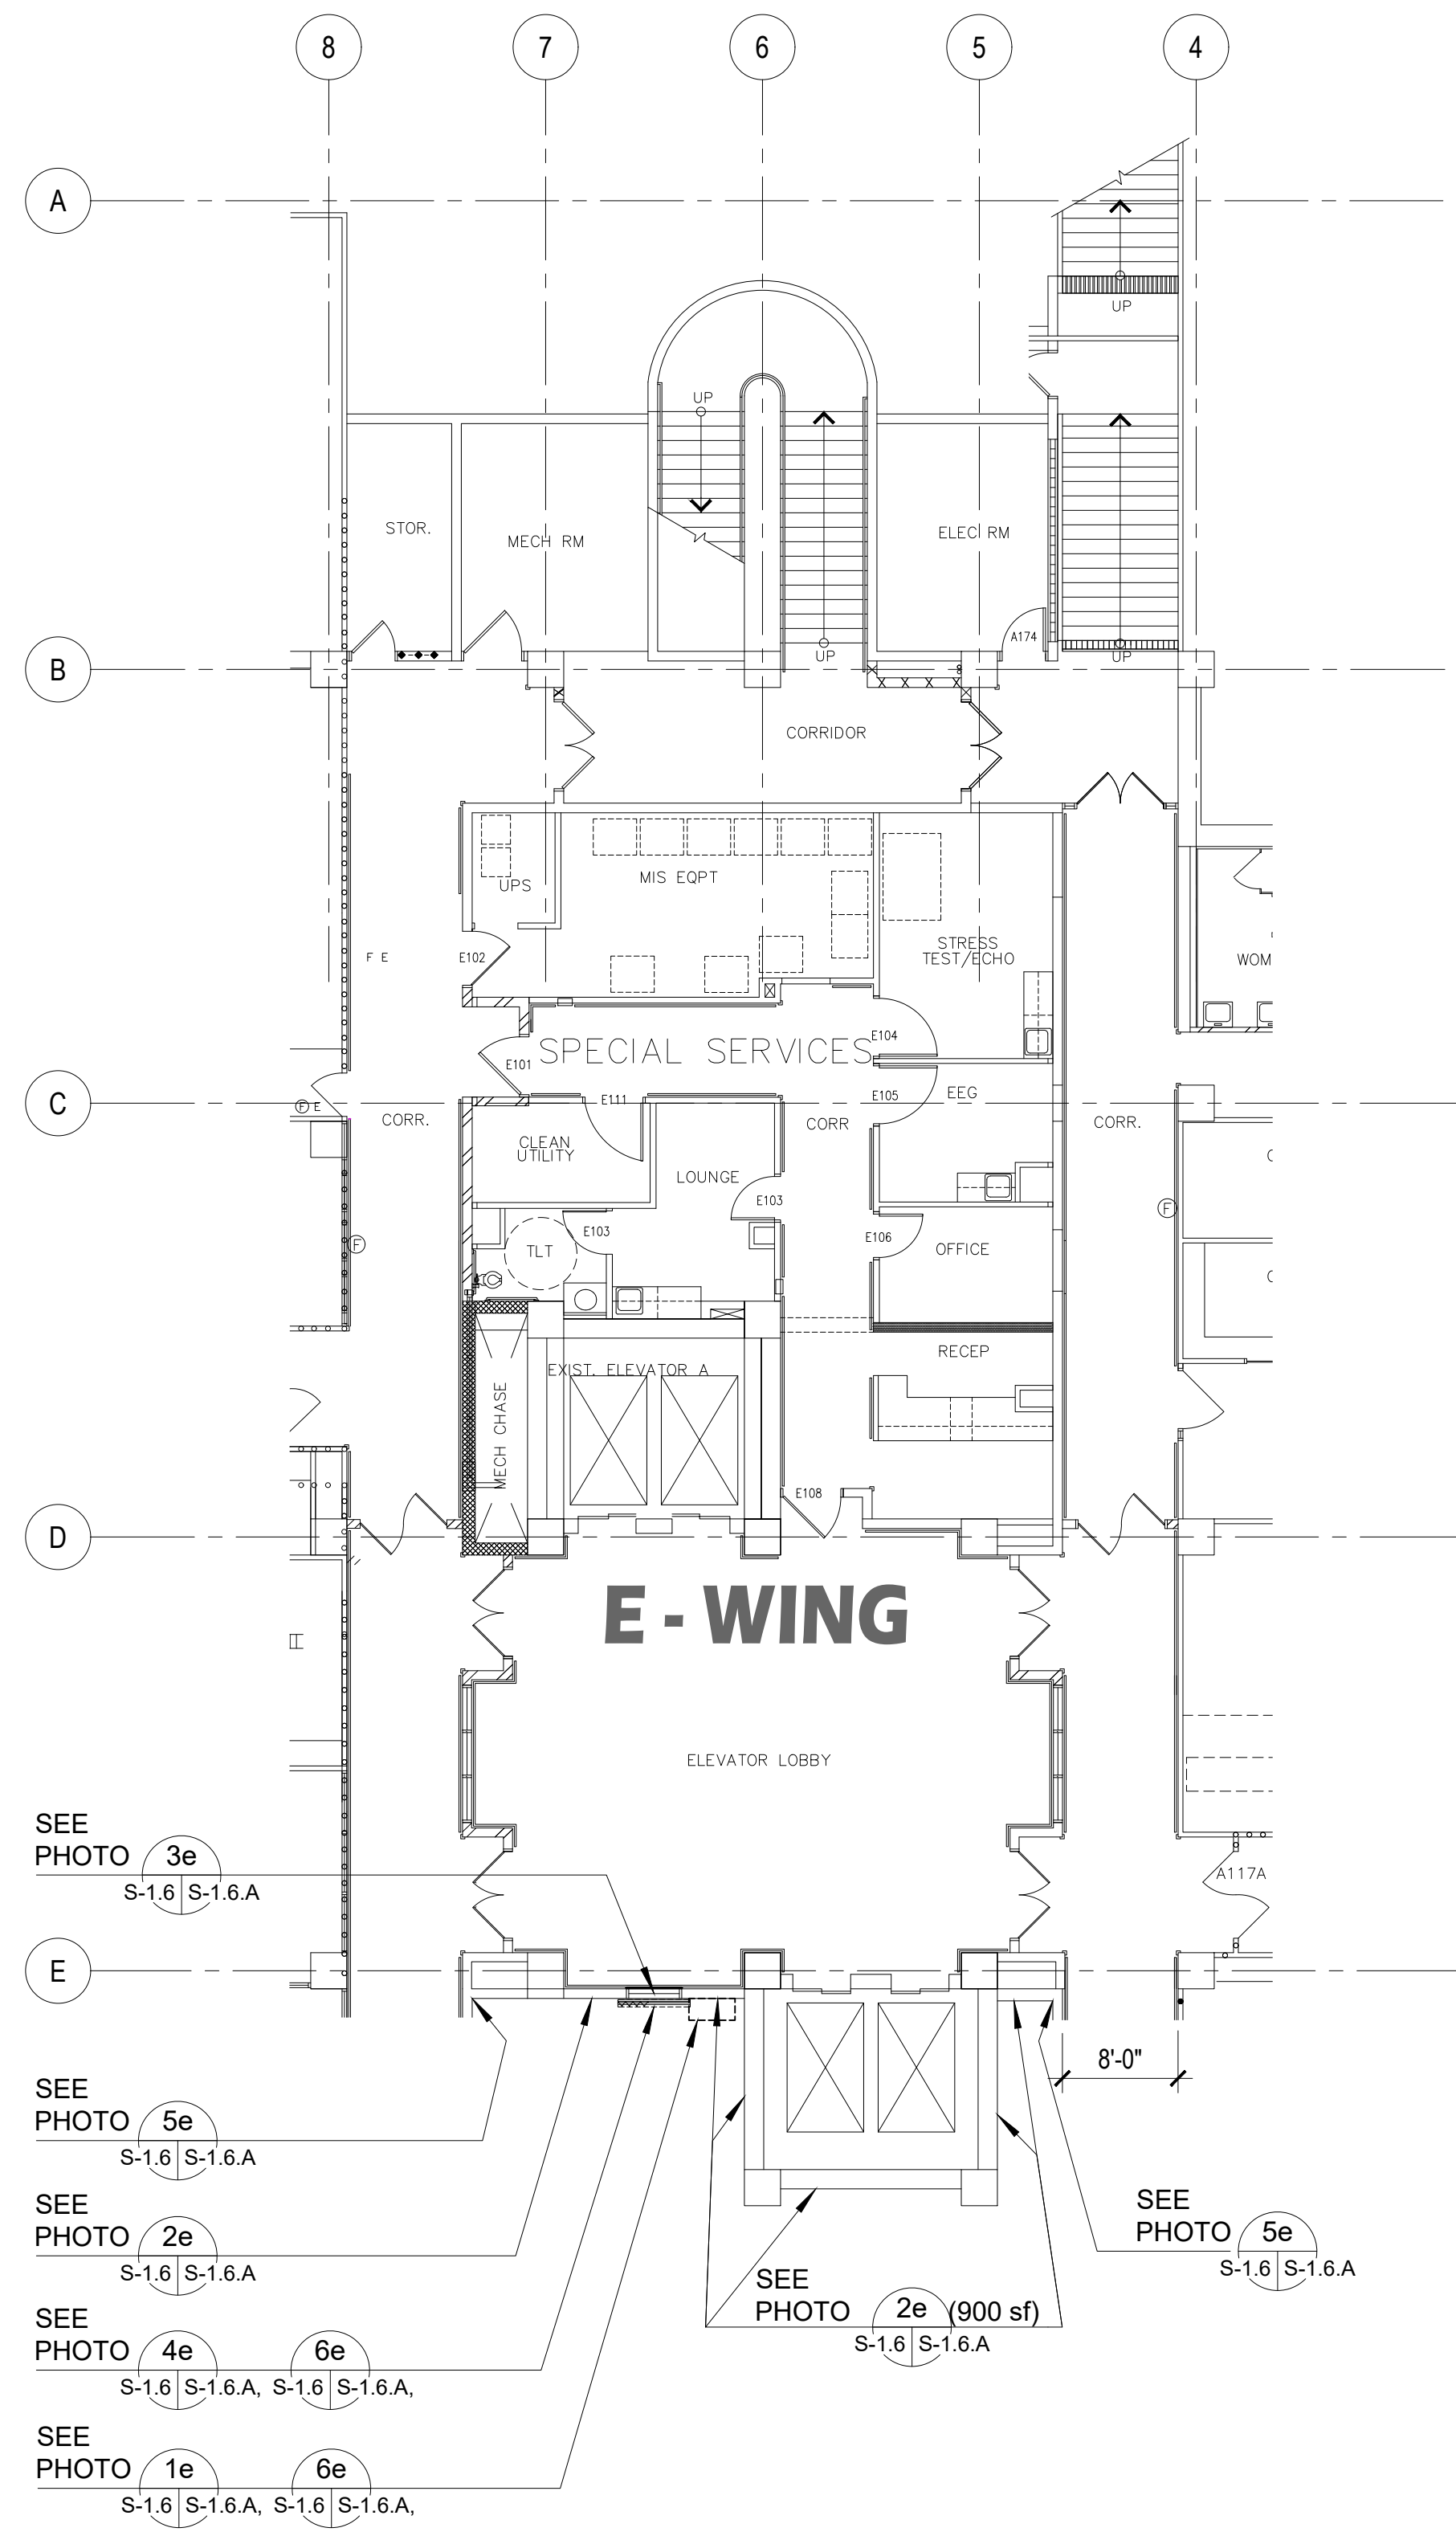
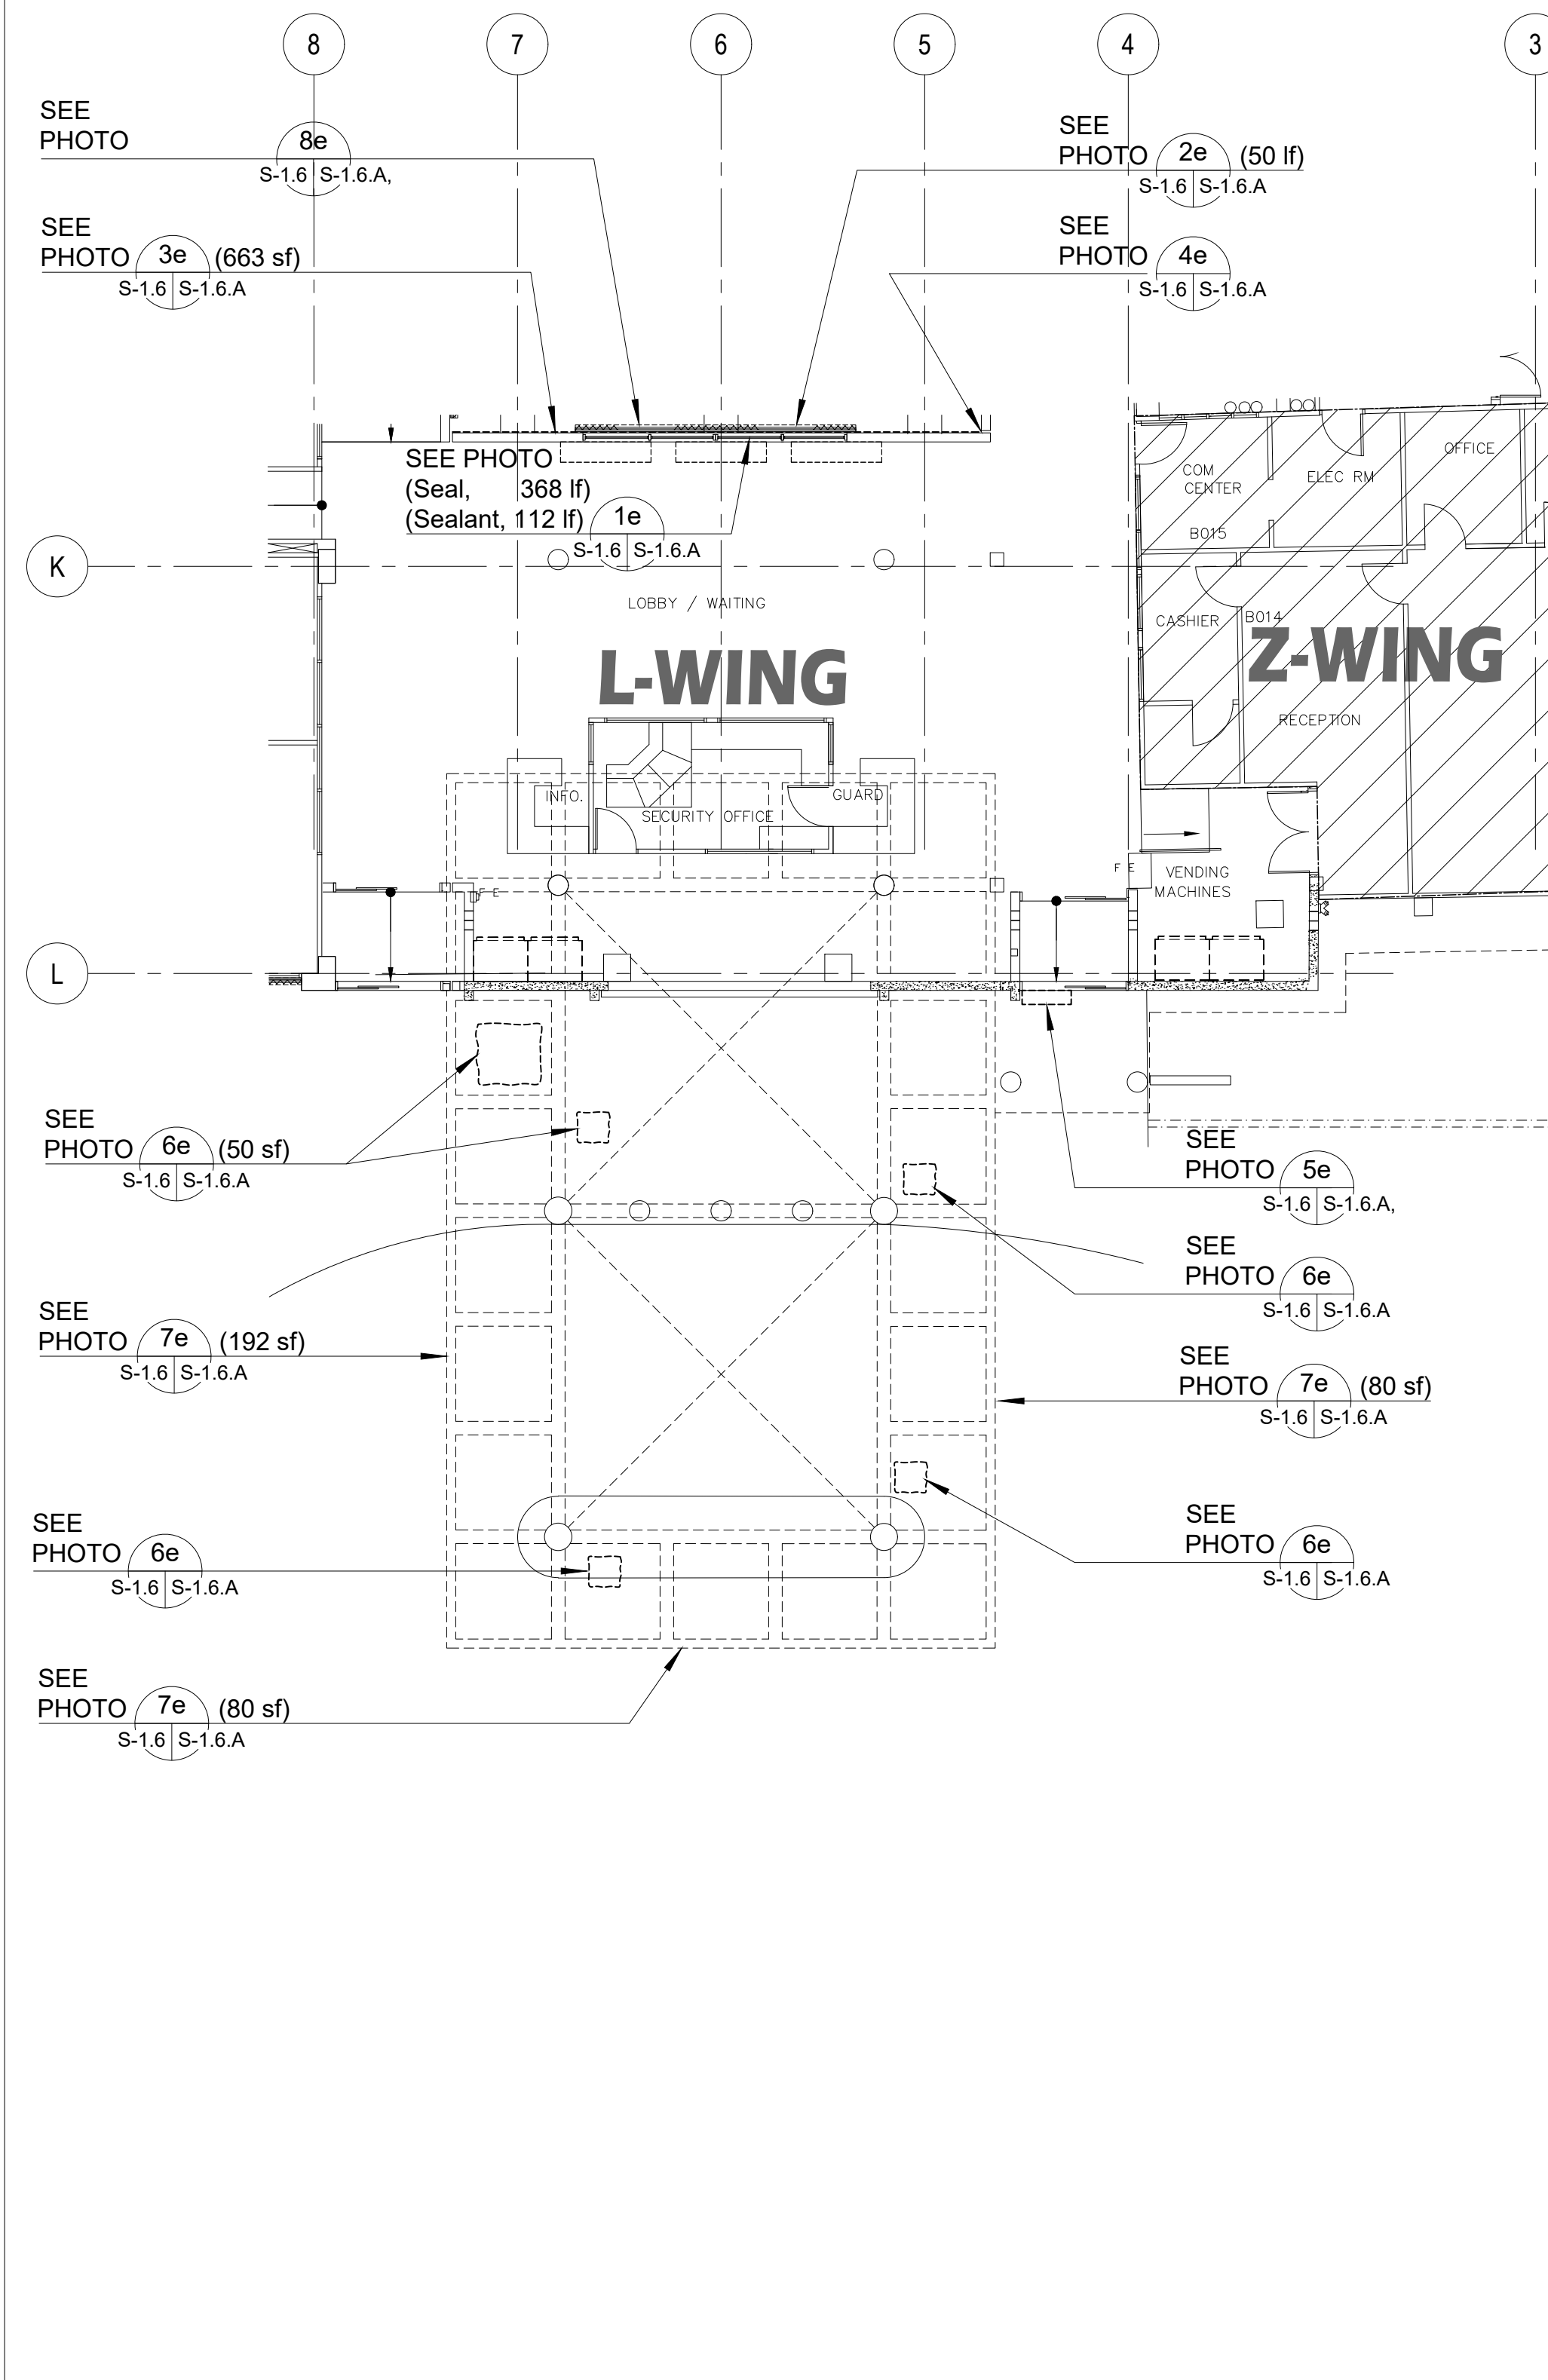
1 FIRST FLOOR PLAN_E-WING; DAMAGED LOCATIONS
S-1.1 | S-1.6 SCALE: 3/32" = 1' - 0"

PHOTO KEY NOTES:			SCOPE of REPAIR WORKS:	
WING	PHOTO No.	DAMAGED DESCRIPTION	REPAIR METHODS	DETAIL SHOWN
E - WING FIRST FLOOR (EXTERIOR)	1e S-1.6 S-1.6.A	DETERIORATED WALL EXHAUST HOOD.	REMOVE EXISTING WALL EXHAUST HOOD and REPLACE with NEW STAINLESS STEEL HOOD to MATCH EXISTING, SEE MECHANICAL PLAN and DETAIL.	
	2e S-1.6 S-1.6.A	DETERIORATED WALL PAINT (900 + 1118 sf).	PRESSURE-WASH EXISTING WALL TO REMOVE DIRT, STAIN, MILDEW, ALGAE and REPAIR ANY AREAS WITH MINOR DAMAGED and PATCH WITH EPOXY MORTAR. PROVIDE NEW PAINT ON ALL WALL, CONC RAILINGS SURFACES, PER GMHA FACILITY STANDARD, TYPICAL.	3 S-12.1 S-12.1
	3e S-1.6 S-1.6.A	DETERIORATED WINDOW FRAME, SEALANT & SEAL (14 sf).	REMOVE EXISTING WINDOW, FRAME & ITS ACCESSORIES and REPLACE WITH NEW. SEE SCHEDULE and DETAILS.	1,2,3 S-9.1 S-9.1
	4e S-1.6 S-1.6.A	DETERIORATED EXISTING TYPHOON SHUTTERS.	REMOVE EXISTING WINDOW SHUTTERS AND ITS ACCESSORIES and REPLACE WITH NEW EXTERIOR MOUNTED TYPHOON RATED INTERLOCKING ALUMINUM SLATS BOXED ROLLER SHUTTERS WITH MANUAL OPERATING SYSTEM. VERIFY WIDTH and HEIGHT OF EXISTING WALL OPENING.	4 S-11.1 S-11.1

5e S-1.6 S-1.6.A	DETERIORATED SEISMIC JOINT COVER (FLOOR, SIDES & CEILING) (36 lf).	REMOVE EXISTING SEISMIC JOINT COVER and REPLACE WITH NEW, SEE DETAILS ON SHEET S-12.1.	1 S-14.1 S-14.1
	6e S-1.6 S-1.6.A	BIRDS DROPPINGS PRESENT ON BEAM, HOODS, PIPES, DUCT WORK, SHUTTER HEAD, ETC. FROM LIGHT TO HEAVILY INFESTED NARROW TO EXTRA WIDE AREAS.	PROVIDE STAINLESS STEEL ANTI BIRD SPIKES ON ALL LEDGES SUCH AS PIPES, SPRINKLER SYSTEMS, STEEL BEAMS, WINDOW SHUTTERS HEAD, HVAC EXHAUST HOODS, AC UNITS, ETC. and PVC AviAngle LEDGE SHIELD ON CONCRETE BEAM LEDGES. SEE SHEET S-9.1 FOR PVC AviAngle LEDGE SHIELD and ANTI BIRD SPIKES SPECIFICATIONS.	5 S-11.1 S-11.1

PHOTO KEY NOTES:			SCOPE of REPAIR WORKS:	
WING	PHOTO No.	DAMAGED DESCRIPTION	REPAIR METHODS	DETAIL SHOWN
L - WING FIRST FLOOR (EXTERIOR)	1e S-1.6 S-1.6.A	DETERIORATED WINDOW SEALANT (112 lf) and SEAL (368 lf).	REMOVE EXISTING WINDOW SEALANT AND SEAL & REPLACE w/ NEW.	
	2e S-1.6 S-1.6.A	DETERIORATED EXISTING TYPHOON SHUTTERS.	REMOVE EXISTING WINDOW SHUTTERS AND ITS ACCESSORIES and REPLACE WITH NEW EXTERIOR MOUNTED TYPHOON RATED INTERLOCKING ALUMINUM SLATS BOXED ROLLER SHUTTERS WITH MANUAL OPERATING SYSTEM. VERIFY WIDTH and HEIGHT OF EXISTING WALL OPENING.	4 S-11.1 S-11.1
	3e S-1.6 S-1.6.A	DETERIORATED WALL PAINT (663 sf).	PRESSURE-WASH EXISTING WALL TO REMOVE DIRT, STAIN, MILDEW, ALGAE and REPAIR ANY AREAS WITH MINOR DAMAGED and PATCH WITH EPOXY MORTAR. PROVIDE NEW PAINT ON ALL WALL, CONC RAILINGS SURFACES, PER GMHA FACILITY STANDARD, TYPICAL.	3 S-12.1 S-12.1
	4e S-1.6 S-1.6.A	DETERIORATED SEISMIC JOINT COVER (FLOOR, SIDES & CEILING) (36 lf).	REMOVE EXISTING SEISMIC JOINT COVER and REPLACE WITH NEW, SEE DETAILS.	1 S-14.1 S-14.1

5e S-1.6 S-1.6.A	DETERIORATED DOOR HEAD BLOWER.	REMOVE and REPLACE EXISTING DOOR HEAD BLOWER with NEW to MATCH EXISTING, SEE MECHANICAL PLAN and DETAIL.	
	6e S-1.6 S-1.6.A	DETERIORATED CEILING PAINT (12 sf).	CLEAN EXISTING SURFACES AND PROVIDE NEW PAINT ON CEILING, PER GMHA FACILITY STANDARD, TYPICAL.	
	7e S-1.6 S-1.6.A	DETERIORATED WALL PAINT AT PARAPET (544 sf).	WATERBLAST TO CLEAN EXISTING PARAPET WALL AND PROVIDE NEW PAINT, PER GMHA FACILITY STANDARD.	
	8e S-1.6 S-1.6.A	BIRDS DROPPINGS PRESENT ON BEAM, HOODS, PIPES, DUCT WORK, SHUTTER HEAD, ETC. FROM LIGHT TO HEAVILY INFESTED NARROW TO EXTRA WIDE AREAS.	PROVIDE STAINLESS STEEL ANTI BIRD SPIKES ON ALL LEDGES SUCH AS PIPES, SPRINKLER SYSTEMS, STEEL BEAMS, WINDOW SHUTTERS HEAD, HVAC EXHAUST HOODS, AC UNITS, ETC. and PVC AviAngle LEDGE SHIELD ON CONCRETE BEAM LEDGES. SEE SHEET S-9.1 FOR PVC AviAngle LEDGE SHIELD and ANTI BIRD SPIKES SPECIFICATIONS.	5 S-11.1 S-11.1

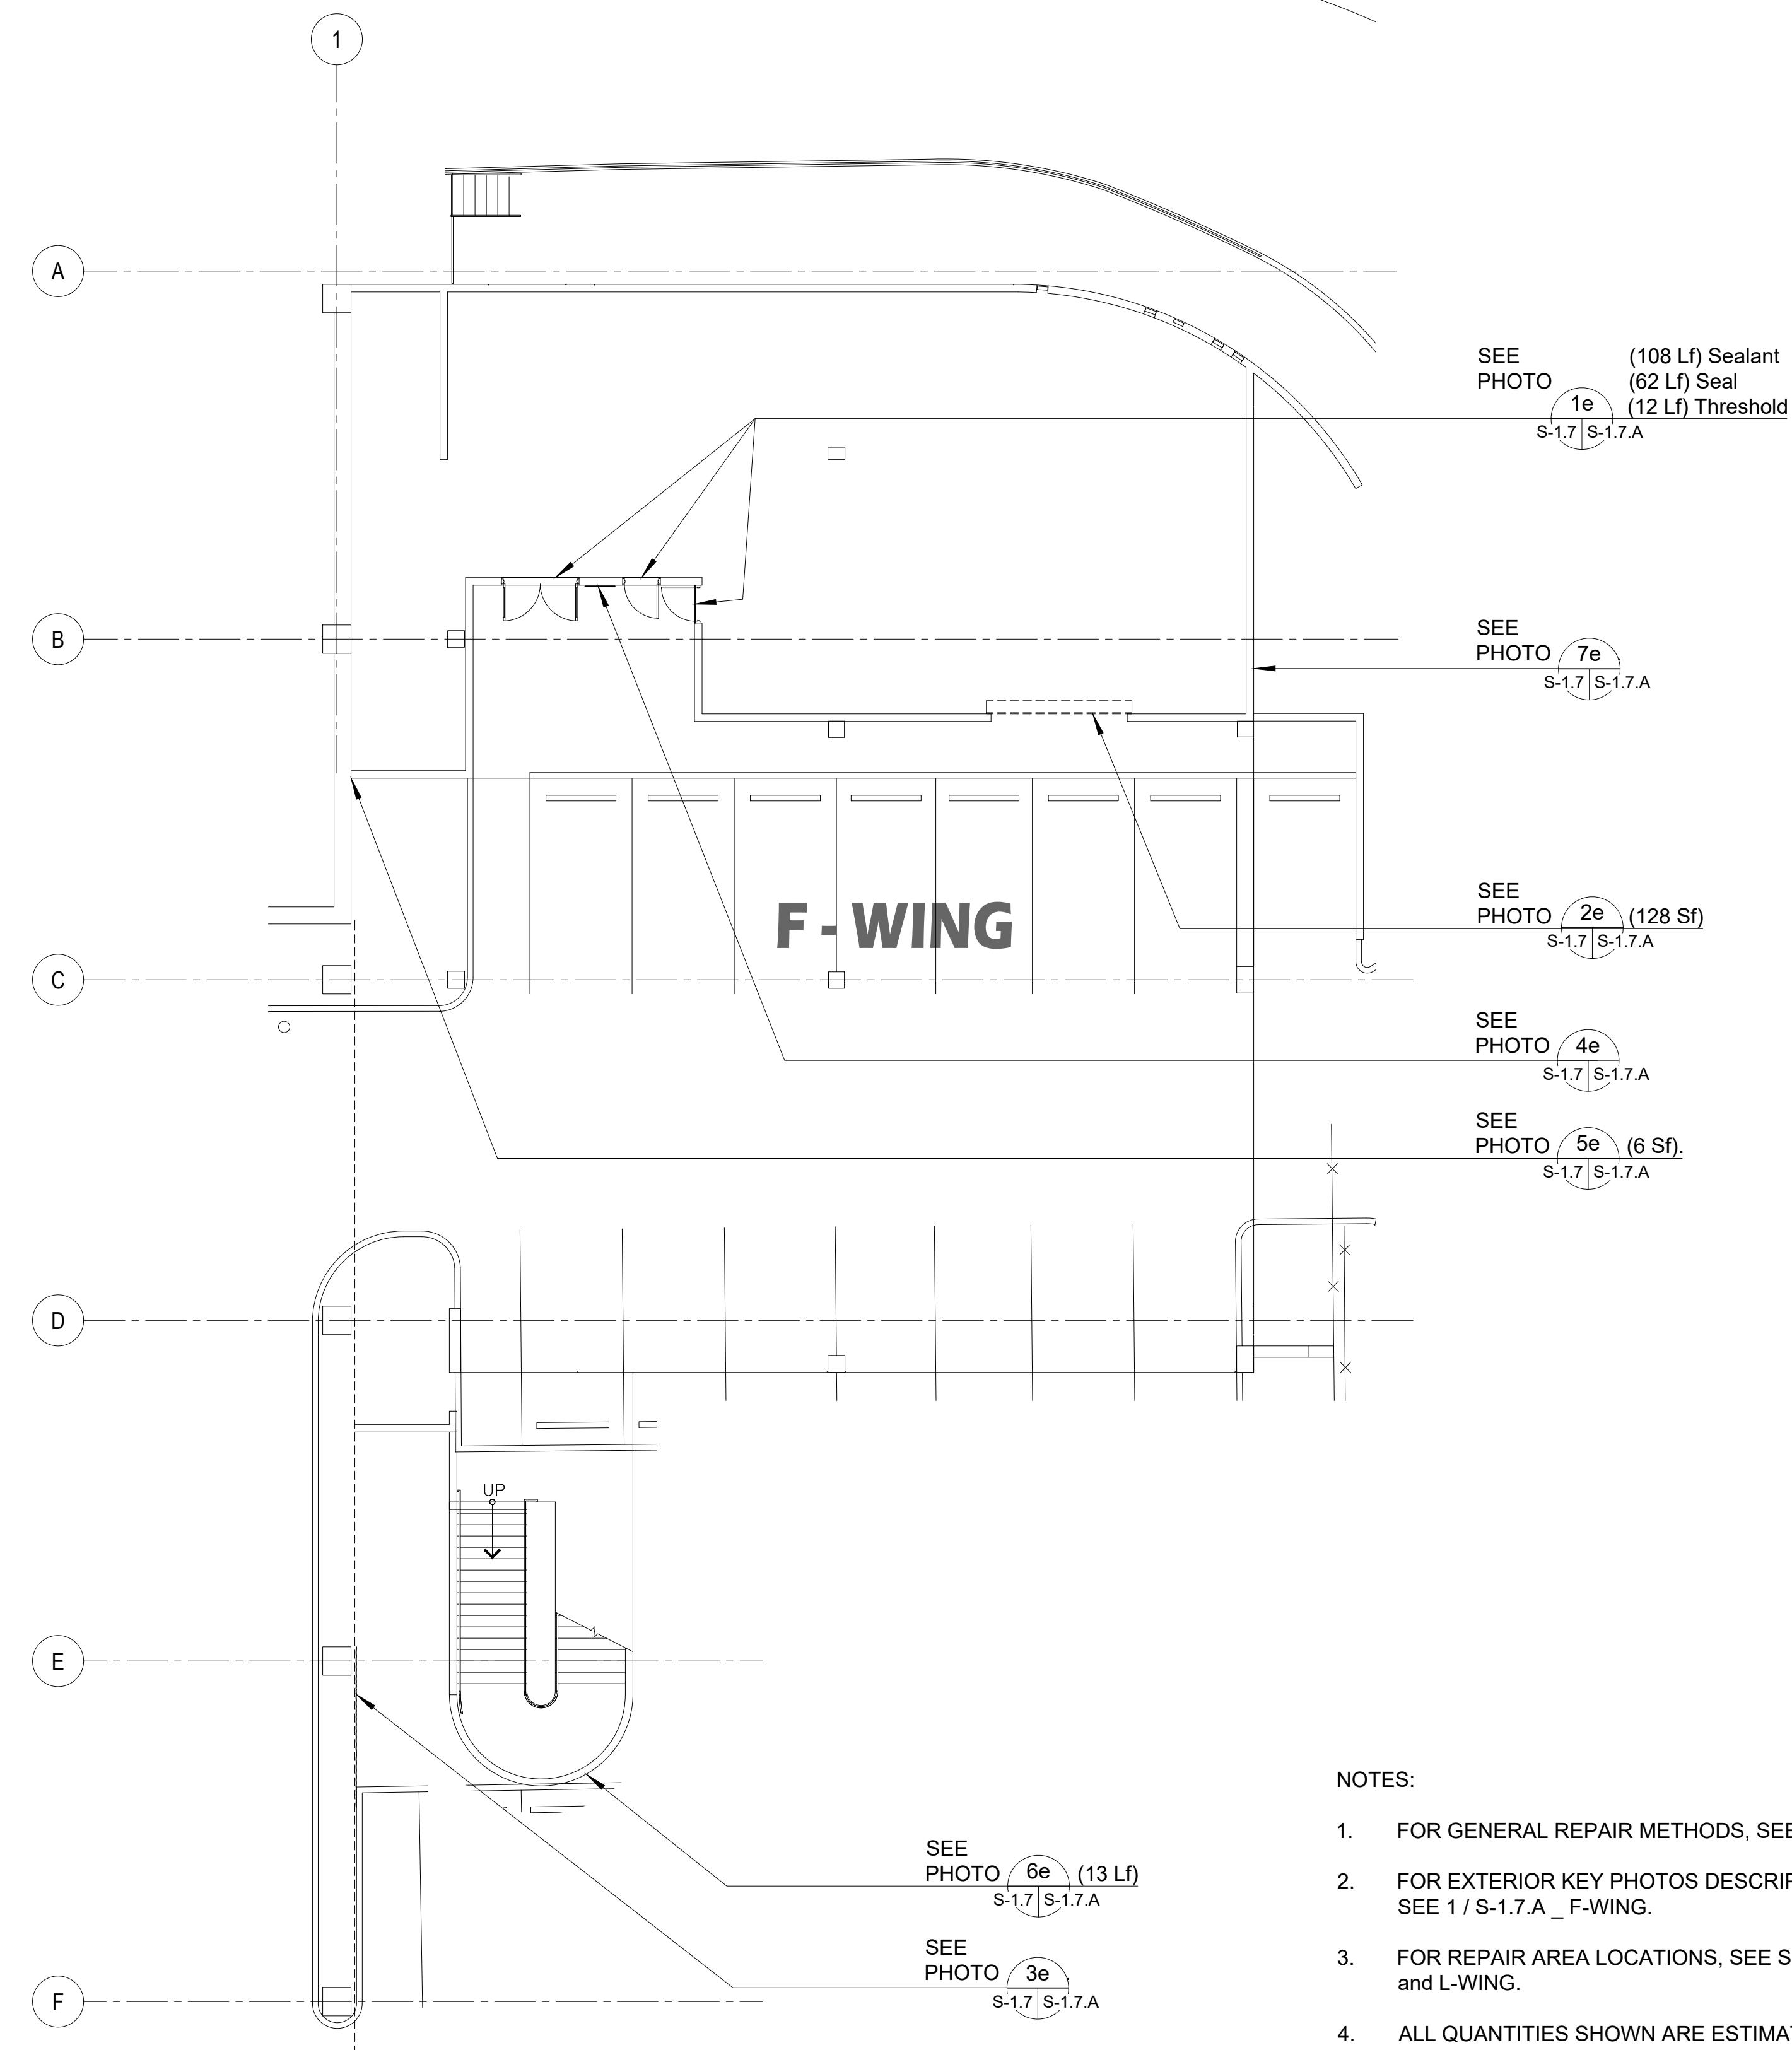
1 FIRST FLOOR PLAN _ F-WING; DAMAGED LOCATIONS
 S-1.1 S-1.7 SCALE: 3/32" = 1' - 0"

PHOTO KEY NOTES:			SCOPE of REPAIR WORKS:	
WING	PHOTO No.	DAMAGED DESCRIPTION	REPAIR METHODS	DETAIL SHOWN
F - WING FIRST FLOOR (EXTERIOR)	1e S-1.7 S-1.7.A	DETERIORATED DOORS, SEALANT (108 Lf), SEAL (62Lf) & DOOR THRESHOLD (12 Lf).	REMOVE EXISTING DOORS & REPLACE w/ NEW. SEE DOOR SCHEDULE ON SHEET S-1.7 and DETAIL.	1,2,3 S-8.1 S-8.1
	2e S-1.7 S-1.7.A	DETERIORATED ROLL-UP DOOR (128 Sf).	REMOVE EXISTING ROLL UP DOOR & REPLACE w/ NEW, SEE SCHEDULE ON SHEET S-1.7 and DETAILS.	1 S-11.1 S-11.1
	3e S-1.7 S-1.7.A	ALGAE, VEGETATION, and MILDEW on ELECTRICAL PIPE PRESENT.	WATERBLAST, CLEAN and REPAIR EXISTING CONDUIT to MATCH EXISTING, PER GMHA FACILITY STANDARD.	
	4e S-1.7 S-1.7.A	WALL OPENING DAMAGED COVER.	REMOVE EXISTING WALL OPENING COVER and REPLACE WITH NEW ORIGINAL MATERIAL COMPONENTS & ASSOCIATED ACCESSORIES.	
	5e S-1.7 S-1.7.A	WALL CORNER SPALLS w/ EXPOSED REBAR (12 Lf), (6 Sf).	SAWCUT and CHIP OFF EXISTING DAMAGED CONCRETE, WIRE BRUSH TO CLEAN EXISTING REBARS & REPAIR PATCH w/ EPOXY MORTAR, SEE DETAIL.	10 S-12.1 S-12.1
