DRAWING INDEX

REV	DATE	BY	DESCRIPTION
GMHA NO. _____ GRANT ID NO. _____ CONTRACT NO. _____ PROJECT NO. _____		PROJECT: GMHA HOSPITAL AND ENVELOPE UPGRADE PROJECT	
DES. BY: kje DRN. BY: jl CHK. BY: rmca		CHIEF ENGR: - ENGR. SUP: - PROJ. ENGR: -	
I HEREBY CERTIFY THAT THIS PLAN WAS PREPARED BY ME OR UNDER MY DIRECT SUPERVISION DATE: 07-31-2024		CONTENTS: FIRST FLOOR PLAN _ A-WING: DAMAGED LOCATIONS, PHOTO KEY NOTES, SCOPE OF REPAIR WORKS, NOTES, and KEY PLAN	
DRAWING NO. S-1.2.1		SH. 07 OF 60

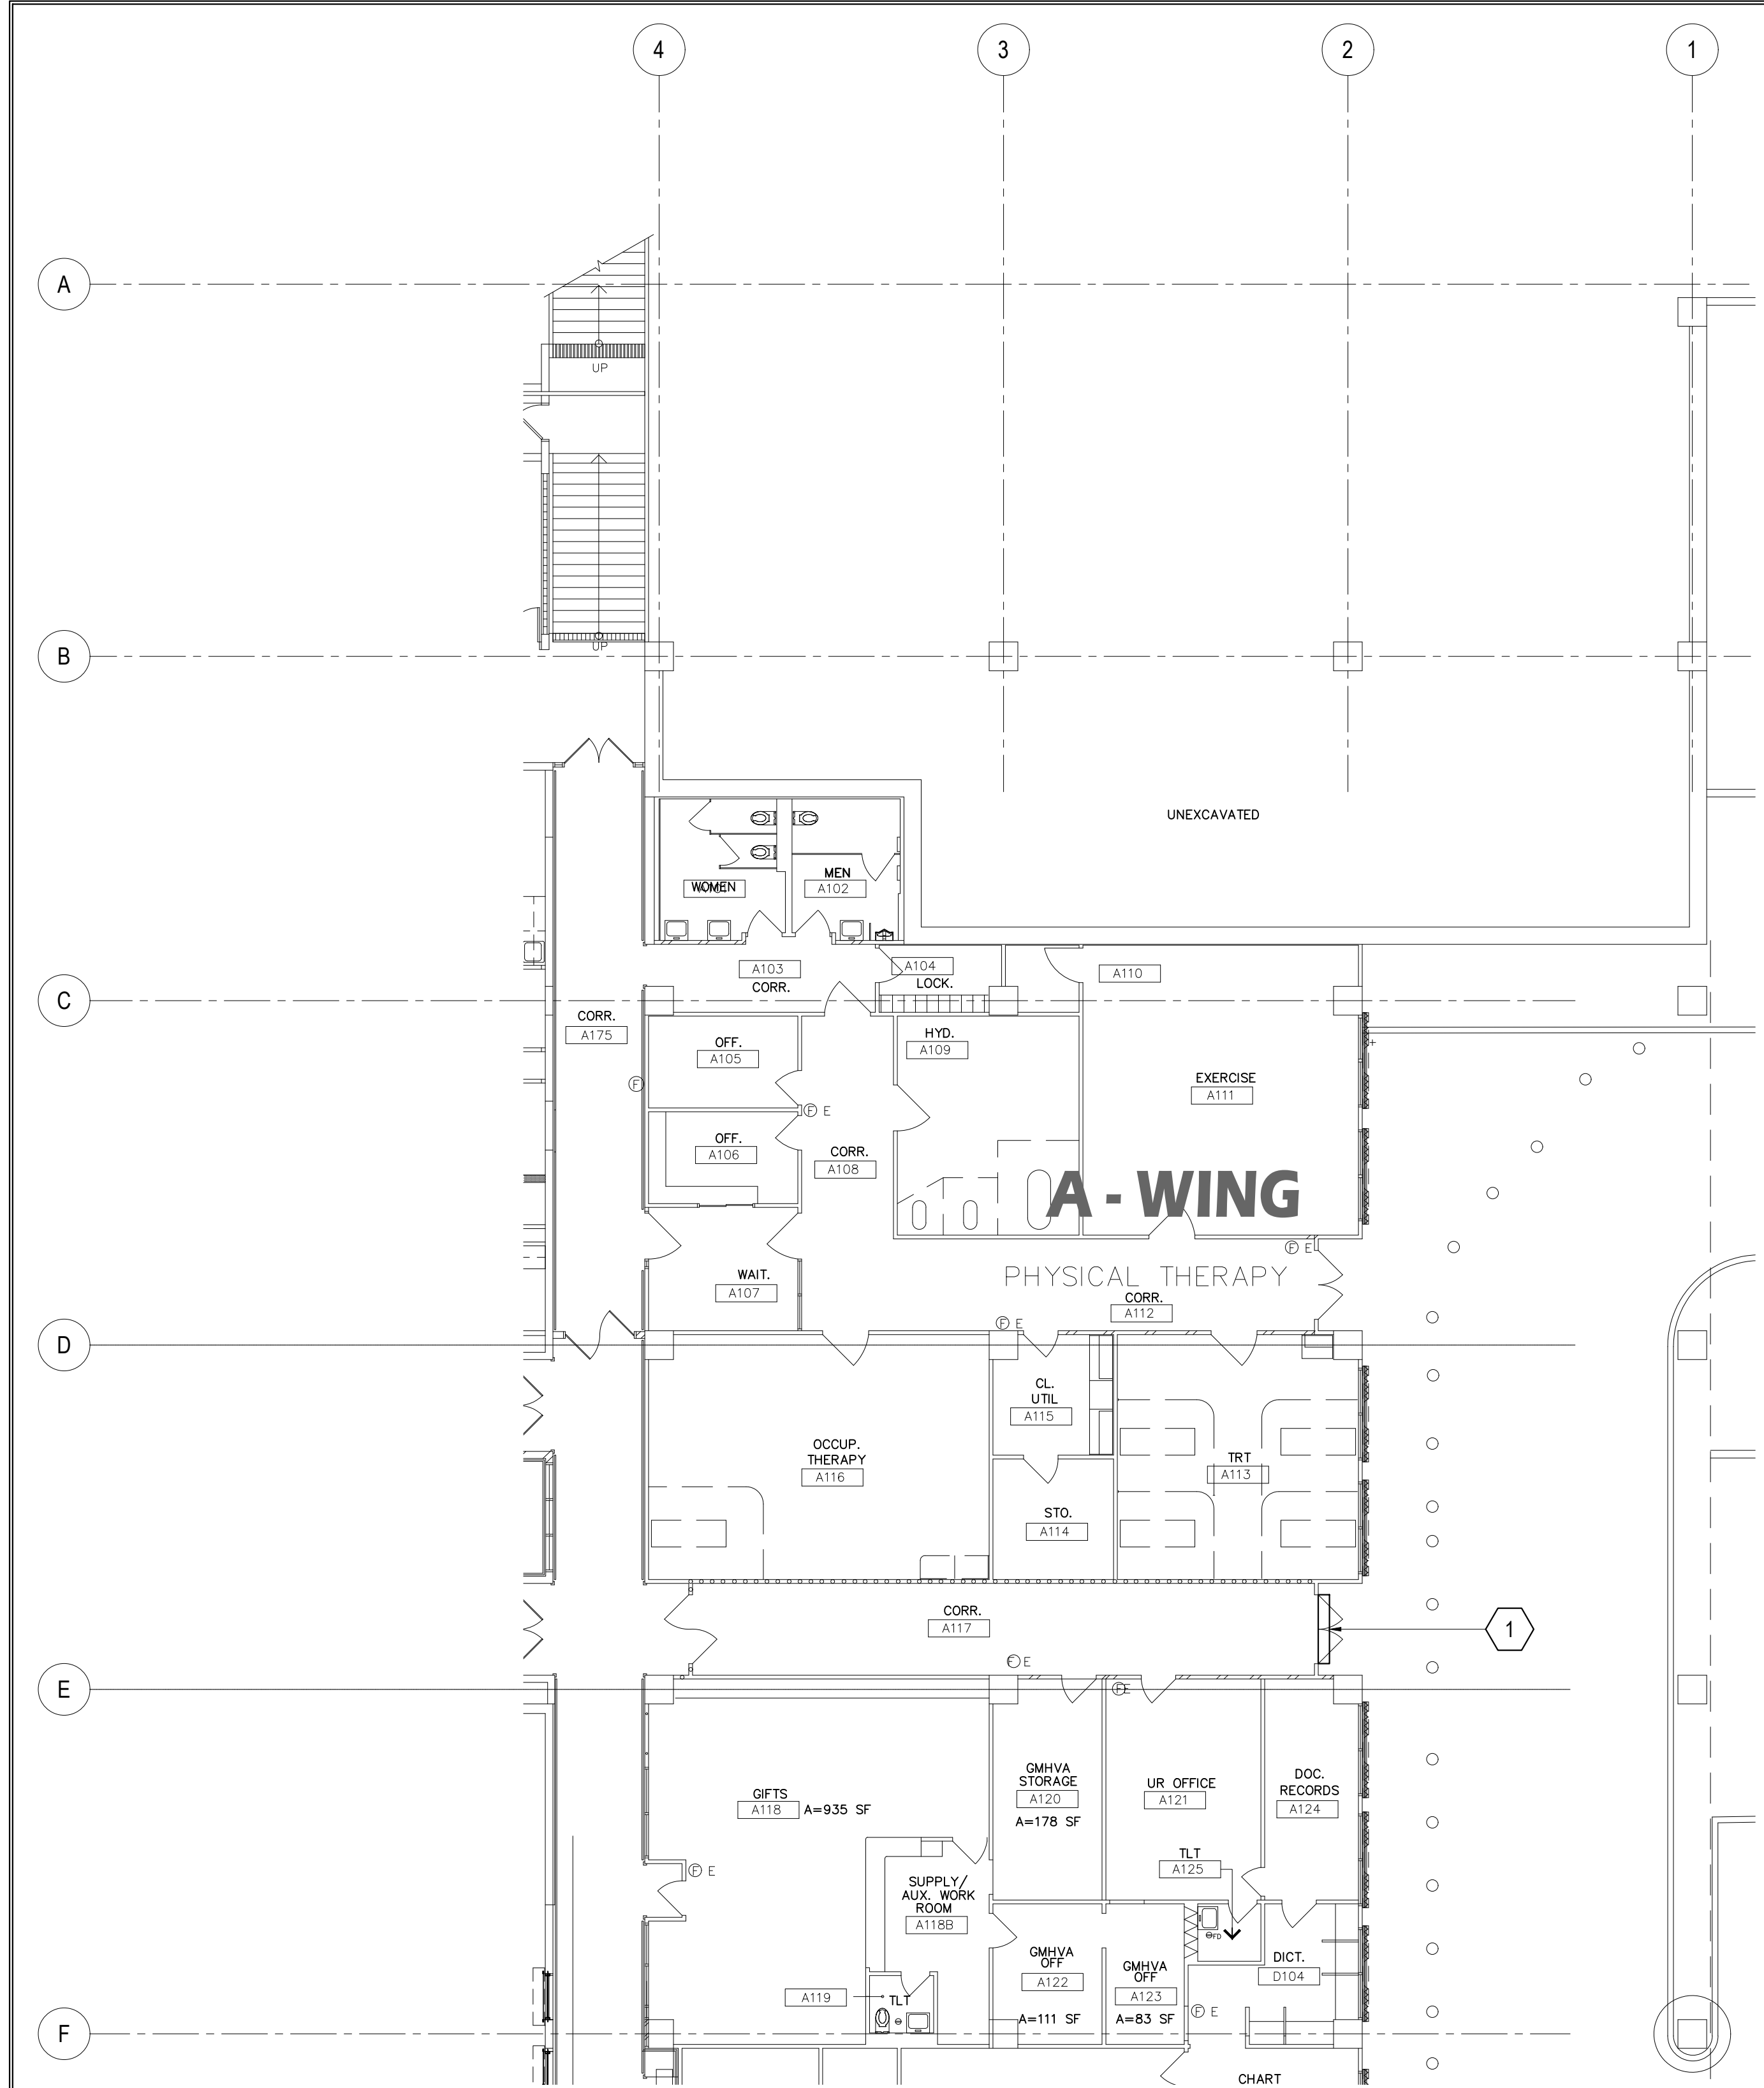
DEMO KEY NOTES:			
WING	MARK	DESCRIPTION	DETAIL SHOWN
A-WING - FIRST FLOOR (EXTERIOR)	1	DETERIORATED WALL EXHAUST. REMOVE EXISTING WALL EXHAUST and REPLACE WITH NEW.

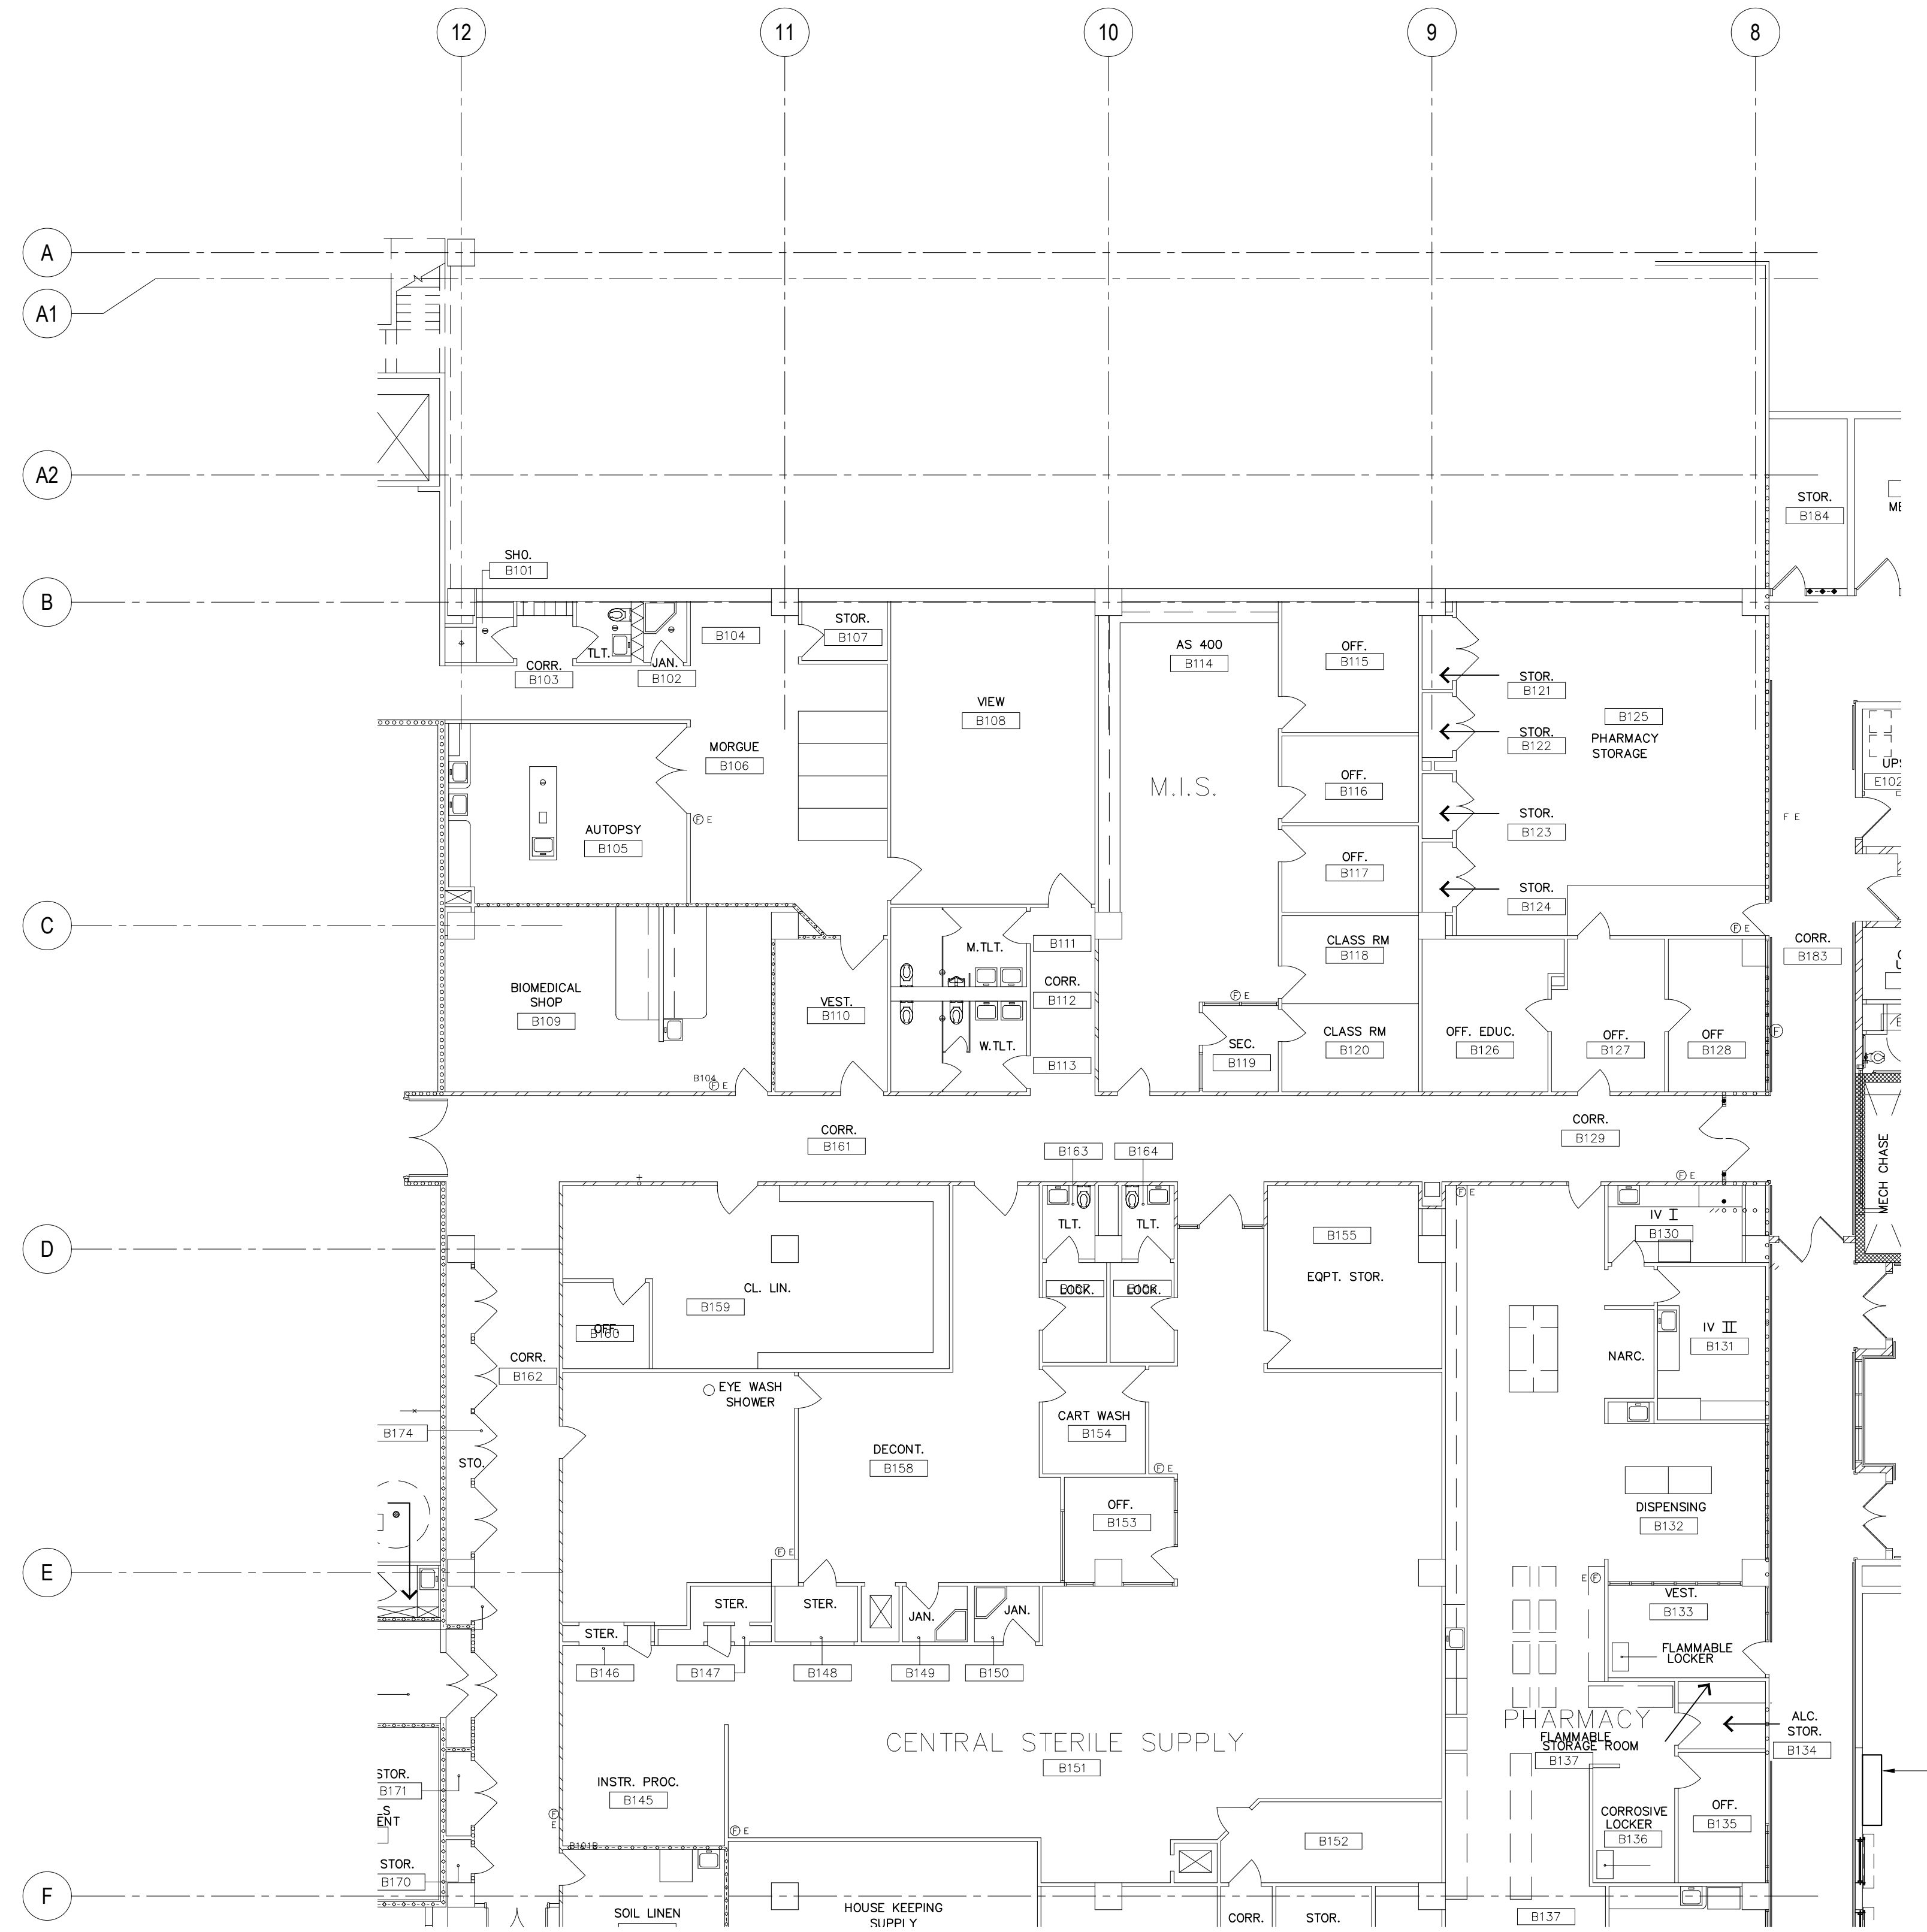
1 FIRST FLOOR PLAN _B-WING: DAMAGED LOCATIONS
 M-1.1 M-1.3 SCALE: 3/32" = 1'-0"

DEMO KEY NOTES:			
WING	MARK	DESCRIPTION	DETAIL SHOWN
B-WING FIRST FLOOR (EXTERIOR)	1	<p>DETERIORATED WALL EXHAUST HOOD w/ VEGETATION (1 Ea).</p> <p>REMOVE EXISTING METAL WALL EXHAUST HOOD & REPLACE w/ NEW. CLEAN SURROUNDING AREAS AND PROVIDE NEW PAINT.</p>

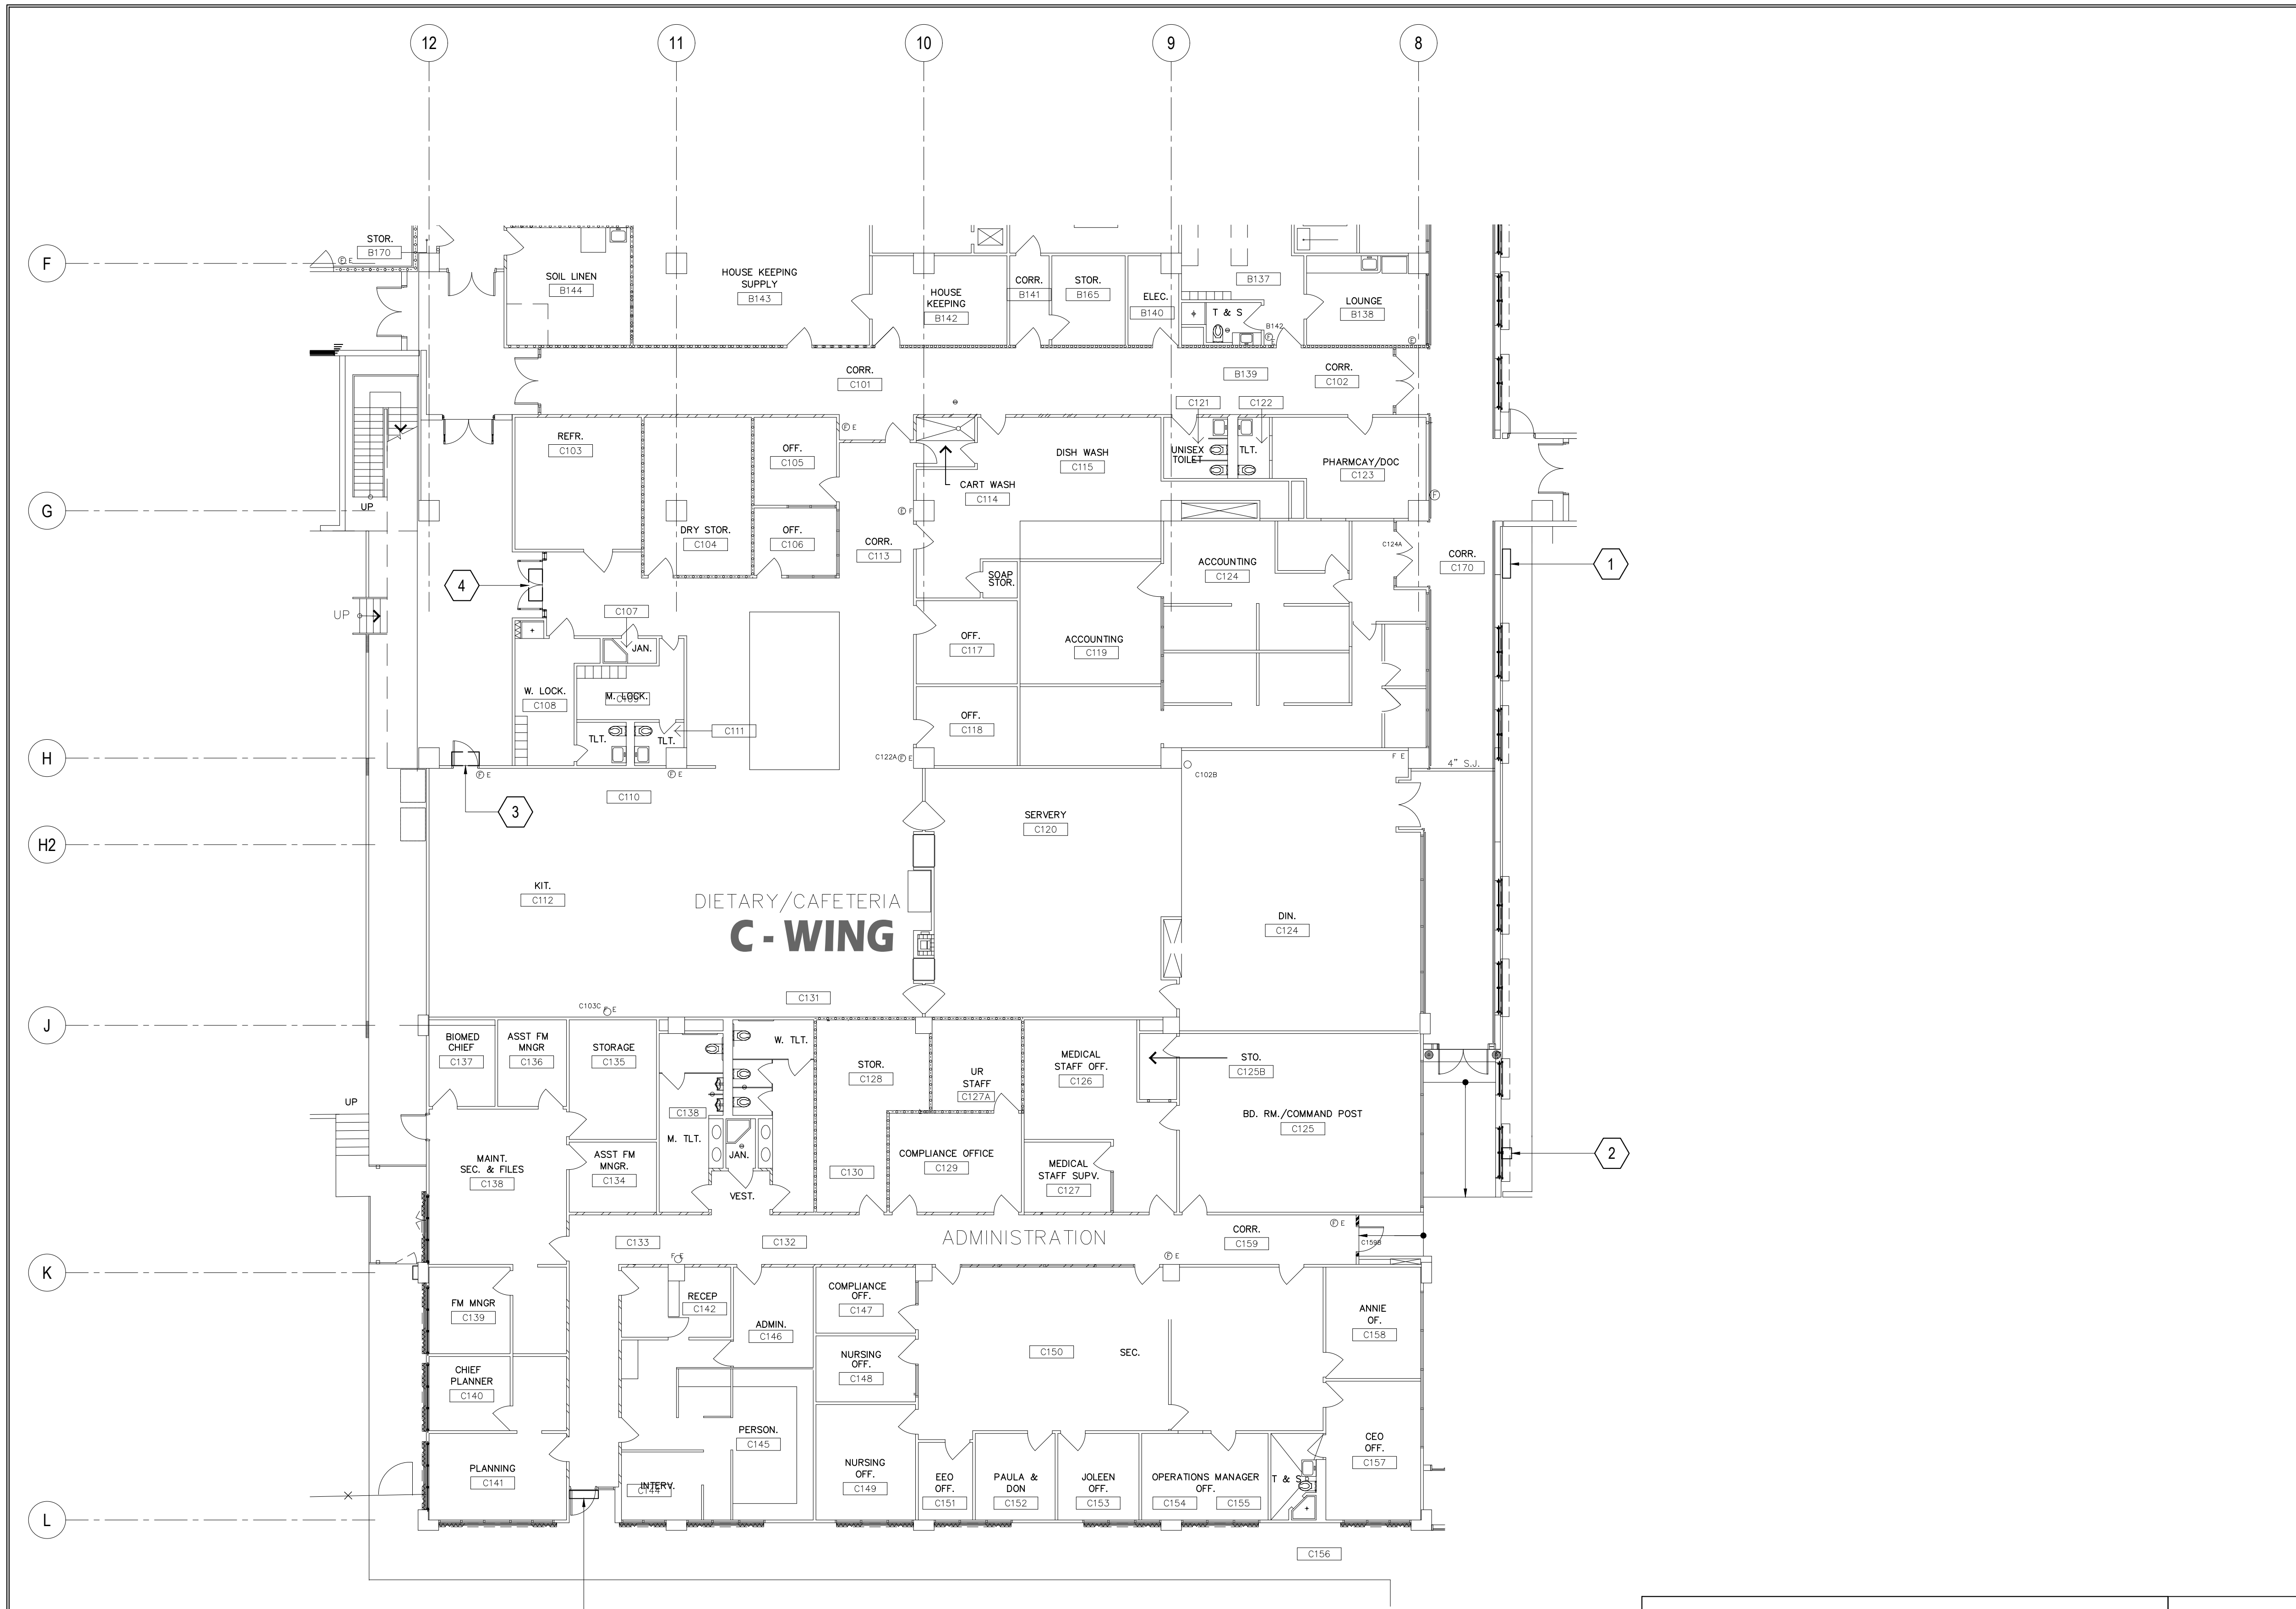
DEMO KEY NOTES:			
WING	MARK	DESCRIPTION	DETAIL SHOWN
C-WING FIRST FLOOR (EXTERIOR)	1	DETERIORATED MECHANICAL AIR INTAKE GRILLE on WALL. REMOVE EXISTING AIR INTAKE GRILLE and REPLACE w/ NEW.	
	2	DETERIORATED EXHAUST HOOD. REMOVE EXISTING WALL EXHAUST HOOD and REPLACE w/ NEW STAINLESS STEEL.	
	3	DETERIORATED DOOR HEAD BLOWER. REMOVE and REPLACE EXISTING DOOR HEAD BLOWER with NEW.	
	4	DETERIORATED DOOR HEAD BLOWER. REMOVE and REPLACE EXISTING DOOR HEAD BLOWER with NEW.

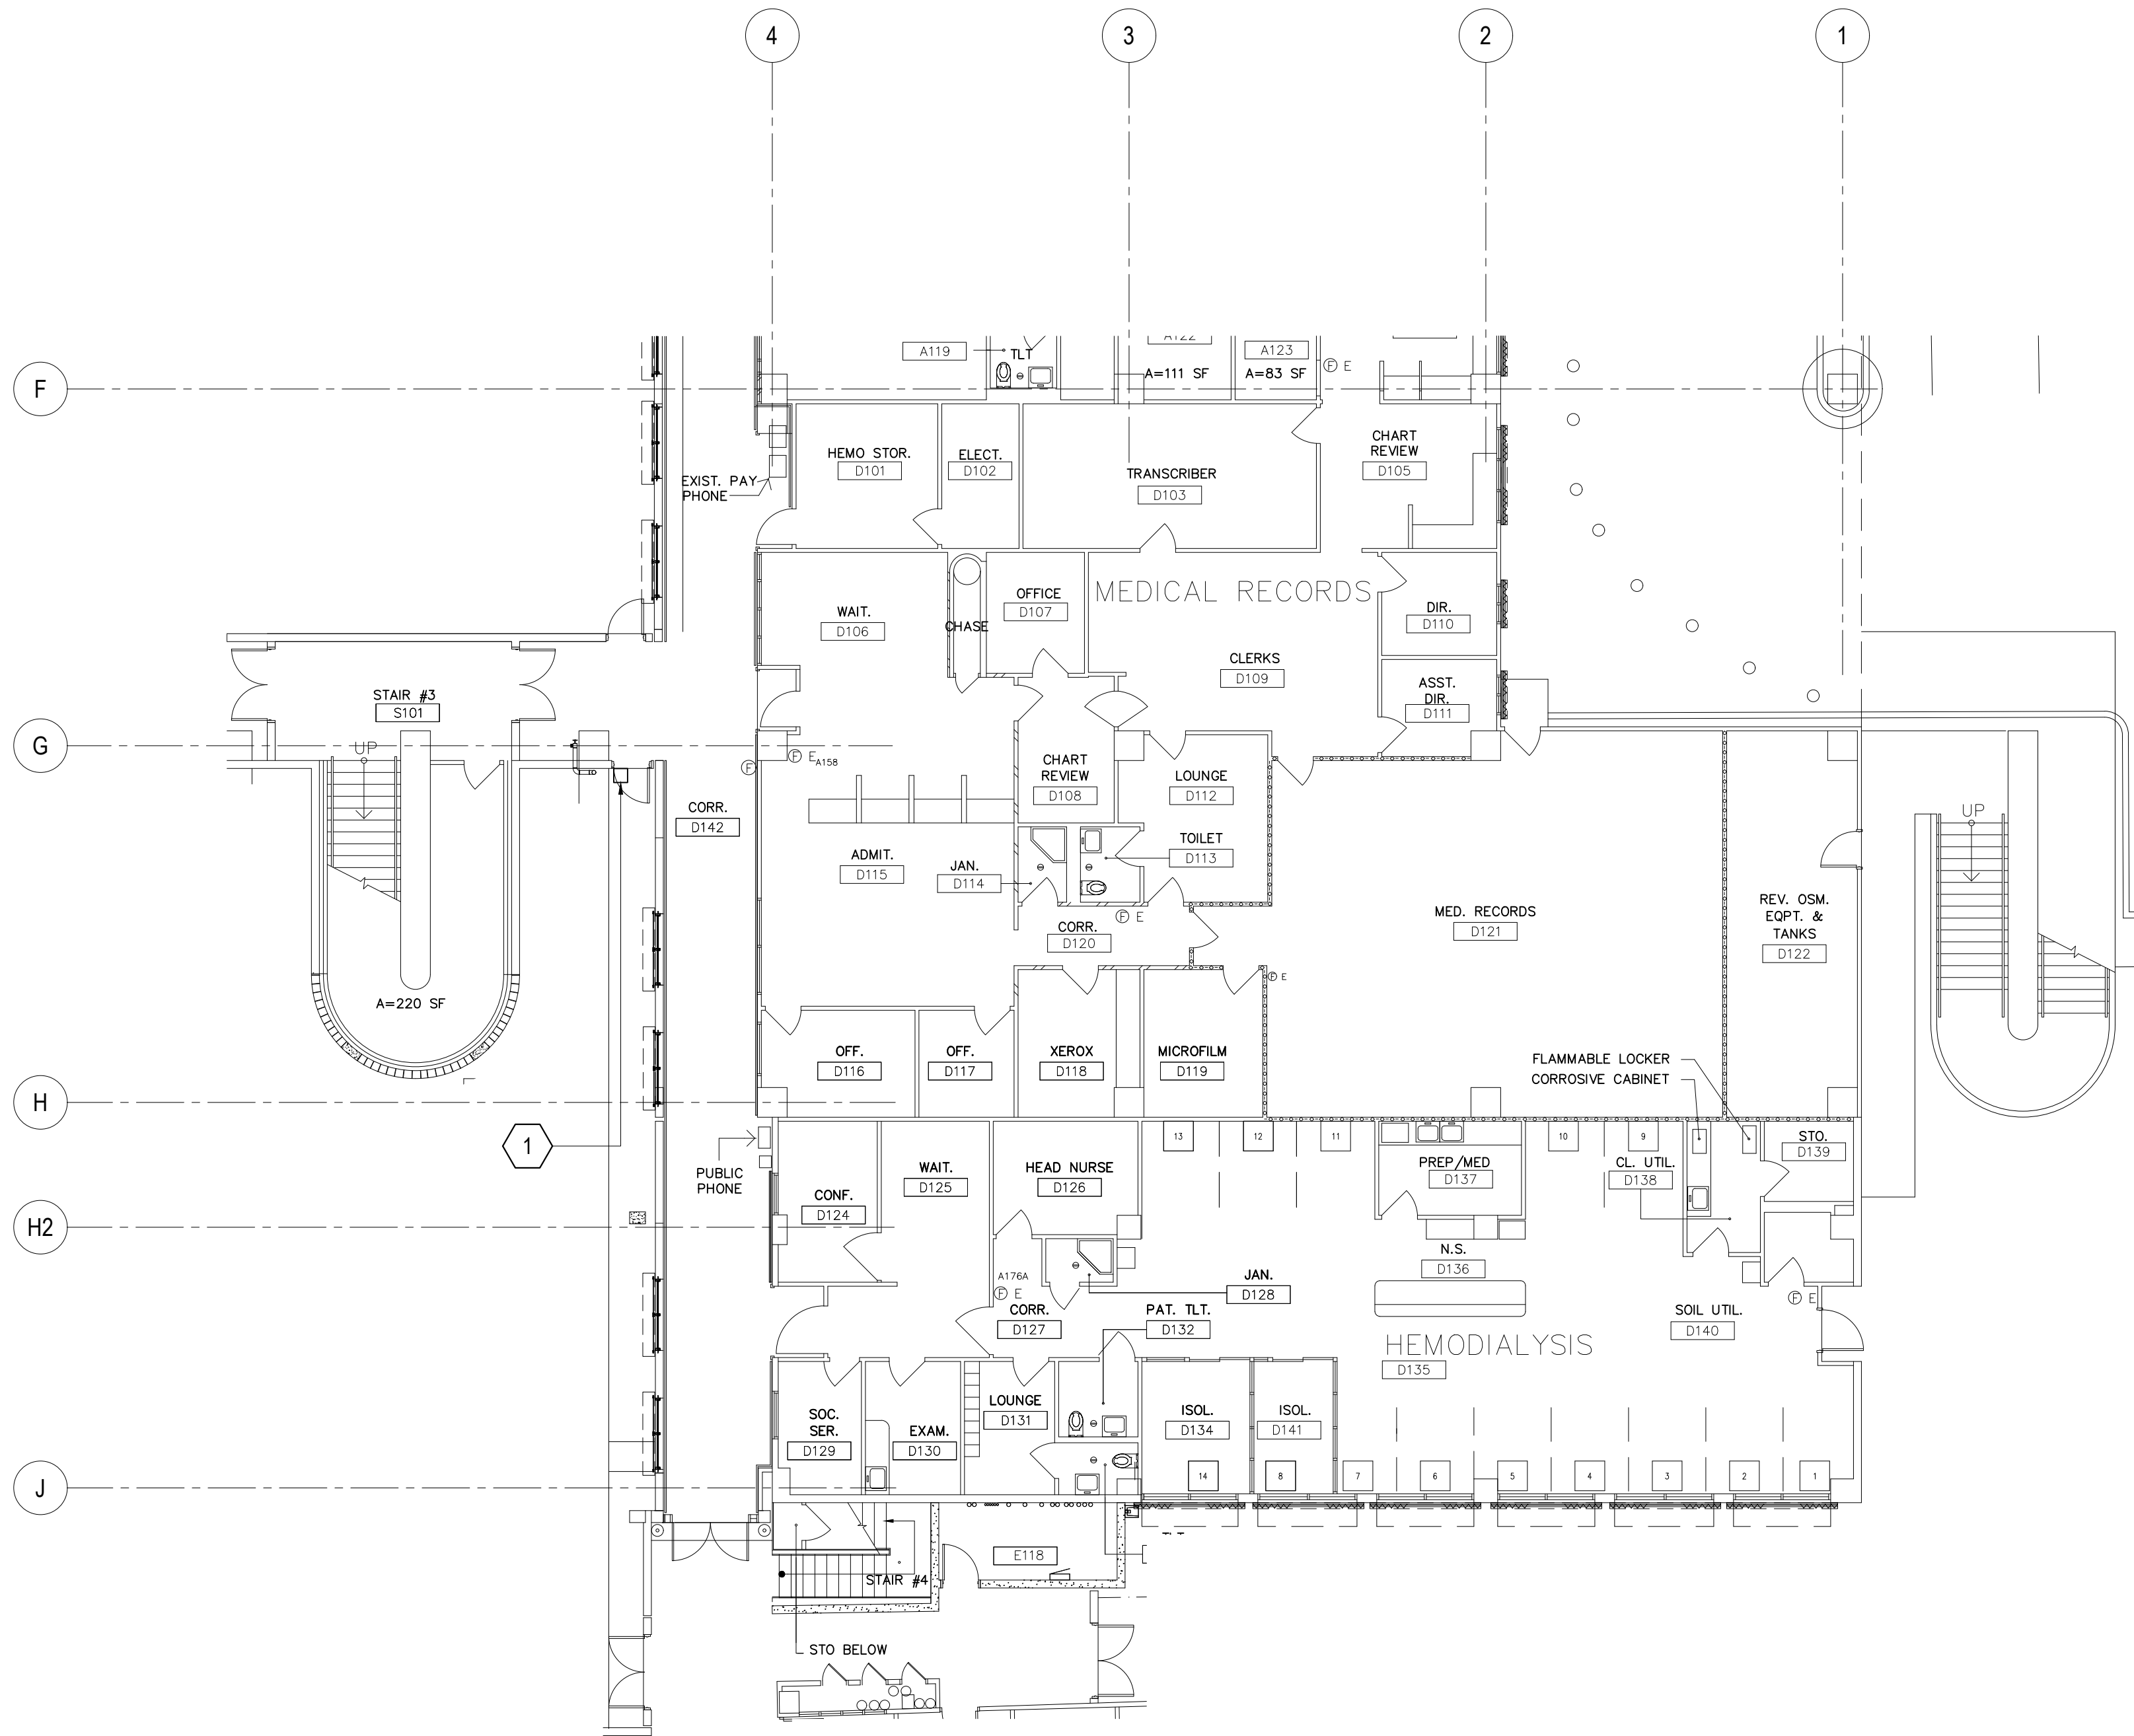
DEMO KEY NOTES:			
WING	MARK	DESCRIPTION	DETAIL SHOWN
D - WING FIRST FLOOR (EXTERIOR)	1	DETERIORATED EXHAUST HOOD. REMOVED EXISTING DAMAGED EXHAUST HOOD and REPLACE w/ NEW STAINLESS STEEL.

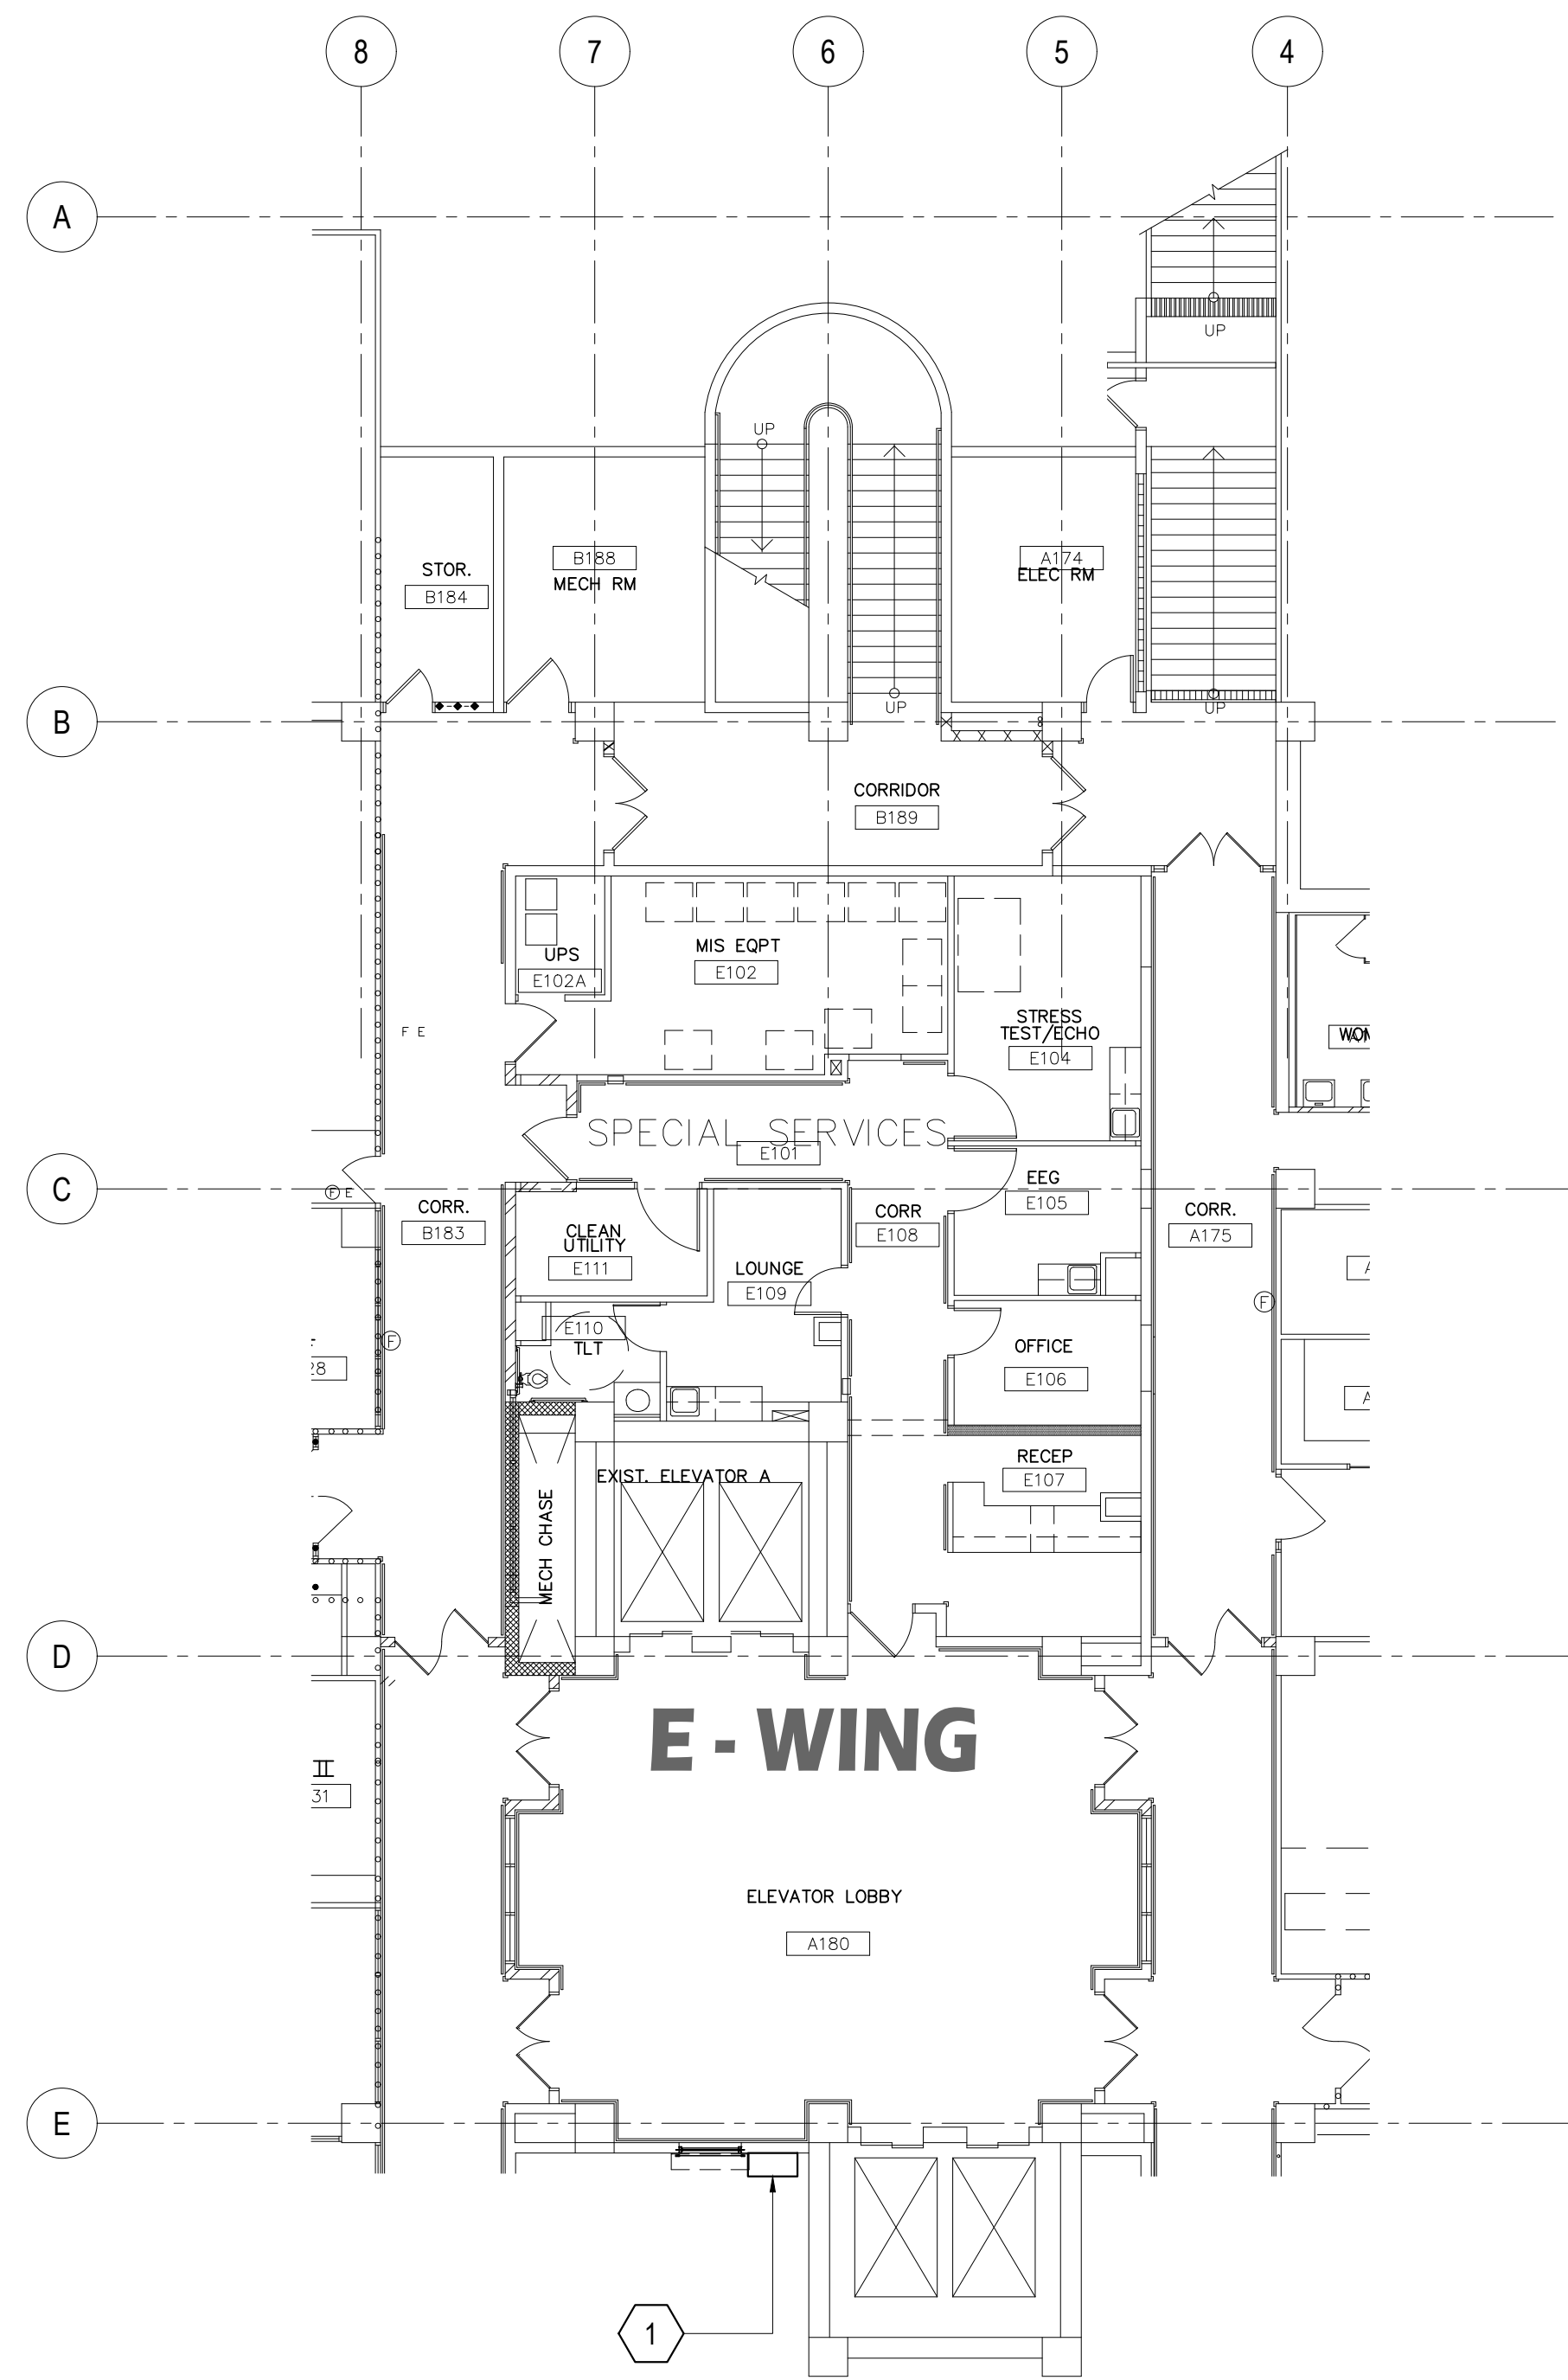
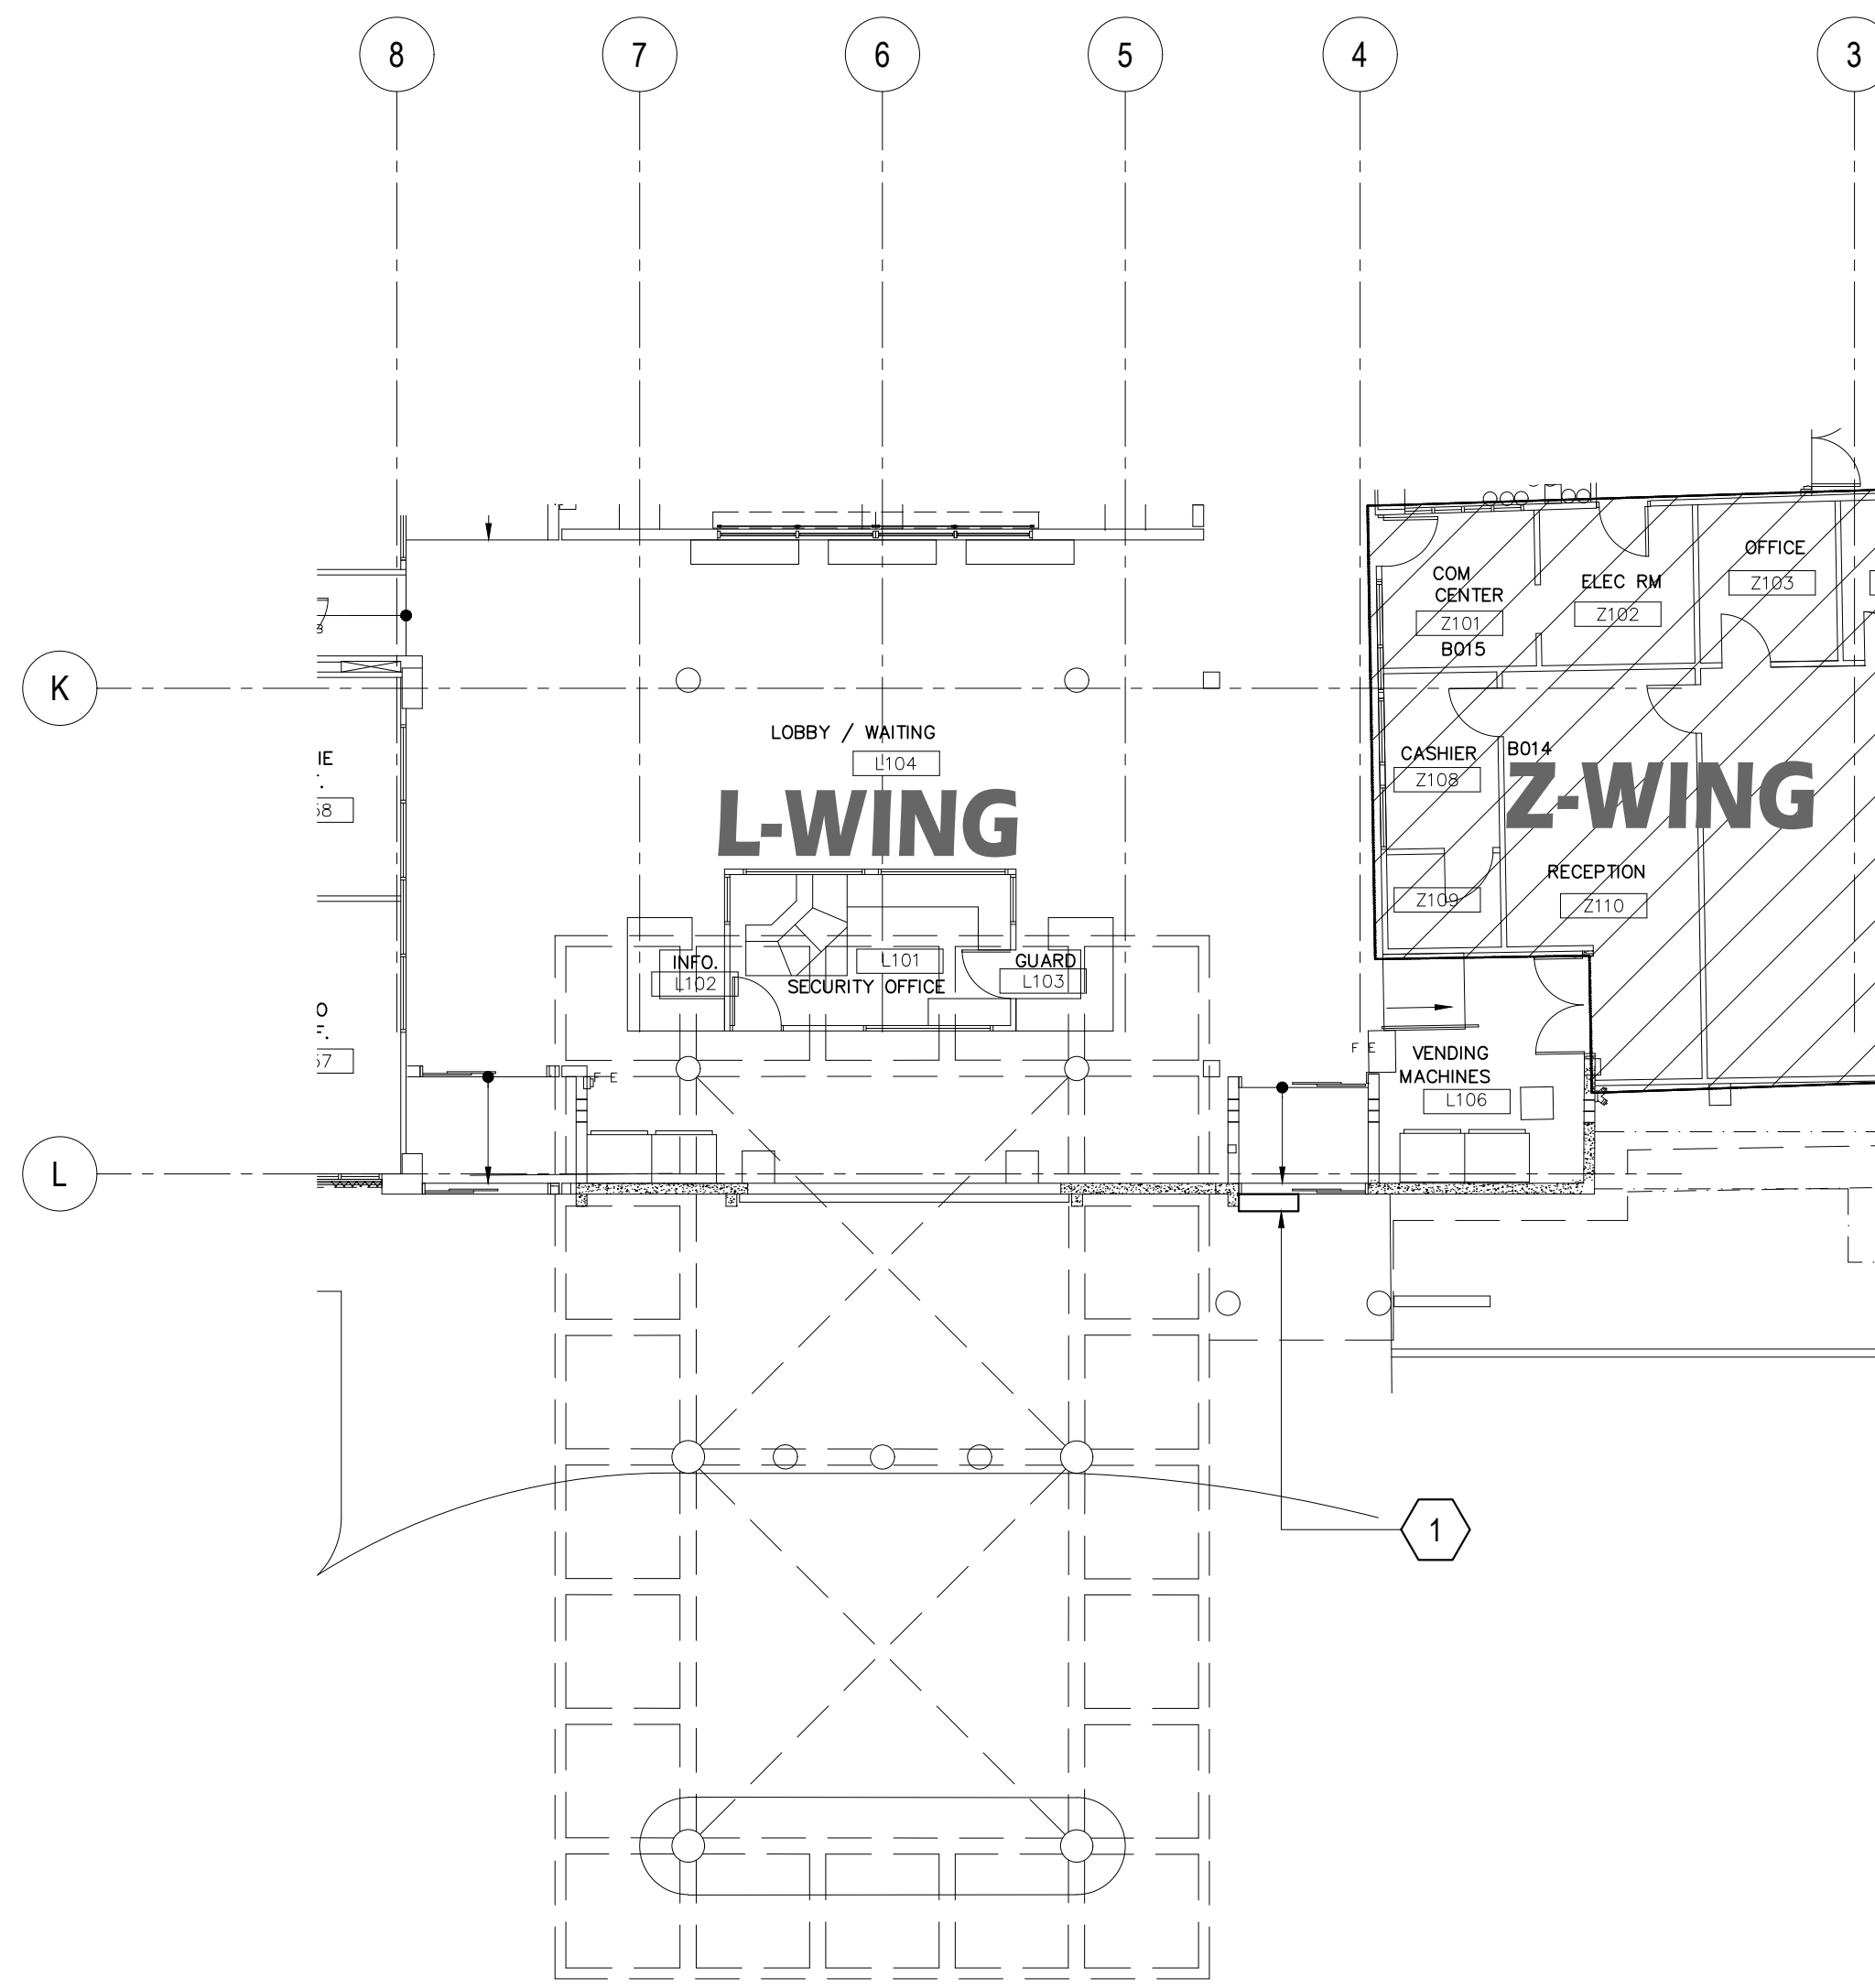
1 FIRST FLOOR PLAN _ E - WING: DAMAGED LOCATIONS
M-1.1 | M-1.6 SCALE: 3/32" = 1' - 0"

DEMO KEY NOTES:			
WING	MARK	DESCRIPTION	DETAIL SHOWN
E - WING FIRST FLOOR (EXTERIOR)	1	DETERIORATED WALL EXHAUST HOOD. REMOVE EXISTING WALL EXHAUST HOOD and REPLACE with NEW STAINLESS STEEL HOOD.
