DRAWING INDEX

REV	DATE	BY	DESCRIPTION
GMHA NO. _____ GRANT ID NO. _____ CONTRACT NO. _____ PROJECT NO. _____		PROJECT: GMHA HOSPITAL AND ENVELOPE UPGRADE PROJECT	
DES. BY: kje DRN. BY: jl CHK. BY: rmca		CHIEF ENGR: - ENGR. SUP: - PROJ. ENGR: -	
I HEREBY CERTIFY THAT THIS PLAN WAS PREPARED BY ME OR UNDER MY DIRECT SUPERVISION DATE: 07-31-2024		CONTENTS: FIRST FLOOR PLAN _ A-WING: DAMAGED LOCATIONS, PHOTO KEY NOTES, SCOPE OF REPAIR WORKS, NOTES, and KEY PLAN	
DRAWING NO. S-1.2.1		SH. 07 OF 60

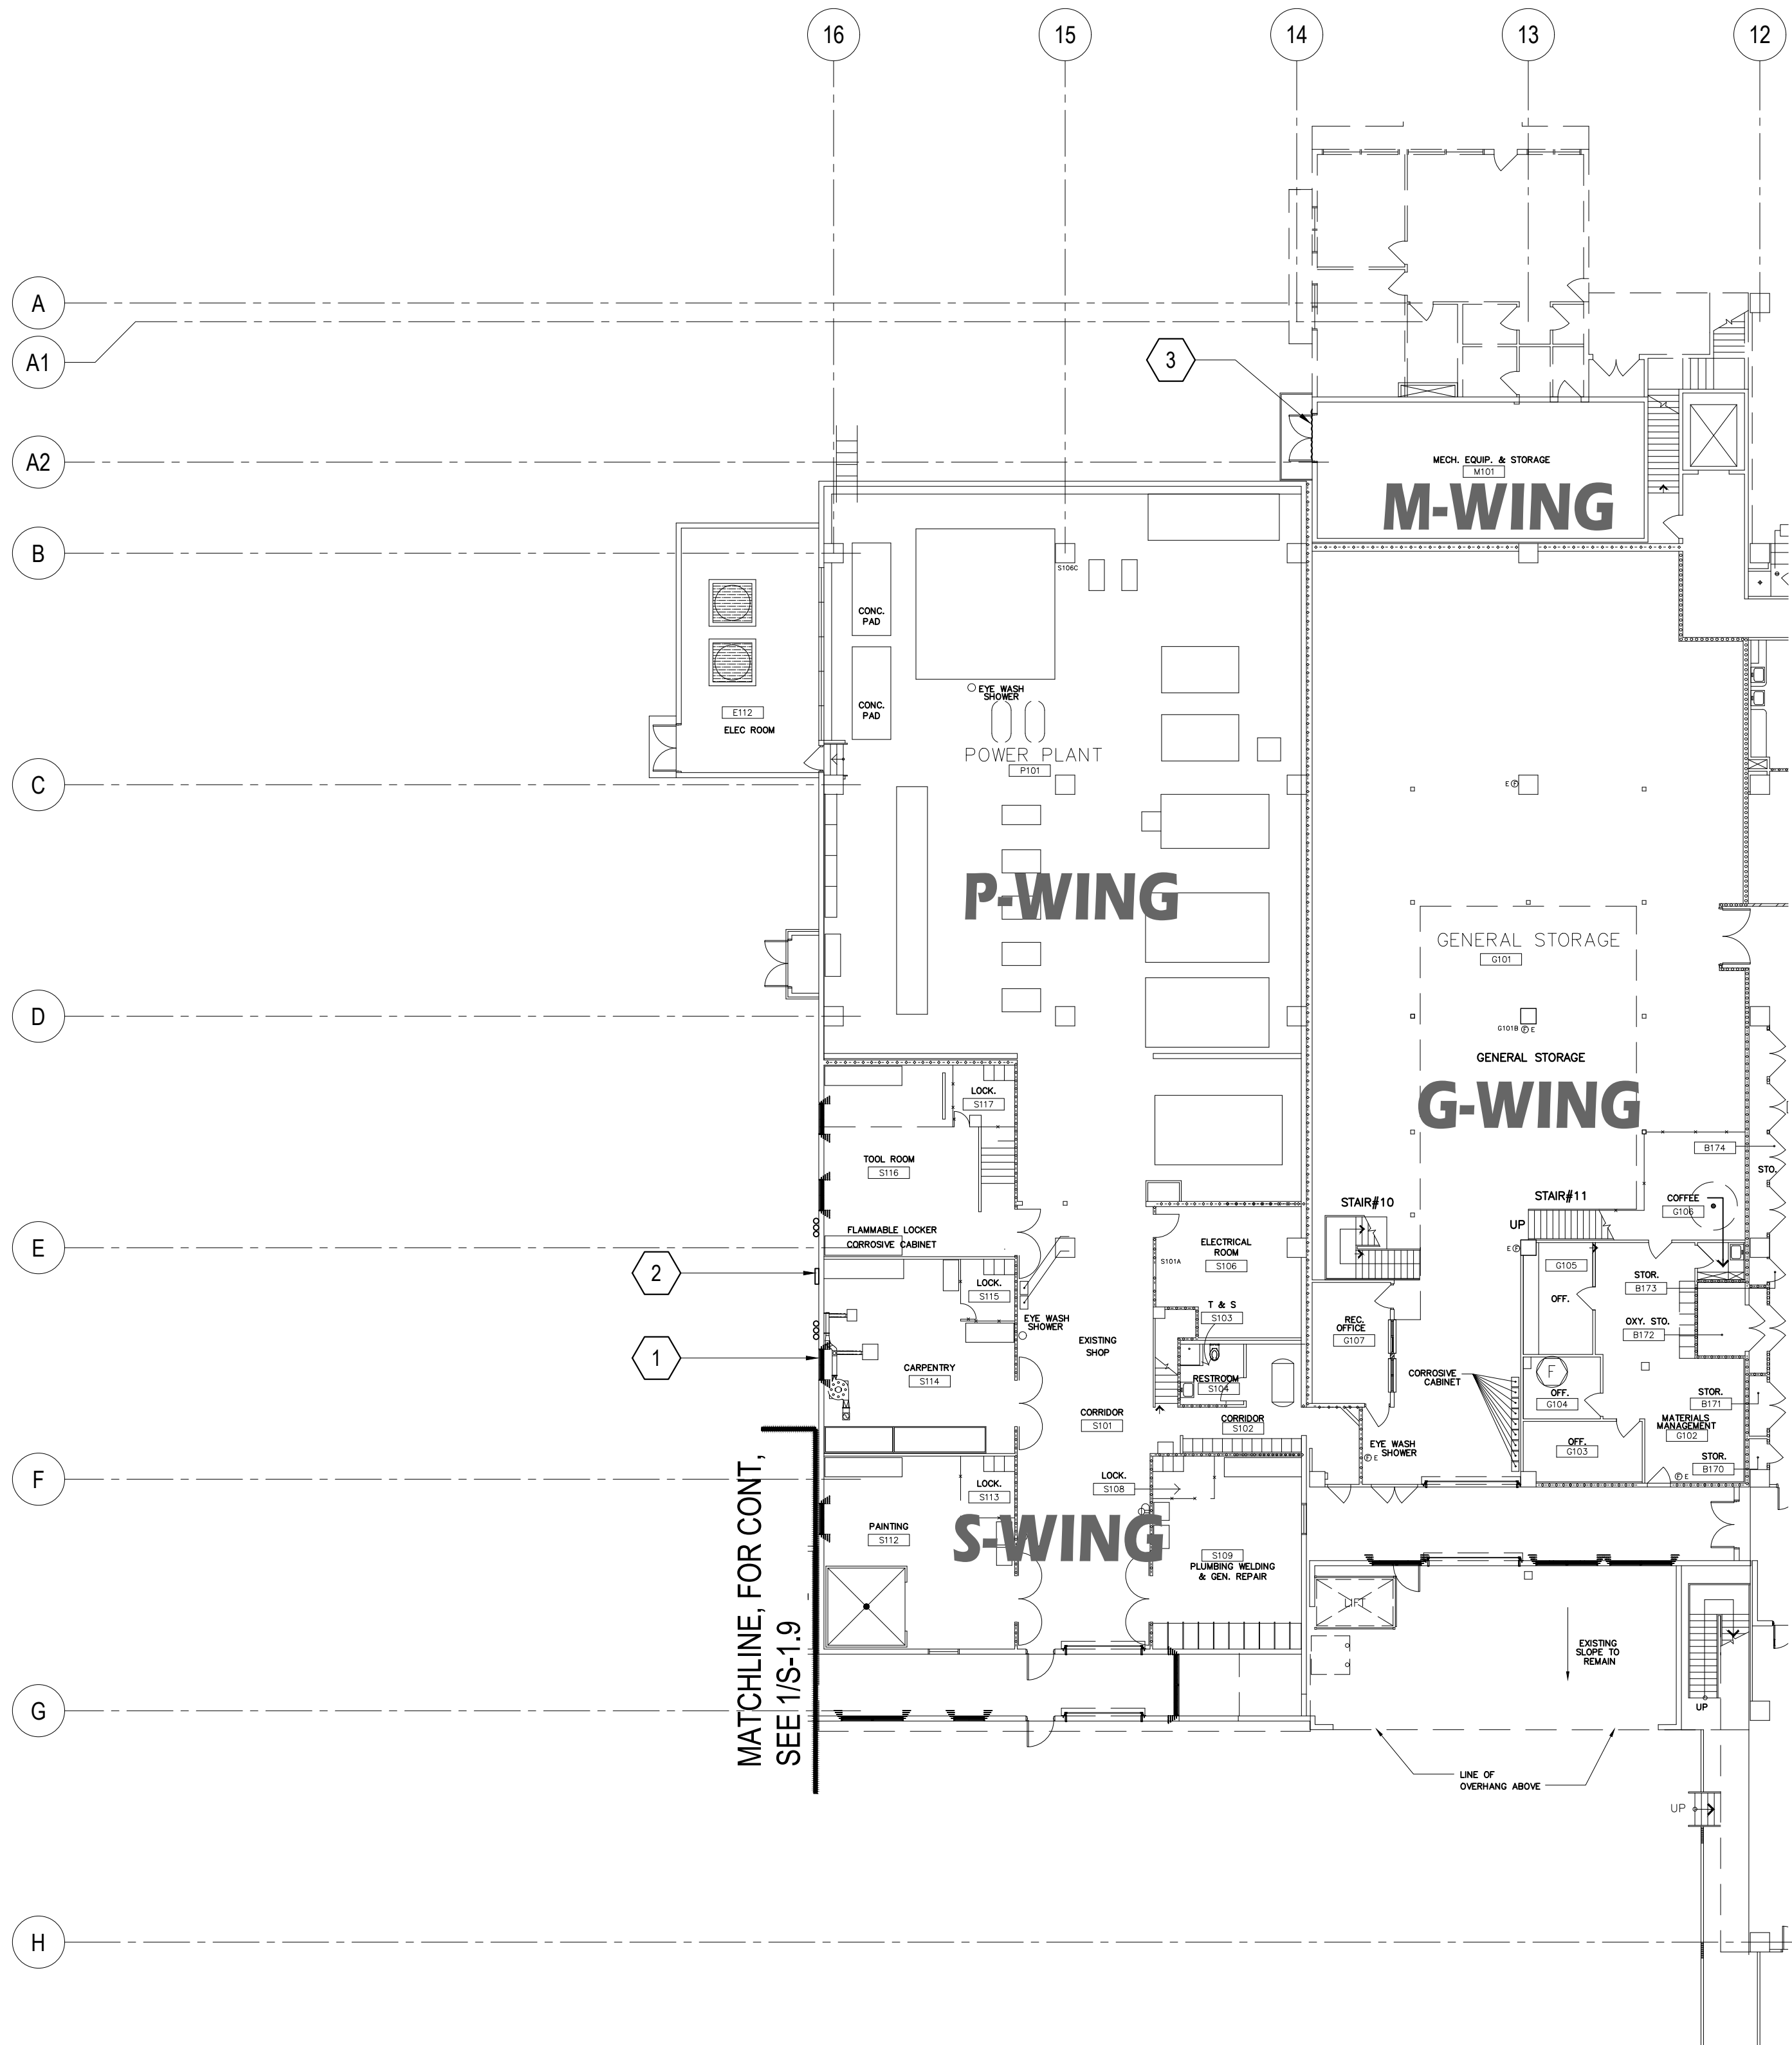
DEMO KEY NOTES:			
WING	MARK	DESCRIPTION	DETAIL SHOWN
G.M.P. S-WING FIRST FLOOR (EXTERIOR)	1	DETERIORATED EXHAUST HOODS. REMOVE EXIST WINDOW EXHAUST HOOD and REPLACE with NEW SSSL HOOD to MATCH EXISTING.	
	2	WALL EXHAUST MISSING PROVIDE NEW EXHAUST HOOD COVER AS REQUIRED.	
	3	DETERIORATED WALL EXHAUST an WALL OPENING COVER MISSING. REMOVE EXIST EXHAUST HOOD & REPLACE w/ NEW, PROVIDE NEW WALL COVER.
