GMHA HOSPITAL ROOF AND ENVELOP UPGRADE PROJECT

PACKAGE A - 3RD & 4TH FLOOR ROOF AND ENVELOP (A,B, & E-WING)

GUAM MEMORIAL HOSPITAL AUTHORITY, TAMUNING, GUAM

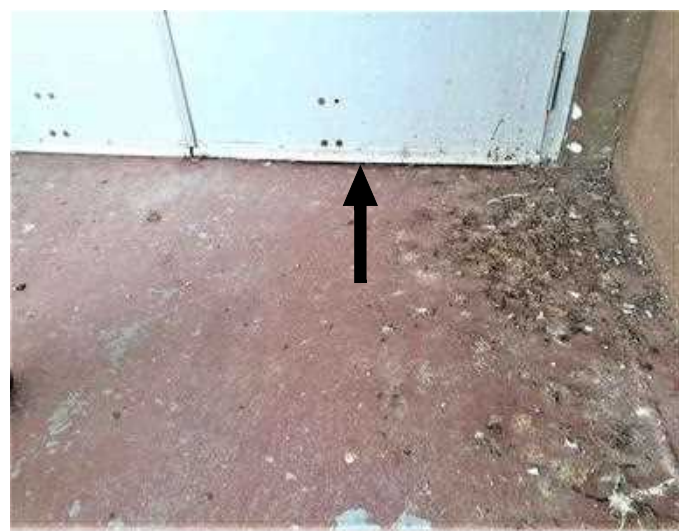
1e PHOTO
S-3.3 S-3.3.A

DETERIORATED DOOR THRESHOLD (12 Lf)

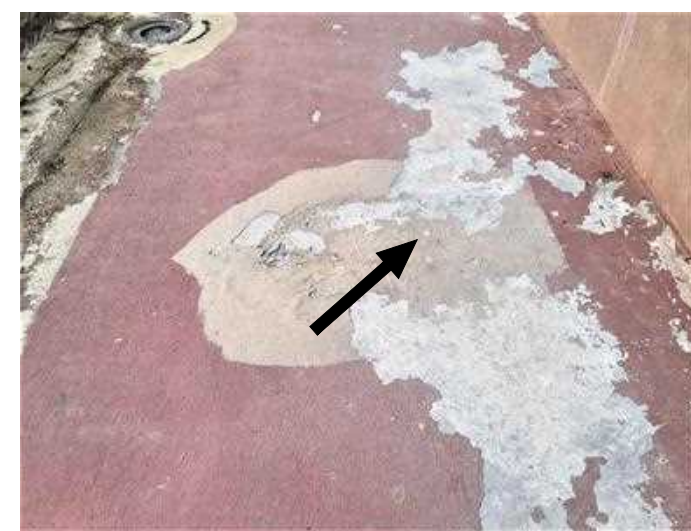
3e PHOTO
S-3.3 S-3.3.A

CONC SPALLS ON FLOORS (4 Sf)

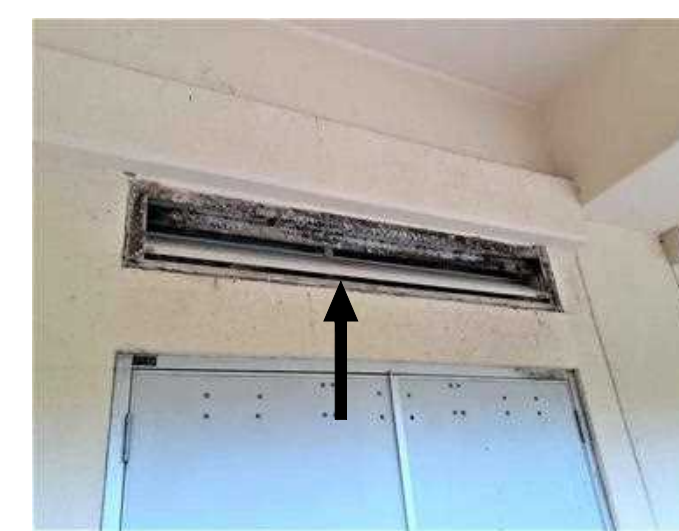
4e PHOTO
S-3.3 S-3.3.A

DETERIORATED DOOR HDR EXHAUST.

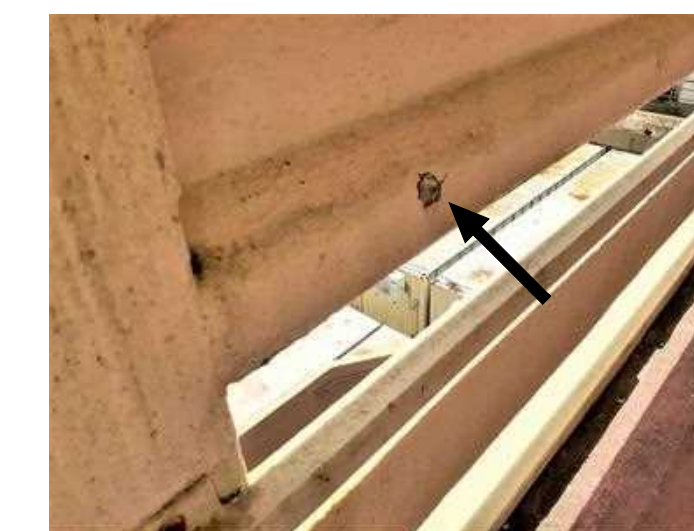
5e PHOTO
S-3.3 S-3.3.A

CONC FLAKING ON RAILING (2 Sf)

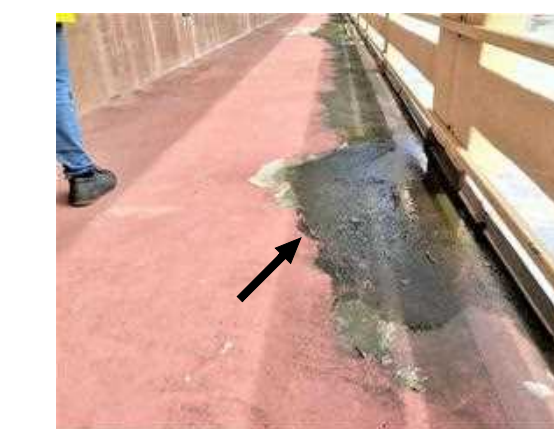
6e PHOTO
S-3.3 S-3.3.A

PONDING ON CORRIDOR (188 Sf)

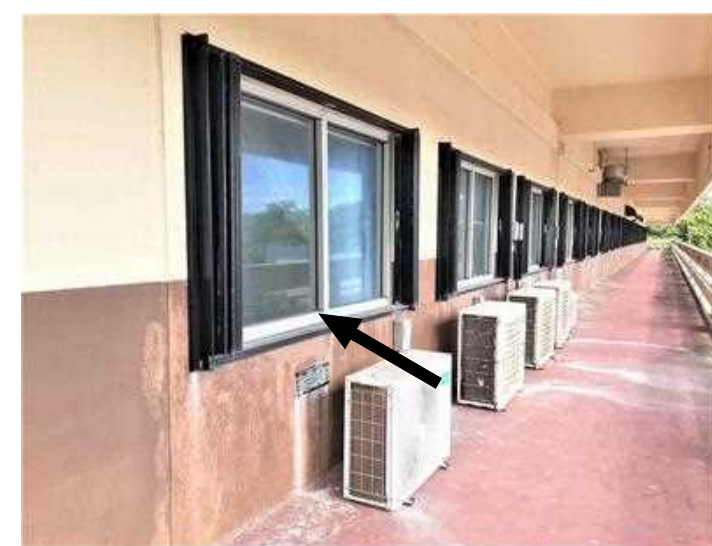
7e PHOTO
S-3.3 S-3.3.A

CONDENSATION AT WINDOWS (10 EA 6'x4')
DETERIORATED SEAL (2 EA 28"x48")

7e S-3.3 S-3.3.A	CONDENSATION AT WINDOWS (10 EA 6"x4") DETERIORATED SEAL (2 EA 28"x48")	REMOVE EXISTING WINDOW SEAL / SEALANT AND REPLACE WITH NEW	
	8e S-3.3 S-3.3.A	BIRD DROPPINGS FROM LIGHT TO HEAVILY INFESTED NARROW TO EXTRA WIDE AREAS (240 Sf).	PROVIDE STAINLESS STEEL ANTI BIRD SPIKES ON ALL LEDGES SUCH AS PIPES, SPRINKLER SYSTEMS, STEEL BEAMS, WINDOW SHUTTERS HEAD, HVAC EXHAUST HOODS, AC UNITS, ETC. and PVC AviAngle LEDGE SHIELD ON CONCRETE BEAM LEDGES. SEE SHEET S-9.1 FOR PVC AviAngle LEDGE SHIELD and ANTI BIRD SPIKES SPECIFICATIONS.	5 S-9.1 S-9.1
	9e S-3.3 S-3.3.A	CONC RAILING SPALLS (8 Lf x 6") 4 sf.	SAWCUT DAMAGED SPALLS, CHIP OFF TO SOUND CONCRETE CLEAN & PATCH w/ EPOXY MORTAR, TYPICAL.	9 S-11.1 S-11.1
	10e S-3.3 S-3.3.A	EXHAUST HOOD COVER MISSING	PROVIDE NEW STAINLESS STEEL BIRD SCREEN COVER.	
	11e S-3.3 S-3.3.A	DETERIORATED FLOOR COATING MEMBRANE (640 sf).	WATERBLAST EXIST CORRIDOR FLOOR, CLEAN AND PROVIDE NEW 60 MIL POLYURETHANE FLOOR COATING TYP TO CORRIDOR SURFACES.

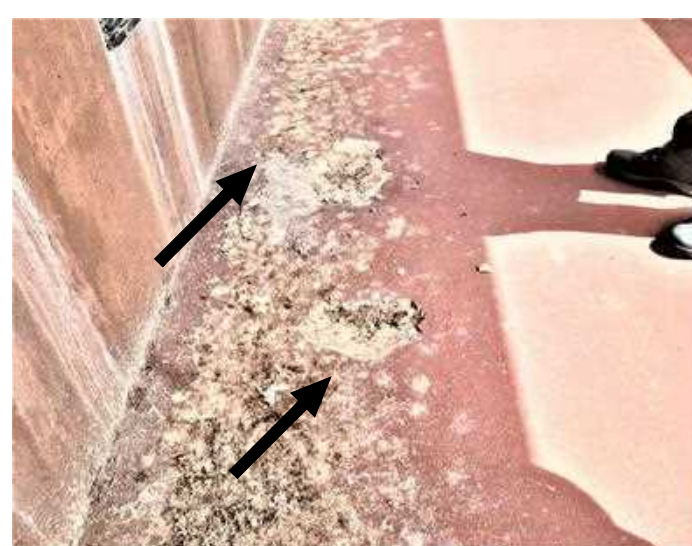
8e PHOTO
S-3.3 S-3.3.A

BIRDS DROPPINGS AT CORRIDOR (240 Sf)
BIRD DROPPINGS FROM BEAM LEDGES
ABOVE, ETC

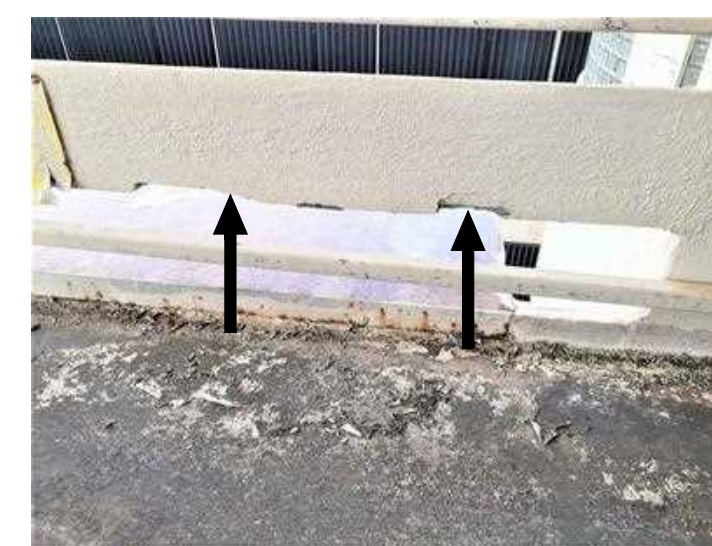
9e PHOTO
S-3.3 S-3.3.A

CONC RAILING SPALLS (8 Lf x 6")

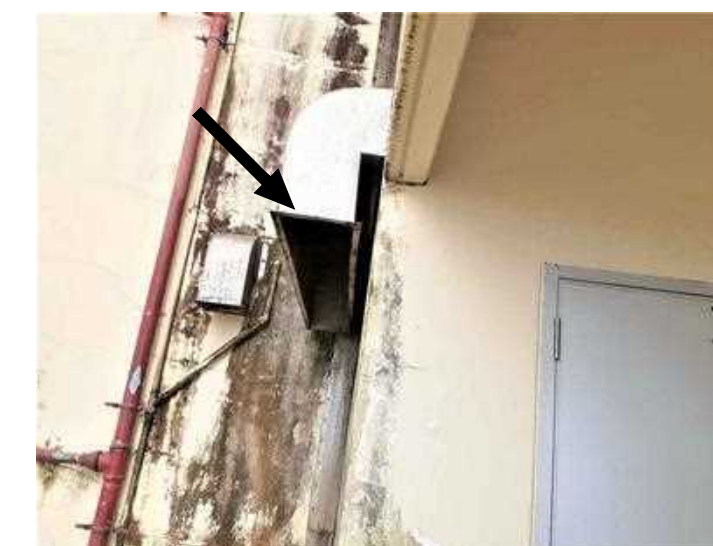
10e PHOTO
S-3.3 S-3.3.A

EXHAUST HOOD COVER MISSING

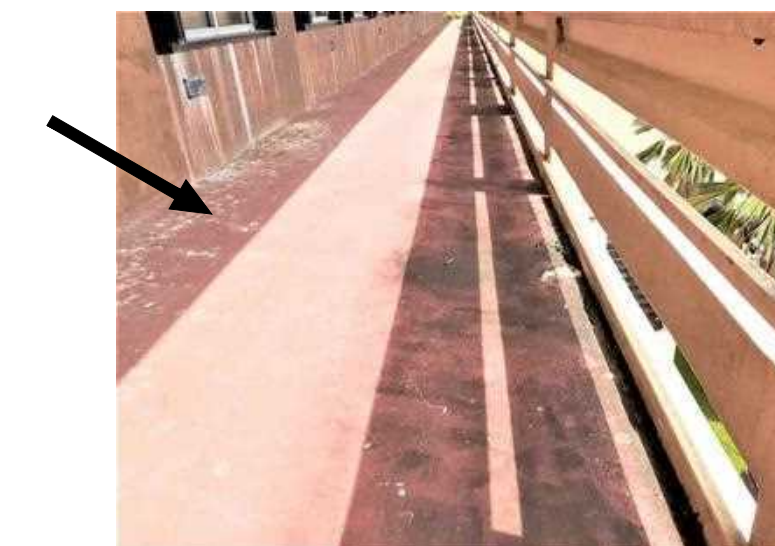
11e PHOTO
S-3.3 S-3.3.A

DETERIORATED FLOOR COATING MEMBRANE (640 sf).

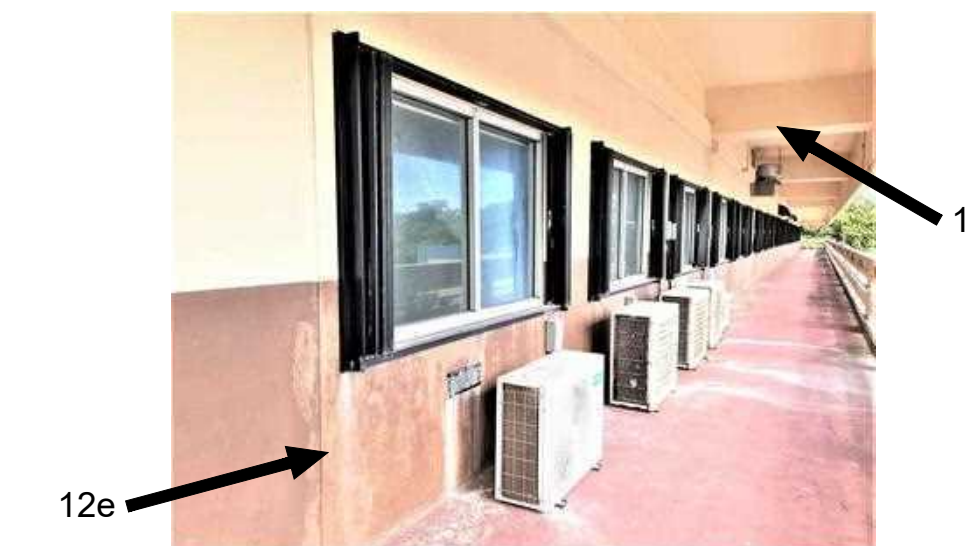
12e PHOTO
S-3.3 S-3.3.A, 13e PHOTO
S-3.3 S-3.3.A

12e DETERIORATED WALL PAINTS (1,040 sf).
13e DETERIORATED CEILING PAINTS (640 sf).

12e S-3.3 S-3.3.A	DETERIORATED WALL PAINT (1,040 sf).	PRESSURE-WASH EXISTING WALL TO REMOVE DIRT, STAIN, MILDEW, ALGAE AND REPAIR ANY AREAS WITH MINOR DAMAGED AND PATCH WITH EPOXY MORTAR. PROVIDE NEW PAINT ON ALL WALL, CONC RAILINGS SURFACES, PER GMHA FACILITY STANDARD, TYPICAL.	
	13e S-3.3 S-3.3.A	DETERIORATED CEILING PAINT (640 sf).	WATERBLAST EXIST CEILING / BEAM SURFACES, CLEAN AND PROVIDE NEW PAINT, PER GMHA FACILITY STANDARD.	
	14e S-3.3 S-3.3.A	DETERIORATED EXISTING TYPHOON SHUTTERS (TYP 2 PLACES).	REMOVE EXISTING WINDOW SHUTTERS AND ITS ACCESSORIES AND REPLACE WITH NEW EXTERIOR MOUNTED TYPHOON RATED INTERLOCKING ALUMINUM SLATS BOXED ROLLER SHUTTERS WITH MANUAL OPERATING SYSTEM. VERIFY WIDTH AND HEIGHT OF EXISTING WALL OPENING.	4 S-9.1 S-9.1
	15e S-3.3 S-3.3.A	DETERIORATED WINDOW SHUTTERS (TYP 21 PLACES).	REMOVE EXISTING WINDOW ACCORDION SHUTTERS AND ITS ACCESSORIES AND REPLACE WITH NEW ALUMINUM ACCORDION SHUTTER, TYPICAL AT EXTERIOR CORRIDORS. REFER TO GMHA FOR COLOR SELECTION.

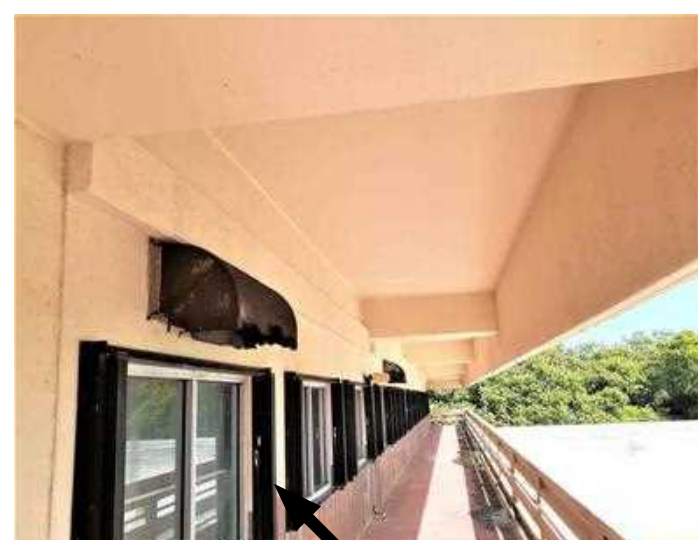
15e PHOTO
S-3.3 S-3.3.A

DETERIORATED WINDOW SHUTTERS
(TYP 14 PLACES)

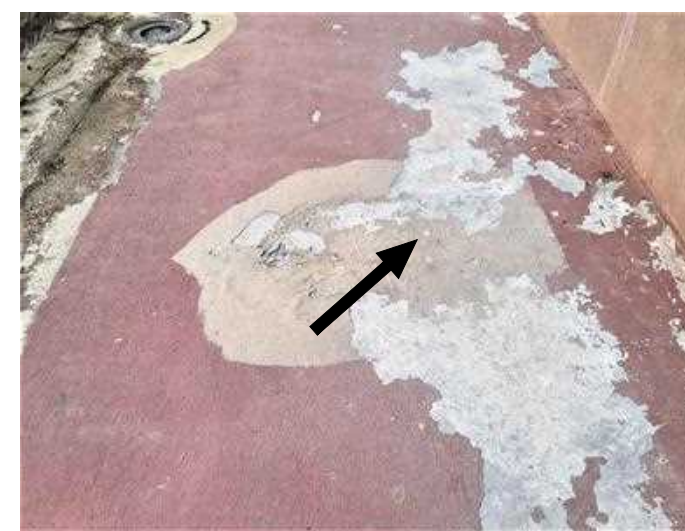
3e PHOTO
S-3.3 S-3.3.A

CONC SPALLS ON FLOORS (4 Sf)

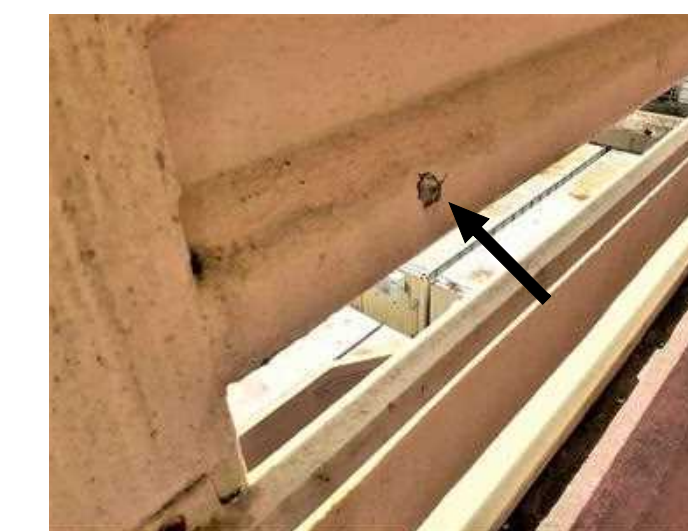
5e PHOTO
S-3.3 S-3.3.A

CONC FLAKING ON RAILING (2 Sf)

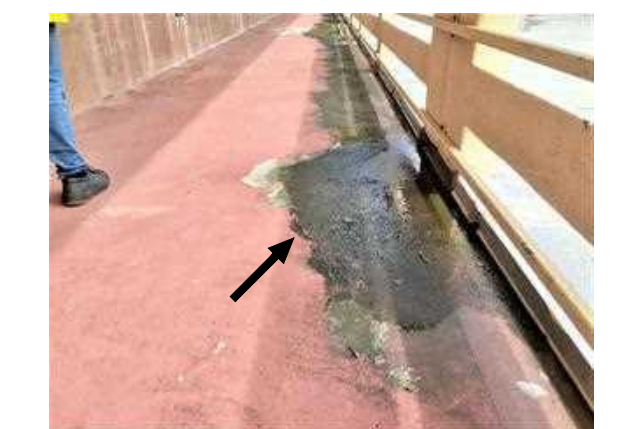
6e PHOTO
S-3.3 S-3.3.A

PONDING ON CORRIDOR (188 Sf)

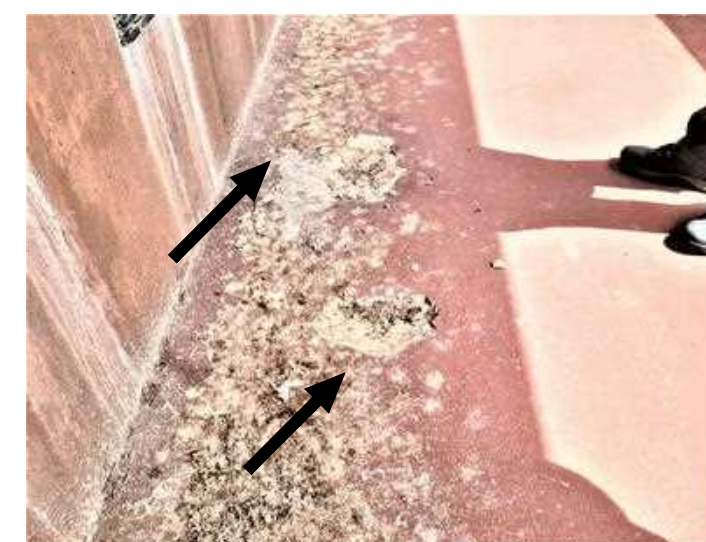
8e PHOTO
S-3.3 S-3.3.A

BIRDS DROPPINGS AT CORRIDOR (240 Sf)
BIRD DROPPINGS FROM BEAM LEDGES
ABOVE, ETC

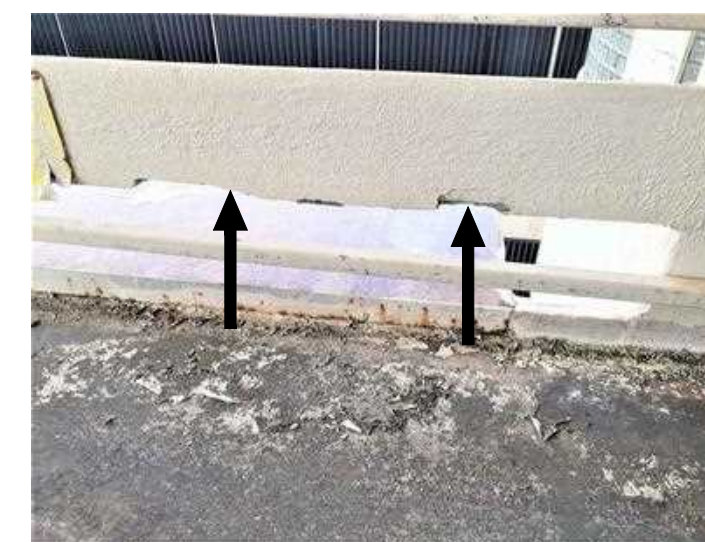
9e PHOTO
S-3.3 S-3.3.A

CONC RAILING SPALLS (8 Lf x 6")

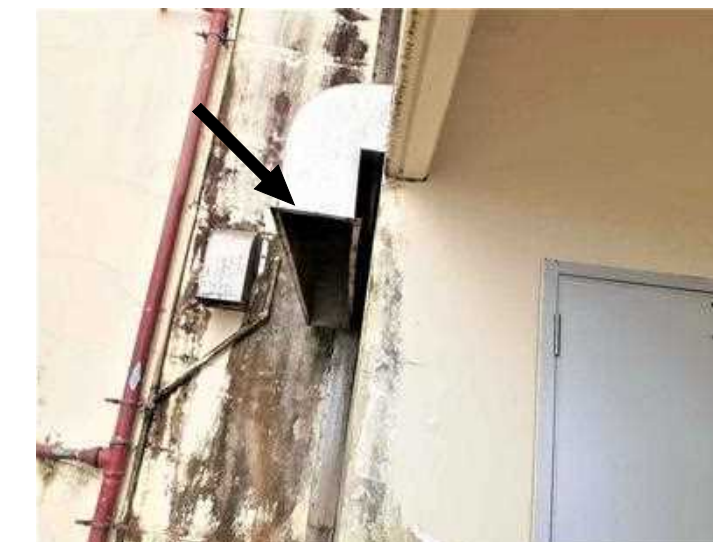
10e PHOTO
S-3.3 S-3.3.A

EXHAUST HOOD COVER MISSING

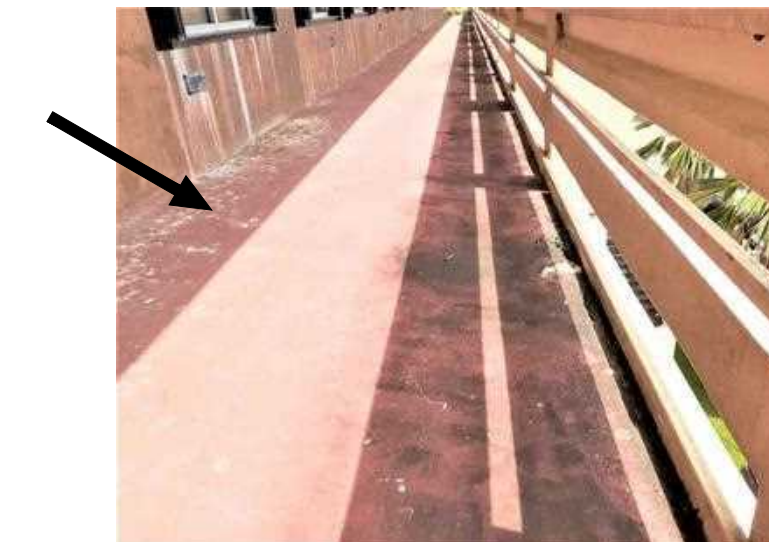
11e PHOTO
S-3.3 S-3.3.A

DETERIORATED FLOOR COATING MEMBRANE (640 sf).

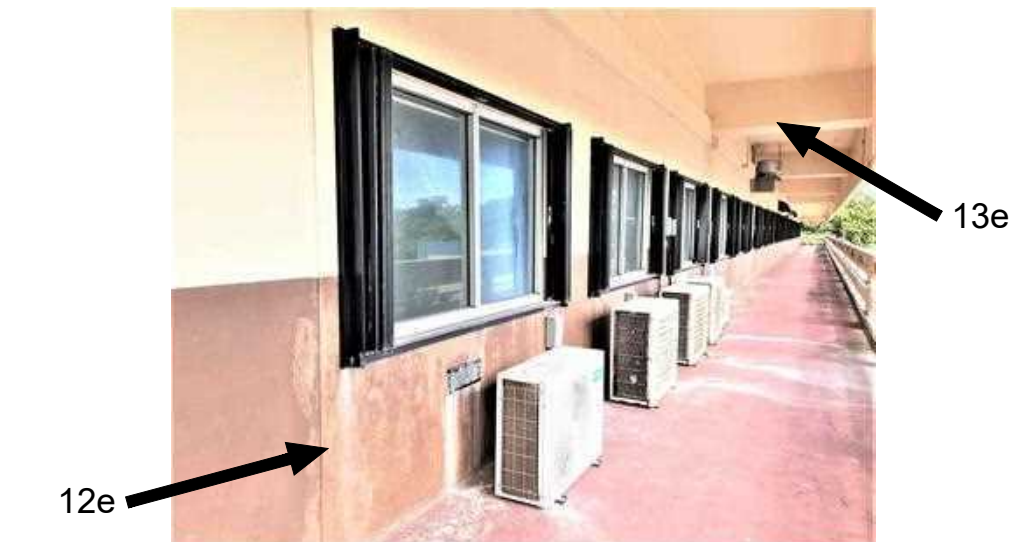
12e PHOTO
S-3.3 S-3.3.A, 13e PHOTO
S-3.3 S-3.3.A

12e DETERIORATED WALL PAINTS (1,040 sf).
13e DETERIORATED CEILING PAINTS (640 sf).

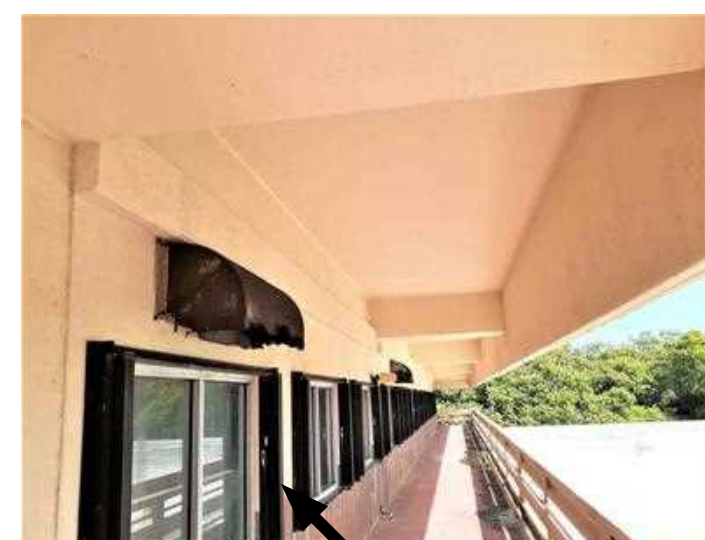
15e PHOTO
S-3.3 S-3.3.A

DETERIORATED WINDOW SHUTTERS
(TYP 14 PLACES)

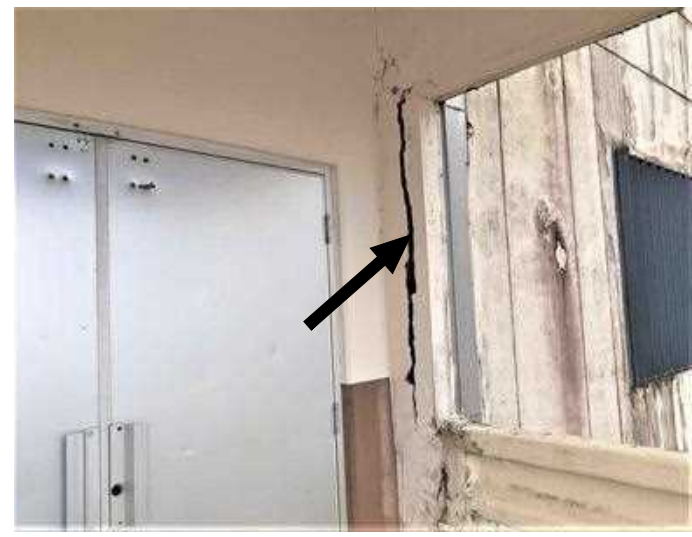
3e PHOTO
S-3.4 S-3.4.A

SEVERE CRACKS ON PILASTER WALL (13 lf).

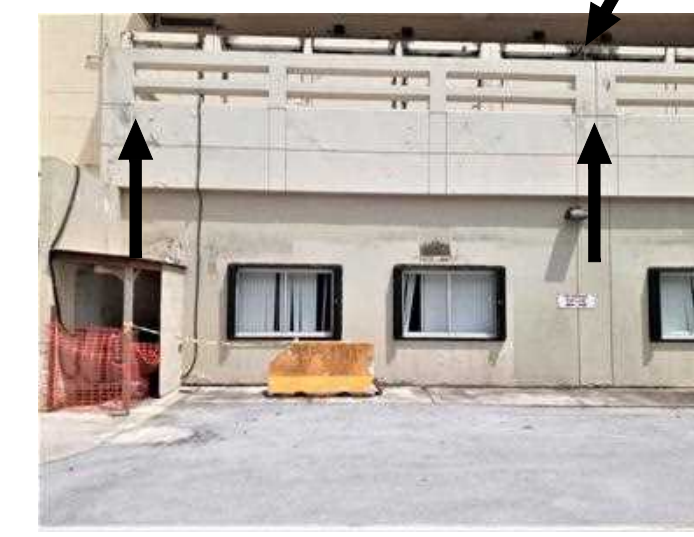
4e PHOTO
S-3.4 S-3.4.A

DETERIORATED PARAPET WALL PAINTS (1440 sf).

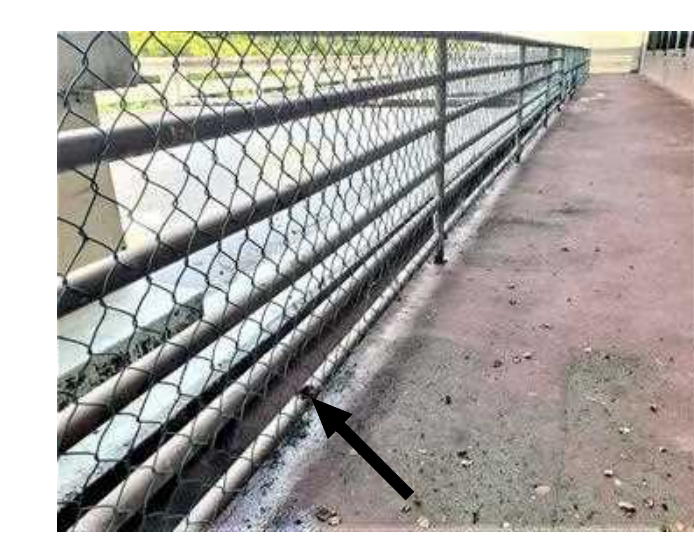
5e PHOTO
S-3.4 S-3.4.A

DETERIORATED CHAIN LINK & PIPE RAILING & ITS ACCESSORIES (158 lf).

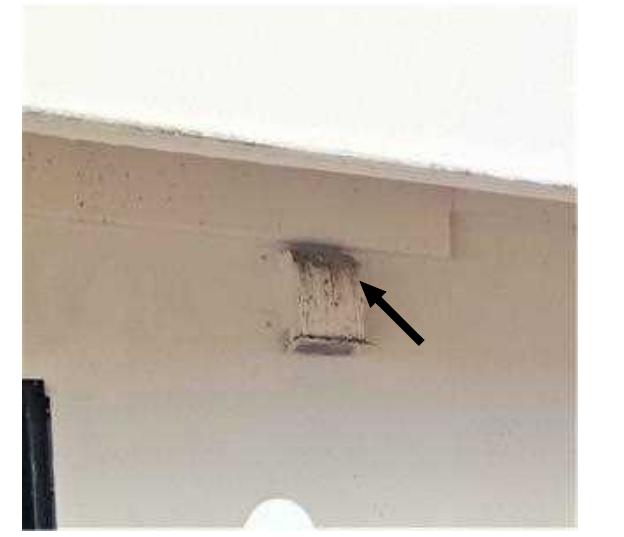
6e PHOTO
S-3.4 S-3.4.A

WALL MOUNTED EXHAUST HOOD RUSTED WITH BIRD DROPPING.

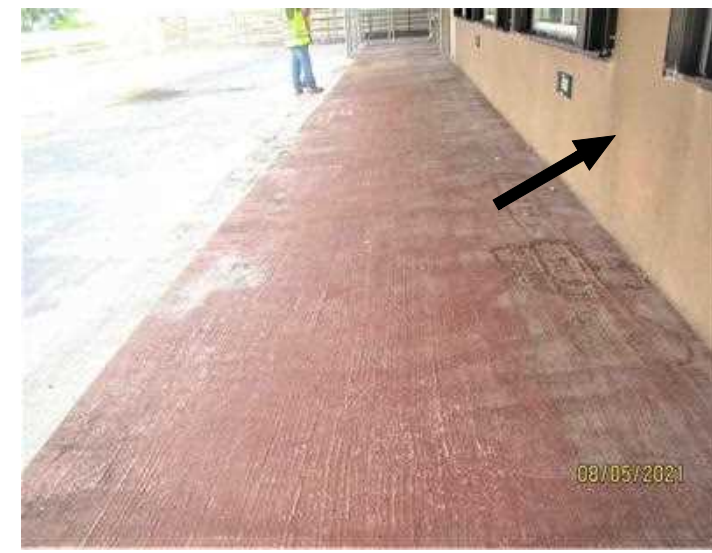
7e PHOTO
S-3.4 S-3.4.A

DETERIORATED WALL PAINT WITH STAINS & MILDEW (5100 sf).

7e	DETERIORATED WALL PAINT WITH STAINS & MILDEW (5100 sf).	PRESSURE-WASH EXISTING WALL TO REMOVE DIRT, STAIN, MILDEW, ALGAE AND REPAIR ANY AREAS WITH MINOR DAMAGED AND PATCH WITH EPOXY MORTAR. PROVIDE NEW PAINT ON ALL WALL, CONC RAILINGS SURFACES, PER GMHA FACILITY STANDARD, TYPICAL.	
	8e	ROOF DRAIN WATER PONDING (4 ea) 860 sf.	WATERBLAST EXIST AFFECTED AREAS, ROUGHEN SURFACES TO 1/4 AMPLITUDE, CLEAN & PROVIDE EPOXY BINDER PRIOR TO POURING OF NEW CONCRETE CEMENT TOPPING. PROVIDE SLOPE ON NEW TOPPING TO DIRECT WATER TO EXISTING ROOF DRAIN OR SCUPPER DRAIN.	
	9e	DETERIORATED WINDOW SEALANT & SEAL (248+240+160+128 SLNT) (48+32+48+32 SEAL).	REMOVE EXISTING WINDOW SEAL / SEALANT AND REPLACE WITH NEW.	
	10e	ROOF CRACKS ON SLAB (38 lf).	GRIND TRACES OF CRACKS ON ROOF. CLEAN AND INJECT WITH EPOXY FILLER, SEE DETAIL.	6 S-3.4 S-11.1
	11e	DETERIORATED ROOF DRAIN STRAINER (4 ea).	REMOVE EXISTING ROOF DRAIN STRAINER/COVER AND REPLACE WITH NEW. SEE DRAIN RESTORATION AND REPAIR DETAILS	8 S-3.4 S-12.1

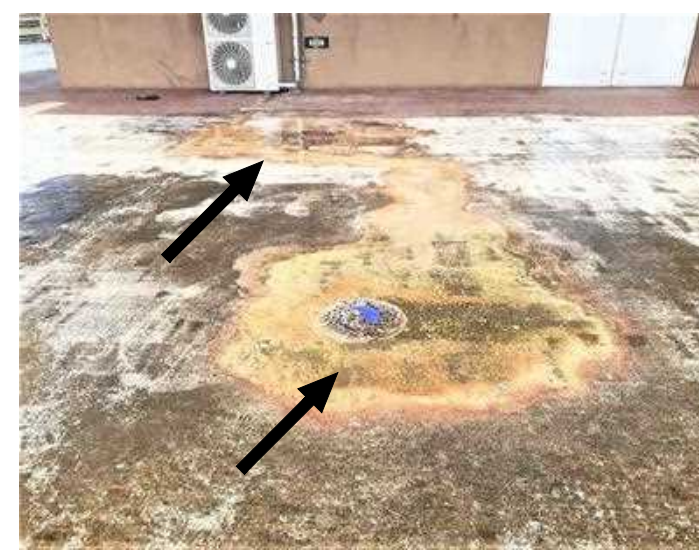
8e PHOTO
S-3.4 S-3.4.A

ROOF DRAIN WATER PONDING (4 ea) 860 sf.

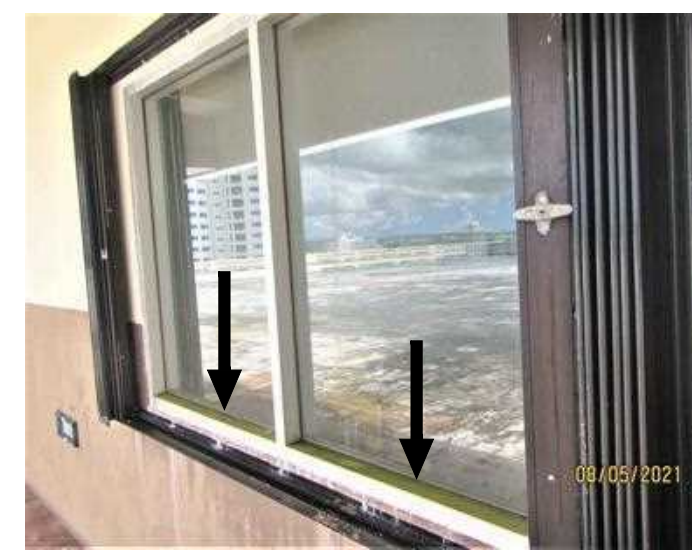
9e PHOTO
S-3.4 S-3.4.A

DETERIORATED WINDOW SEALANT & SEAL (248+240+160+128 SLNT) (48+32+48+32 SEAL).

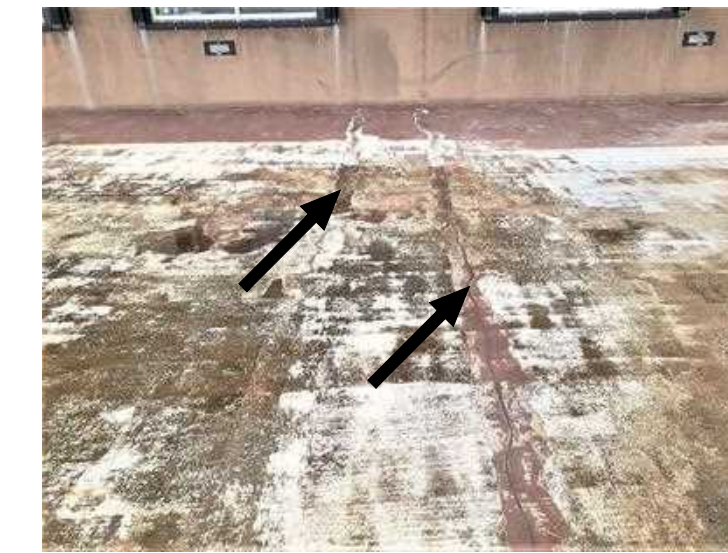
10e PHOTO
S-3.4 S-3.4.A

ROOF CRACKS ON SLAB (38 lf).

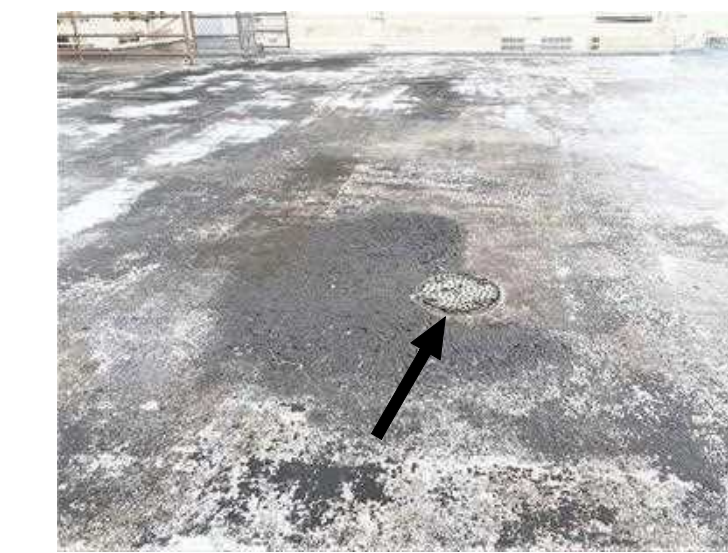
11e PHOTO
S-3.4 S-3.4.A

DETERIORATED ROOF DRAIN STRAINER (4 ea).

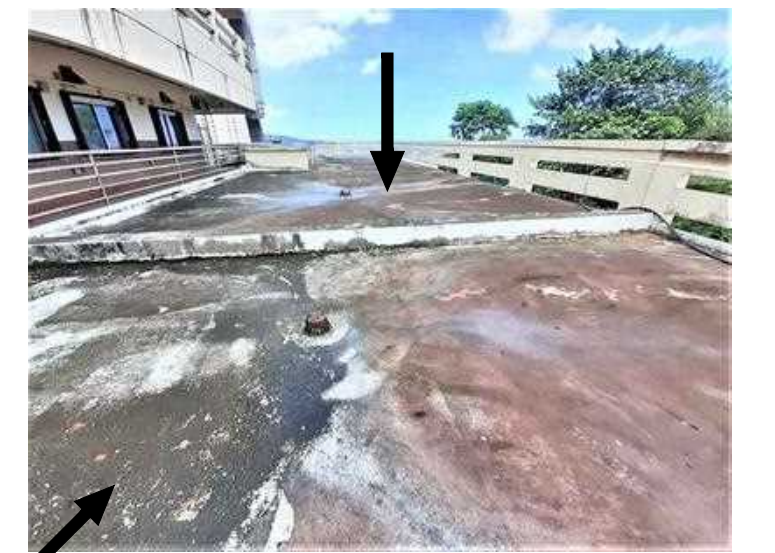
12e PHOTO
S-3.4 S-3.4.A

DETERIORATED ROOF COATING MEMBRANE (9900 sf).

12e	DETERIORATED ROOF COATING MEMBRANE (9900 sf).	WATERBLAST EXISTING ROOF SURFACES, CLEAN AND PROVIDE NEW 45 MIL POLYURATHANE ROOF COATING TYP TO ALL ROOF SURFACES.	
	13e	CONCRETE SPALLS ON WINDOW SILL TRIM (12 sf).	SAWCUT DAMAGED SPALLS, CHIP OFF TO SOUND CONCRETE CLEAN & PATCH w/ EPOXY MORTAR, TYPICAL.	9 S-11.1 S-11.1
	14e	DETERIORATED EXHAUST HOOD (7 ea).	REMOVE EXIST WALL MOUNTED HOOD & REPLACE WITH NEW. REFER TO MECHANICAL DRAWINGS.	
	15e	DETERIORATED ROOF DRAIN DOME COVER (6 ea).	REMOVE EXISTING ROOF DRAIN STRAINER/COVER AND REPLACE WITH NEW. SEE DRAIN RESTORATION AND REPAIR DETAILS	8 S-3.4 S-12.1
	16e	CONCRETE SPALLS ON PARAPET (8 sf).	SAWCUT DAMAGED SPALLS, CHIP OFF TO SOUND CONCRETE CLEAN & PATCH w/ EPOXY MORTAR, TYPICAL.	9 S-11.1 S-11.1
	17e	WATER PONDING WITH GREEN ALGAE (392 sf).	WATERBLAST EXIST AFFECTED AREAS, ROUGHEN SURFACES TO 1/4 AMPLITUDE, CLEAN & PROVIDE EPOXY BINDER PRIOR TO POURING OF NEW CONCRETE CEMENT TOPPING. PROVIDE SLOPE ON NEW TOPPING TO DIRECT WATER TO EXISTING ROOF DRAIN OR SCUPPER DRAIN.

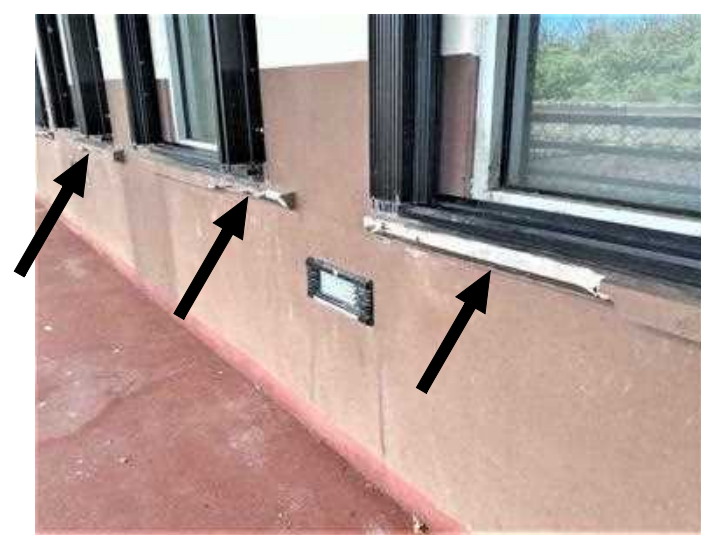
13e PHOTO
S-3.4 S-3.4.A

CONCRETE SPALLS ON WINDOW SILL TRIM (12 sf).

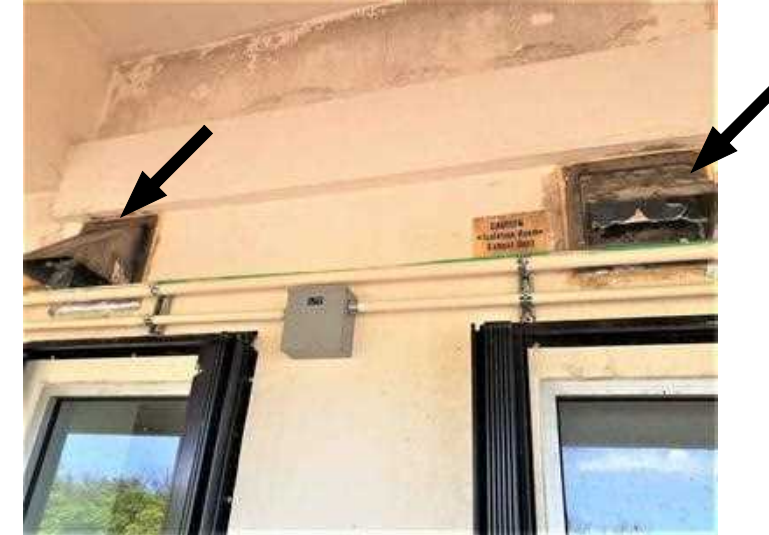
14e PHOTO
S-3.4 S-3.4.A

DETERIORATED EXHAUST HOOD (7 ea).

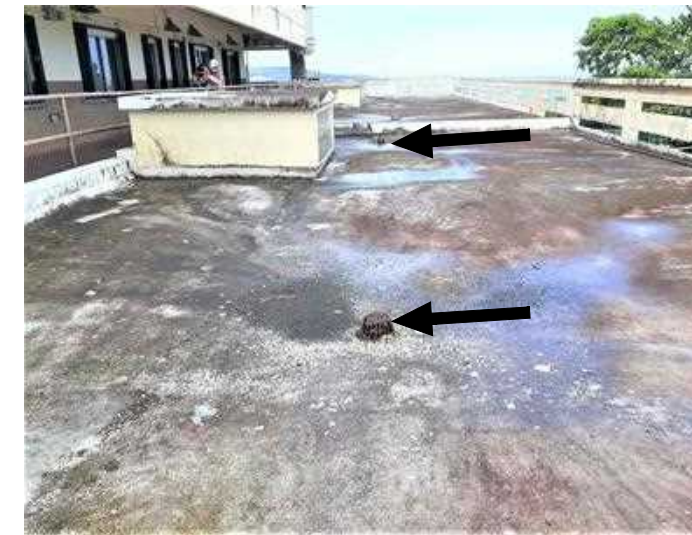
15e PHOTO
S-3.4 S-3.4.A

DETERIORATED ROOF DRAIN DOME COVER (6 ea).

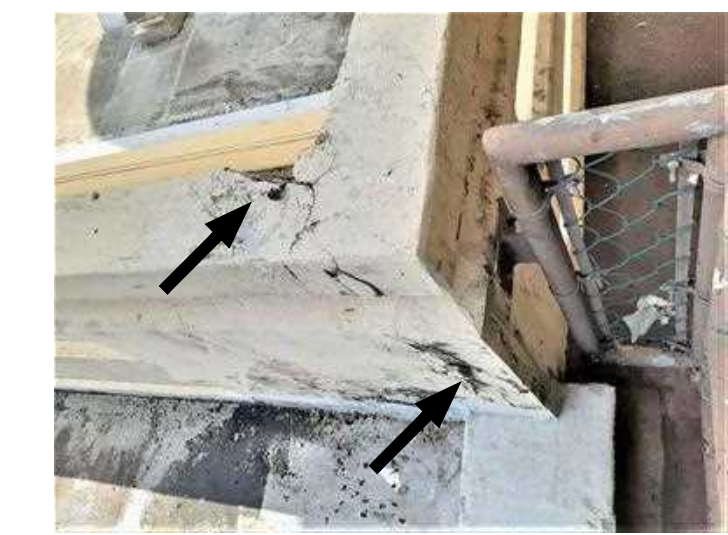
16e PHOTO
S-3.4 S-3.4.A

CONCRETE SPALLS ON PARAPET (8 sf).

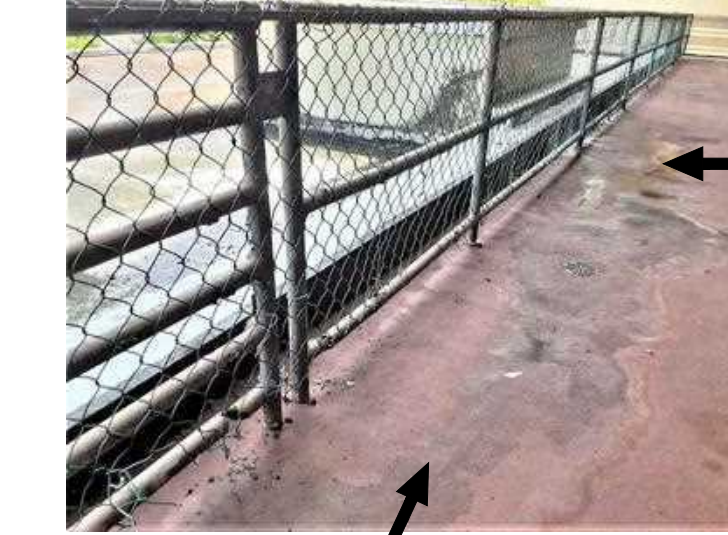
17e PHOTO
S-3.4 S-3.4.A

WATER PONDING WITH GREEN ALGAE (392 sf).

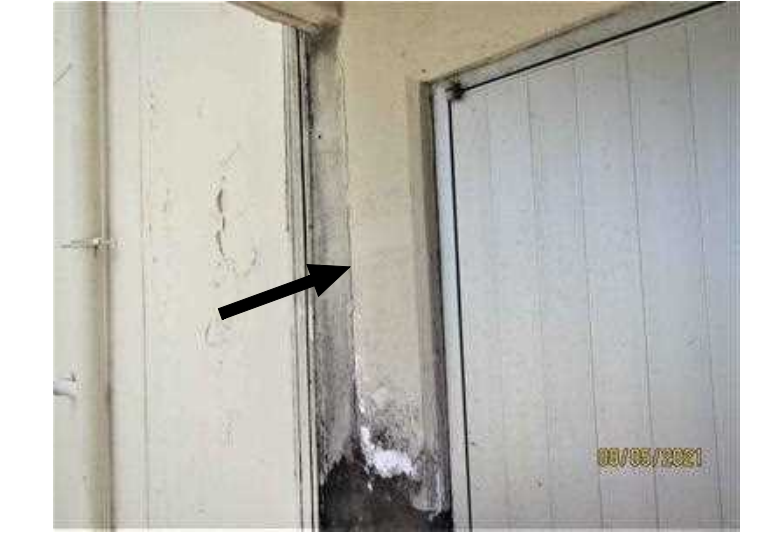
18e PHOTO
S-3.4 S-3.4.A

CRACKS ON WALLS (13 lf).

18e	CRACKS ON WALLS (13 lf).	GRIND TRACES OF CRACKS ON WALL, CLEAN AND INJECT WITH EPOXY FILLER, SEE DETAIL.	3 S-3.4 S-11.1
	19e	FAILED DOOR & ITS ACCESSORIES (1 ea).	REMOVE EXIST DOOR & ITS ACCESSORIES AND REPLACE w/ NEW. COORDINATE SAFETY HARDWARE w/ HOSPITAL SECURITY SYSTEM.	1,2,3 S-8.1 S-8.1
	20e	BIRDS DROPPINGS FROM LIGHT TO HEAVILY INFESTED NARROW TO EXTRA WIDE AREAS.	PROVIDE STAINLESS STEEL ANTI BIRD SPIKES ON ALL LEDGES SUCH AS PIPES, SPRINKLER SYSTEMS, STEEL BEAMS, WINDOW SHUTTERS HEAD, HVAC EXHAUST HOODS, AC UNITS, ETC. and PVC AviAngle LEDGE SHIELD ON CONCRETE BEAM LEDGES. SEE SHEET S-9.1 FOR PVC AviAngle LEDGE SHIELD and ANTI BIRD SPIKES SPECIFICATIONS.	5 S-9.1 S-9.1
	21e	DETERIORATED WINDOW SHUTTERS (TYP 21 PLACES).	REMOVE EXISTING WINDOW ACCORDION SHUTTERS AND ITS ACCESSORIES AND REPLACE WITH NEW ALUMINUM ACCORDION SHUTTER, TYPICAL AT EXTERIOR CORRIDORS. REFER TO GMHA FOR COLOR SELECTION.

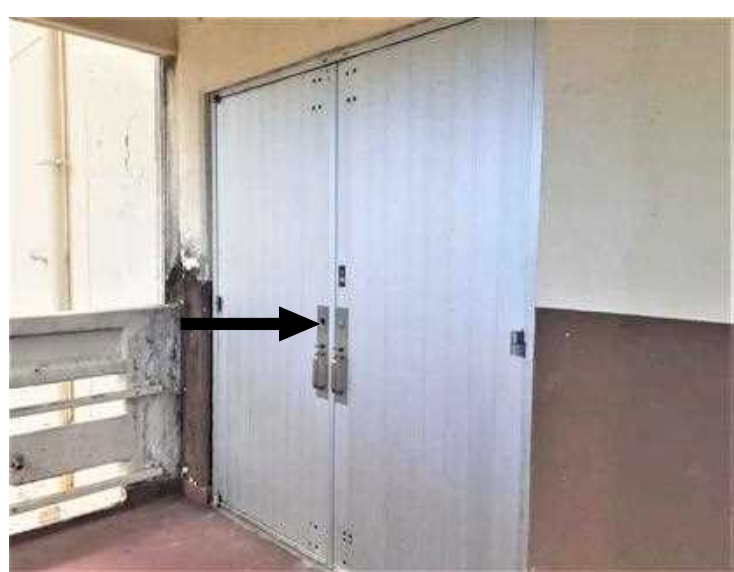
19e PHOTO
S-3.4 S-3.4.A

FAILED DOOR & ITS ACCESSORIES (1 ea).

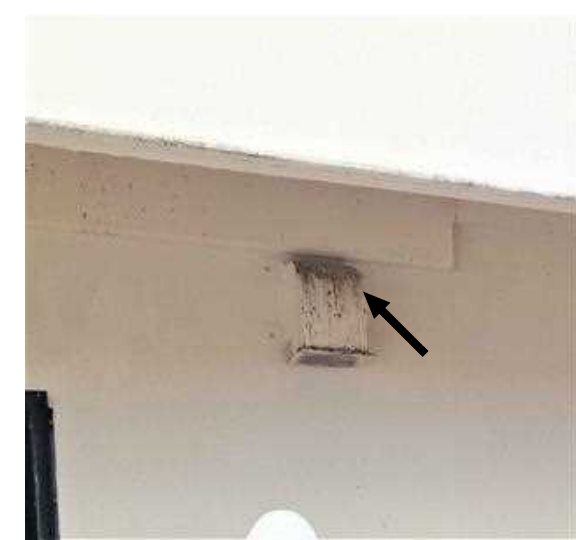
20e PHOTO
S-3.4 S-3.4.A

BIRD DROPPINGS PRESENT ON HOOD.

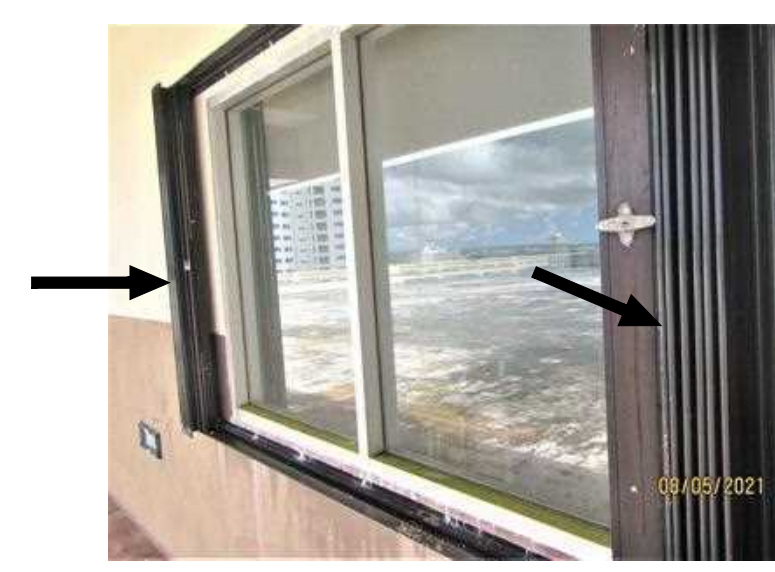
21e PHOTO
S-3.4 S-3.4.A

DETERIORATED WINDOW ACCORDION SHUTTER

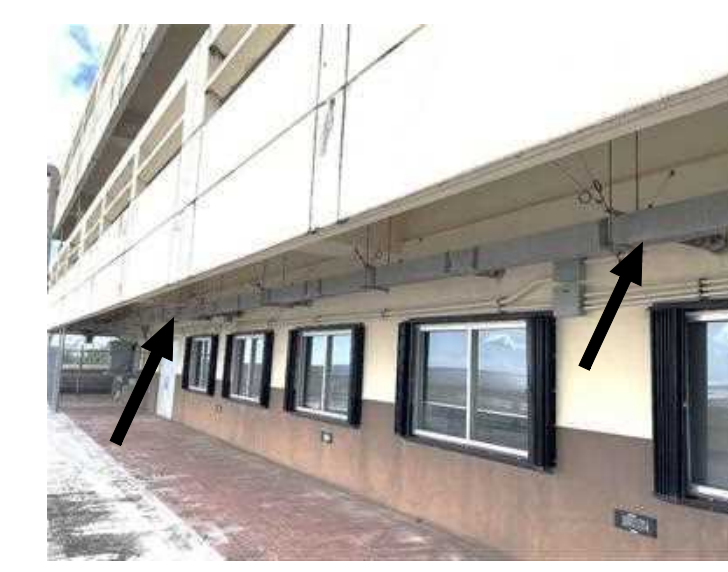
22e PHOTO
S-3.4 S-3.4.A

EXISTING EXTERIOR SUSPENDED AC DUCTING

22e	EXISTING EXTERIOR SUSPENDED AC DUCTING.	PROVIDE STAINLESS STEEL ANTI BIRD SPIKES ON ALL LEDGES SUCH AS PIPES, SPRINKLER SYSTEMS, STEEL BEAMS, BEAM LEDGES, WINDOW SHUTTERS HEAD, HVAC EXHAUST HOODS, AC UNITS, ETC. SEE 2 / S-10.1 FOR ANTI BIRD SPIKES SPECIFICATIONS.	5 S-9.1 S-9.1

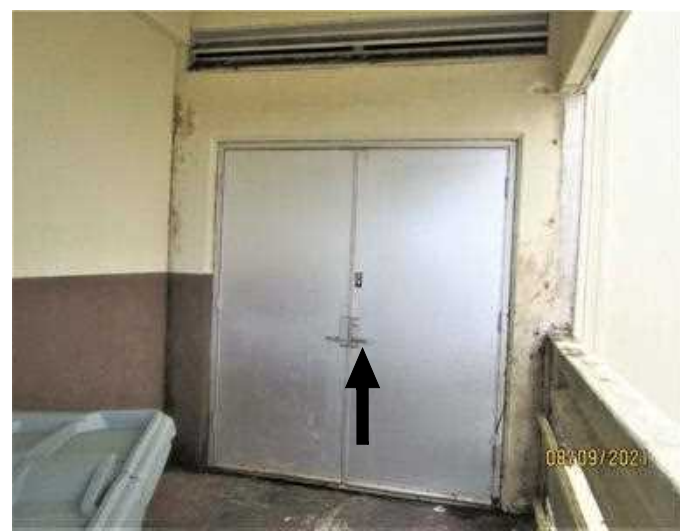
2e PHOTO
S-4.2 S-4.2.A

BROKEN OVERHEAD DOOR AIR INTAKE

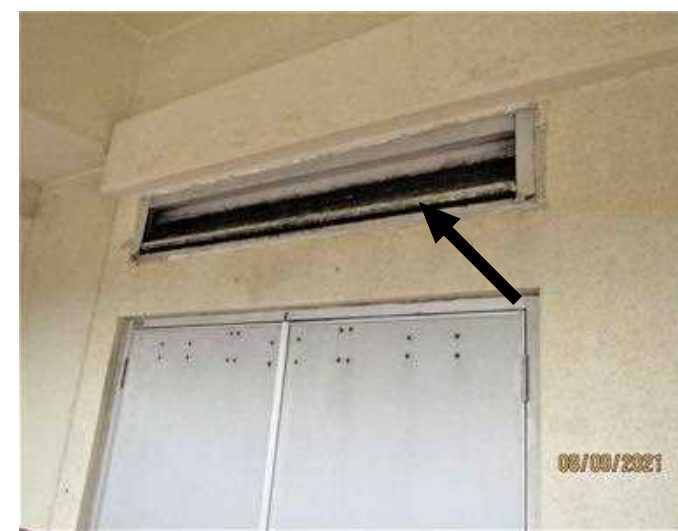
3e PHOTO
S-4.2 S-4.2.A

DETERIORATED WALL EXHAUST HOOD

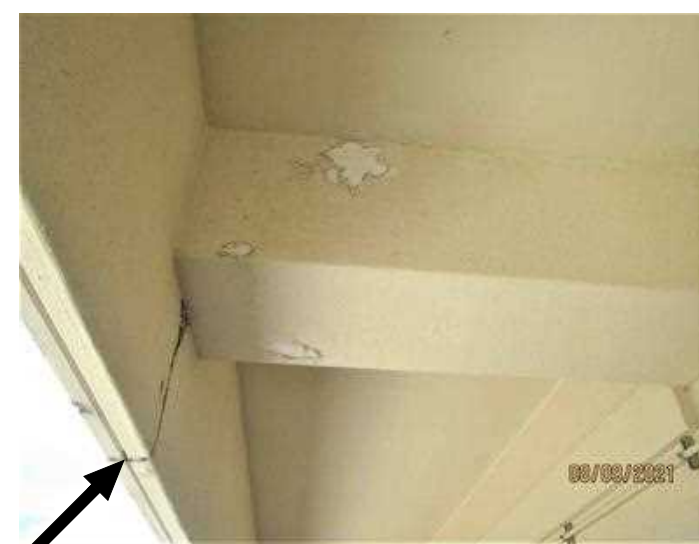
9e PHOTO
S-4.2 S-4.2.A

COLUMN SPALLS (10 SF)

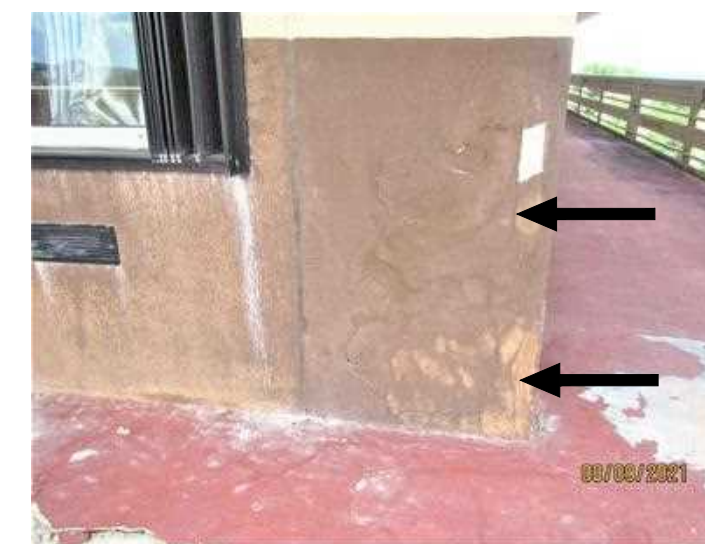
10e PHOTO
S-4.2 S-4.2.A

BEAM SPALLS (10 Sf)

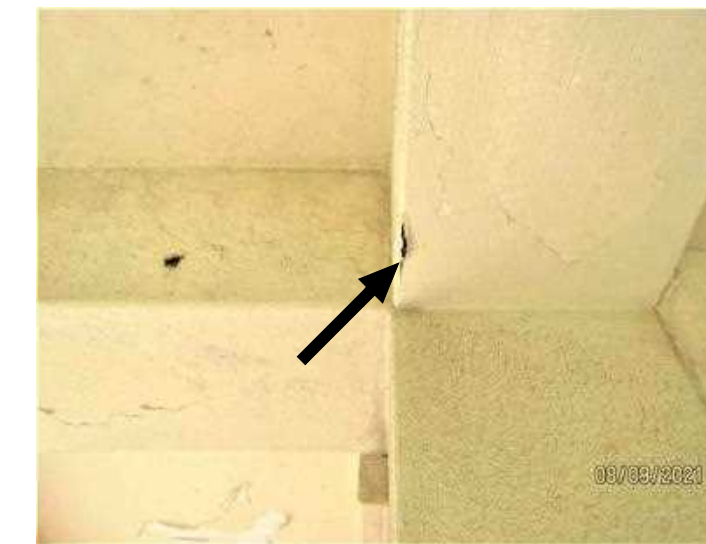
11e PHOTO
S-4.2 S-4.2.A

PAINT FLAKING AT BEAM (20 Sf)

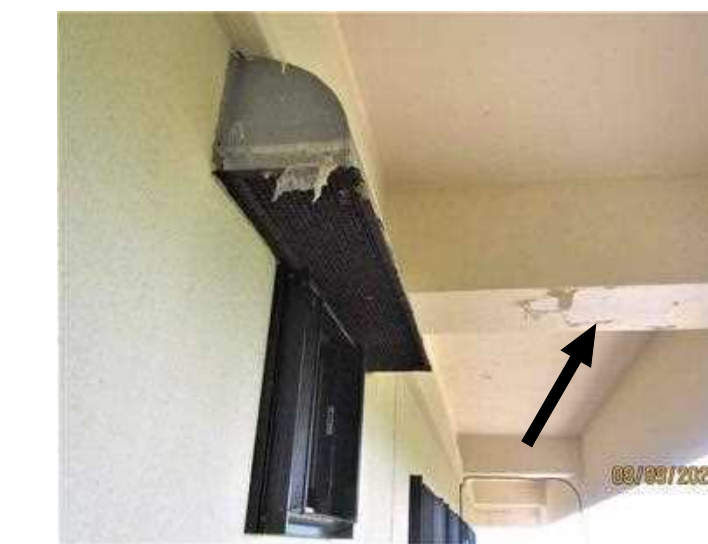
12e PHOTO
S-4.2 S-4.2.A

SPALLS AT CEILING (4 Sf)

12e S-4.2 S-4.2.A	SPALLS AT CEILING (4 Sf)	SAWCUT DAMAGED SPALLS AT CEILING, CHIP OFF TO SOUND CONCRETE CLEAN & PATCH w/ EPOXY MORTAR, TYPICAL.	2 S-11.1 S-11.1
	13e S-4.2 S-4.2.A	PAINT FLAKING AT SOFFIT (16 Sf)	WATERBLAST EXISTING SOFFIT, SCRAPE OFF PAINT FLAKING, CLEAN AND PROVIDE NEW PAINT, PER GMHA FACILITY STANDARD.	
	14e S-4.2 S-4.2.A	CONC SPALLS ON FLOOR WITH EXPOSED REBAR (36 Sf)	SAWCUT DAMAGED SPALLS, CHIP OFF TO SOUND CONCRETE CLEAN & PATCH w/ EPOXY MORTAR, TYPICAL.	9 S-11.1 S-11.1
	15e S-4.2 S-4.2.A	WALL CRACKS (9 Lf)	GRIND TRACES OF CRACKS, CLEAN AND INJECT WITH EPOXY FILLER, SEE DETAIL.	4 S-11.1 S-11.1
	16e S-4.2 S-4.2.A	DETERIORATED DOOR THRESHOLD (6 Lf)	REMOVE EXISTING DOOR THRESHOLD AND REPLACE WITH NEW.	3 S-9.1 S-9.1
	17e S-4.2 S-4.2.A	DETERIORATED EXISTING TYPHOON SHUTTERS (TYP 2 PLACES).	REMOVE EXISTING WINDOW SHUTTERS AND ITS ACCESSORIES AND REPLACE WITH NEW EXTERIOR MOUNTED TYPHOON RATED INTERLOCKING ALUMINUM SLATS ROLLER SHUTTERS WITH MANUAL OPERATING SYSTEM. VERIFY WIDTH AND HEIGHT OF EXISTING WALL OPENING.	4 S-9.1 S-9.1

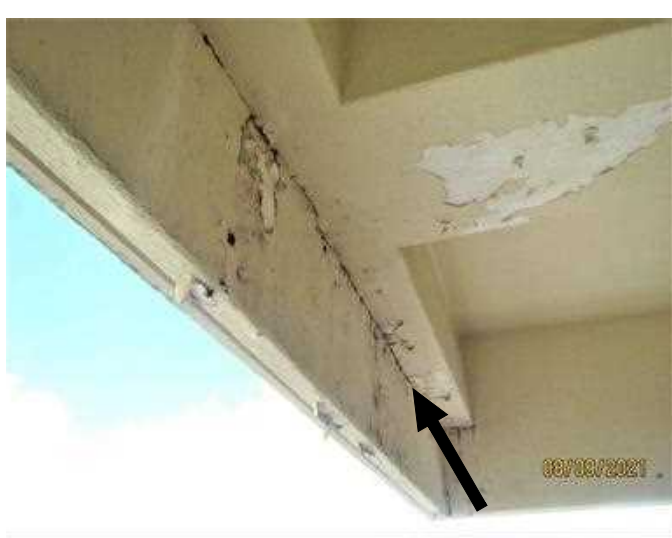
13e PHOTO
S-4.2 S-4.2.A

PAINT FLAKING AT SOFFIT (16 Sf)

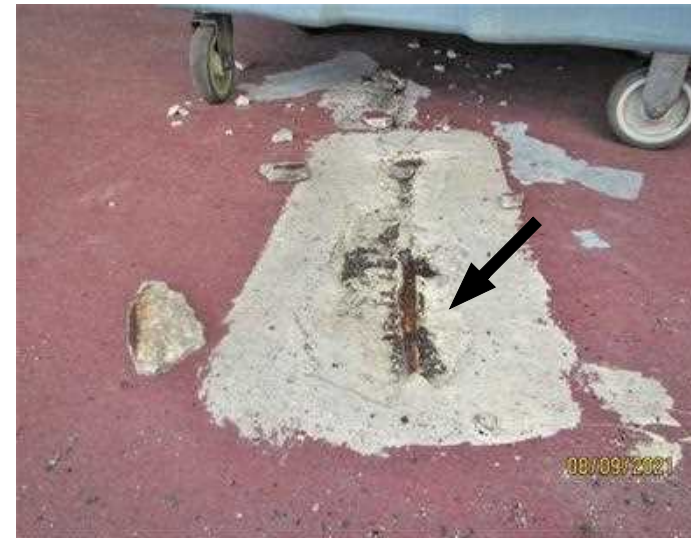
14e PHOTO
S-4.2 S-4.2.A

CONC SPALLS ON FLOOR WITH EXPOSED REBAR (36 Sf)

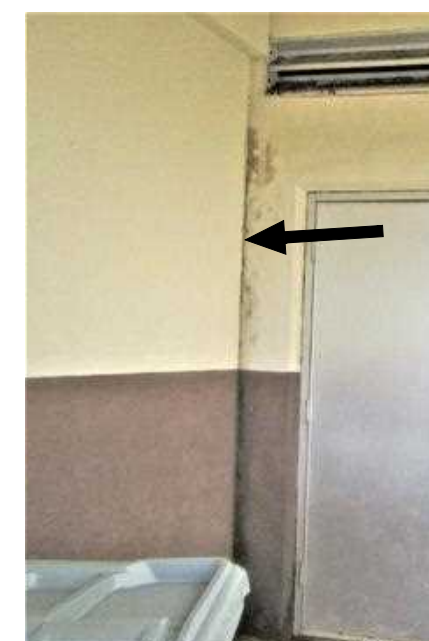
15e PHOTO
S-4.2 S-4.2.A

WALL CRACKS (9 Lf)

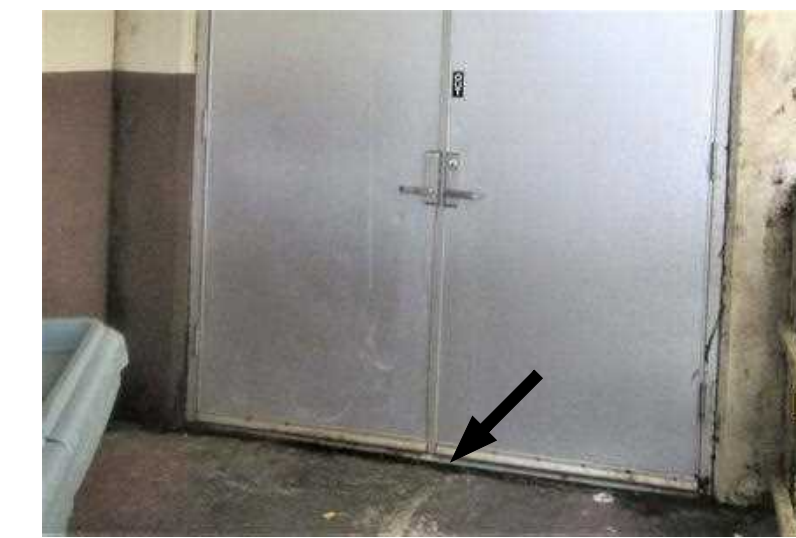
16e PHOTO
S-4.2 S-4.2.A

DETERIORATED DOOR THRESHOLD (6 Lf)

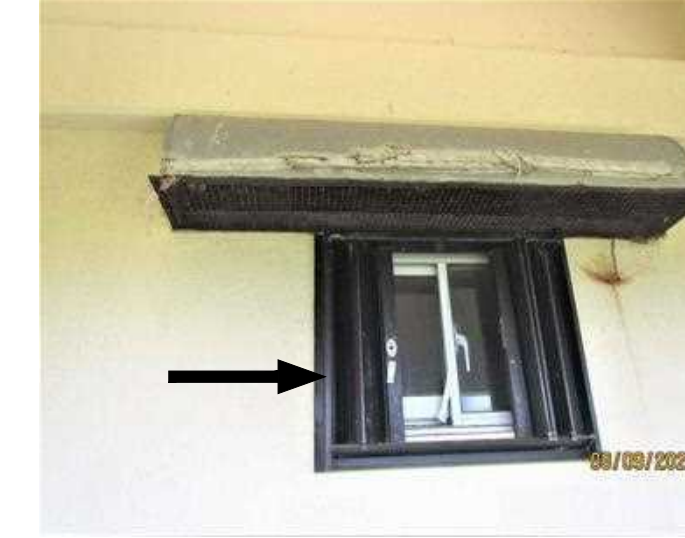
18e PHOTO
S-4.2 S-4.2.A

DETERIORATED WINDOW SHUTTERS
(TYP 23 PLACES)

18e S-4.2 S-4.2.A	DETERIORATED WINDOW SHUTTERS (TYP 21 PLACES).	REMOVE EXISTING WINDOW ACCORDION SHUTTERS AND ITS ACCESSORIES AND REPLACE WITH NEW ALUMINUM ACCORDION SHUTTER, TYPICAL AT EXTERIOR CORRIDORS. REFER TO GMHA FOR COLOR SELECTION.	
	19e S-4.2 S-4.2.A	BIRDS DROPPINGS FROM LIGHT TO HEAVILY INFESTED NARROW TO EXTRA WIDE AREAS.	PROVIDE STAINLESS STEEL ANTI BIRD SPIKES ON ALL LEDGES SUCH AS PIPES, SPRINKLER SYSTEMS, STEEL BEAMS, WINDOW SHUTTERS HEAD, HVAC EXHAUST HOODS, AC UNITS, ETC. AND PVC AviAngle LEDGE SHIELD ON CONCRETE BEAM LEDGES. SEE SHEET S-9.1 FOR PVC AviAngle LEDGE SHIELD and ANTI BIRD SPIKES SPECIFICATIONS.	5 S-9.1 S-9.1
	20e S-4.2 S-4.2.A	DETERIORATED WALL PAINT (1,950+1,170+390 Sf) = 3,510 Sf.	PRESSURE-WASH EXISTING WALL TO REMOVE DIRT, STAIN, MILDEW, ALGAE AND REPAIR ANY AREAS WITH MINOR DAMAGED AND PATCH WITH EPOXY MORTAR. PROVIDE NEW PAINT ON ALL WALL, CONC RAILINGS SURFACES, PER GMHA FACILITY STANDARD, TYPICAL.
