GMHA HOSPITAL ROOF AND ENVELOP UPGRADE PROJECT

PACKAGE A - 3RD & 4TH FLOOR ROOF AND ENVELOP (A,B, & E-WING)

GUAM MEMORIAL HOSPITAL AUTHORITY, TAMUNING, GUAM

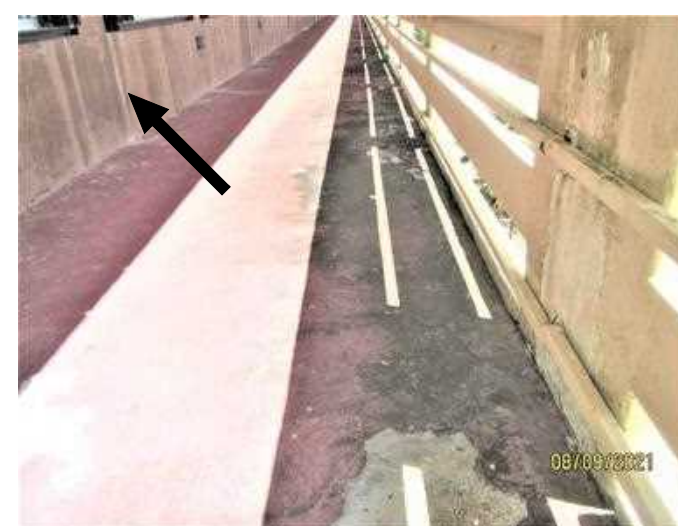
20e PHOTO
S-4.2 S-4.2.A

DETERIORATED WALL PAINT (3,510 Sf)

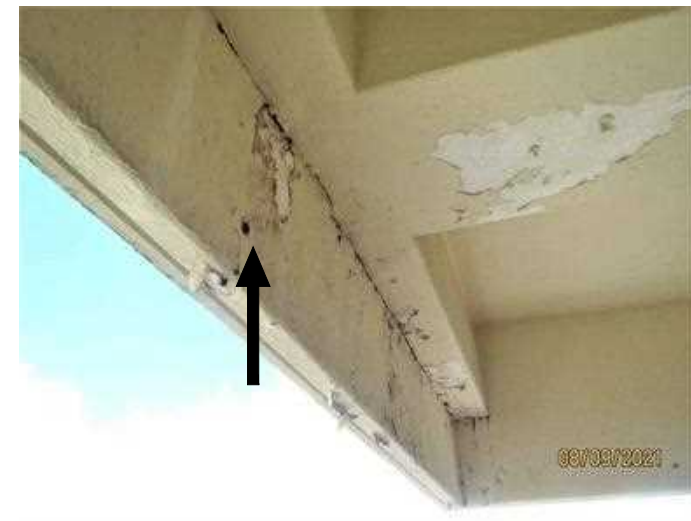
2e PHOTO
S-4.3 S-4.3.A

SPALL WITH EXPOSED REBAR AT SOFFIT FASCIA (2 Sf)

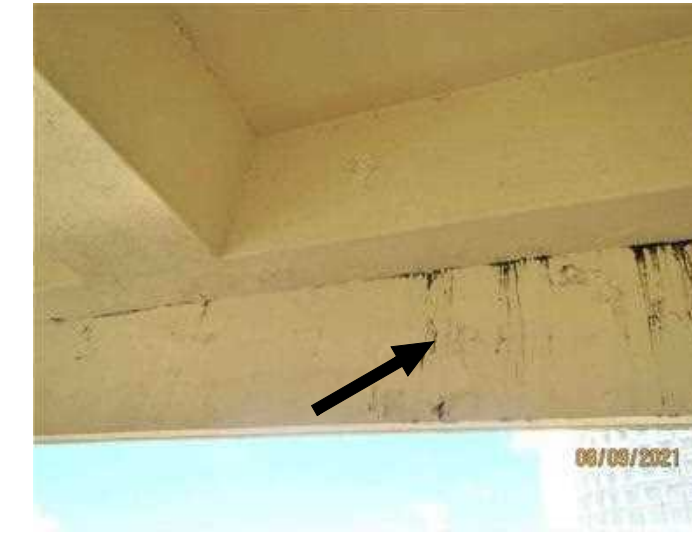
4e PHOTO
S-4.3 S-4.3.A

PAINT FLAKING AT SOFFIT FASCIA (60 Sf)

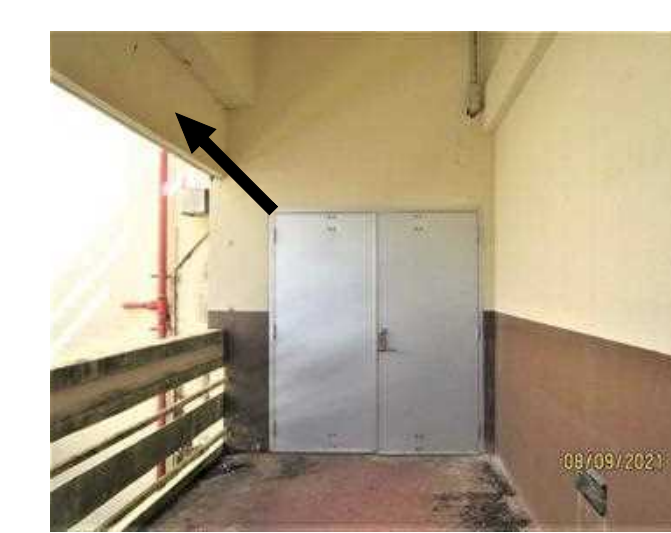
5e PHOTO
S-4.3 S-4.3.A

CONC SPALLS ON PARAPET (4 Lf)

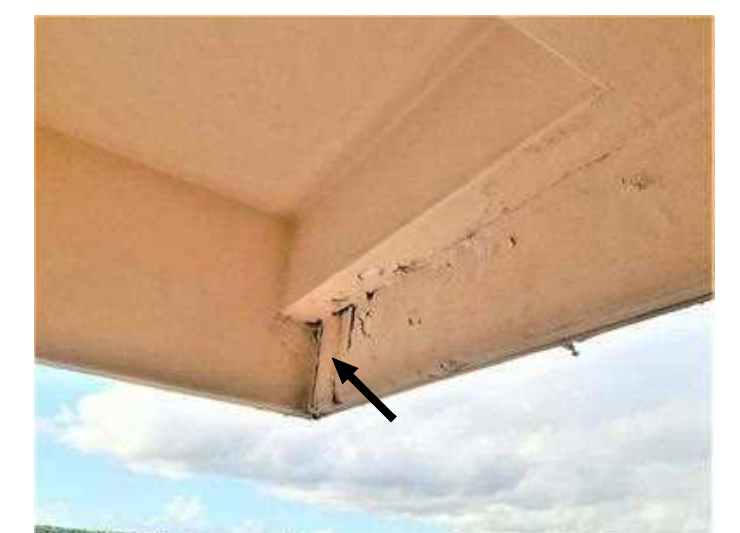
6e PHOTO
S-4.3 S-4.3.A

CRACK AT SOFFIT CORNER (2 Lf)

6e S-4.3 S-4.3.A	CRACK AT SOFFIT CORNER (2 Lf)	GRIND TRACES OF CRACKS, CLEAN AND INJECT WITH EPOXY MORTAR, SEE DETAIL.	8 S-11.1 S-11.1
	7e S-4.3 S-4.3.A	DETERIORATED EXHAUST HOOD	REMOVE EXISTING WALL EXHAUST HOOD AND REPLACE WITH NEW, REFER TO MECHANICAL DRAWINGS.	
	8e S-4.3 S-4.3.A	MILDEW WITH MOISTURE ON WINDOW SILL (4-6'x4') (2-48"x32")	WATERBLAST EXISTING DAMAGED WINDOWS AND CLEAN ALL REMAINING DIRT, WIPE OFF TO RESTORE SURFACE.	
	9e S-4.3 S-4.3.A	DETERIORATED WINDOW SEAL & SEALANT (212 Lf)	REMOVE EXISTING WINDOW SEAL / SEALANT AND REPLACE WITH NEW.	
	10e S-4.3 S-4.3.A	SPALLS AT CEILING (5 Sf)	SAWCUT DAMAGED SPALLS, CHIP OFF TO SOUND CONCRETE CLEAN & PATCH w/ EPOXY MORTAR, TYPICAL.	10 S-11.1 S-11.1
	11e S-4.3 S-4.3.A	CRACKS ON PARAPET RAILINGS (2 Lf)	GRIND TRACES OF CRACKS, CLEAN AND INJECT WITH EPOXY MORTAR, SEE DETAIL.	8 S-11.1 S-11.1
	12e S-4.3 S-4.3.A	CONC SPALLS ON FLOOR (16 Sf)	SAWCUT DAMAGED SPALLS, CHIP OFF TO SOUND CONCRETE CLEAN & PATCH w/ EPOXY MORTAR, TYPICAL.	9 S-11.1 S-11.1

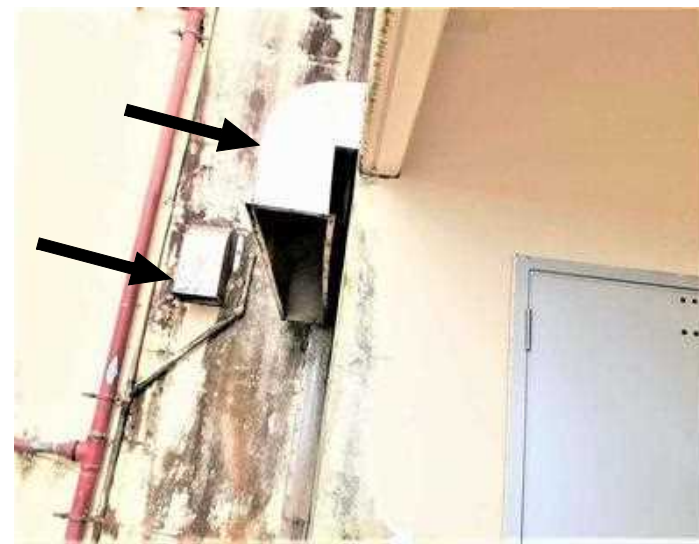
7e PHOTO
S-4.3 S-4.3.A

DETERIORATED EXHAUST HOOD

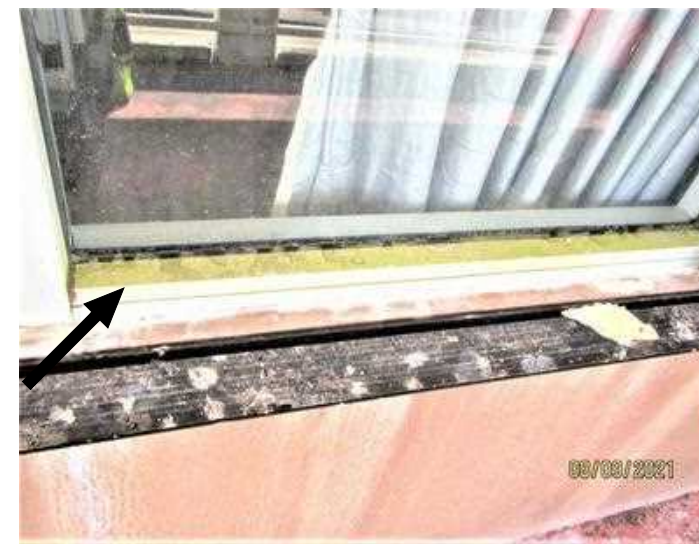
8e PHOTO
S-4.3 S-4.3.A

MILDEW WITH MOISTURE ON WINDOW SILL (4-6'x4') (2-48"x32")

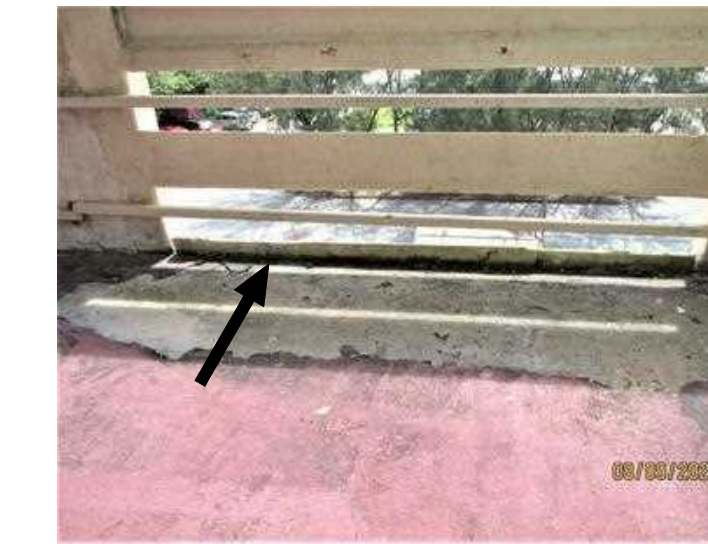
11e PHOTO
S-4.3 S-4.3.A

CRACKS ON PARAPET RAILINGS (2 Lf)

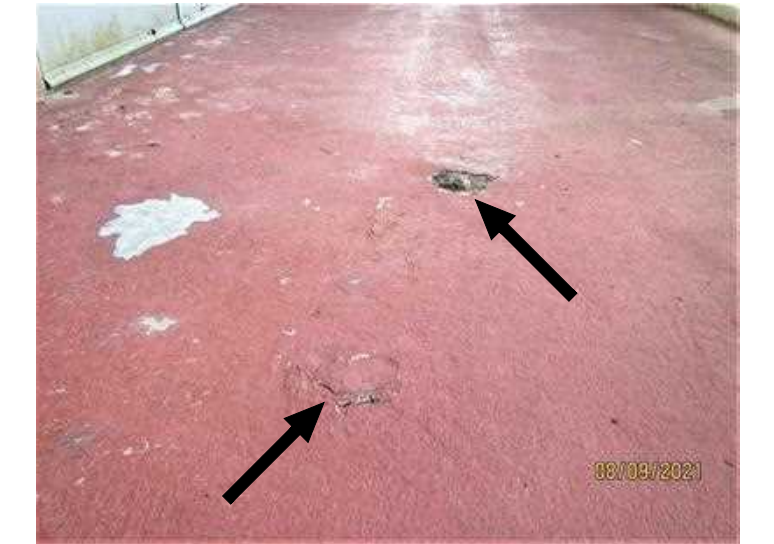
12e PHOTO
S-4.3 S-4.3.A

CONC SPALLS ON FLOOR (16 Sf)

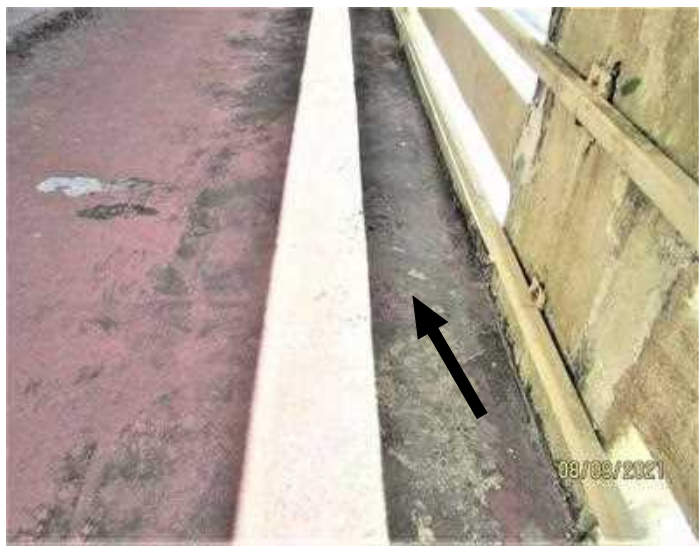
13e PHOTO
S-4.3 S-4.3.A

FLOOR DIRT WITH ALGAE (114 Sf)

13e S-4.3 S-4.3.A	FLOOR DIRT WITH ALGAE (114 Sf)	WATERBLAST EXISTING AFFECTED FLOOR AREAS, CLEAN AND PROVIDE NEW POLYURETHANE FLOOR COATING, TYPICAL.	
	14e S-4.3 S-4.3.A	DETERIORATED DOOR THRESHOLD (12 Lf)	REMOVE EXISTING DOOR THRESHOLD AND REPLACE WITH NEW.	3 S-8.1 S-8.1
	15e S-4.3 S-4.3.A	DETERIORATED DOOR SEAL & SEALANT (SEALANT 80 Lf) (SEAL 56 Lf)	REMOVE EXISTING DOOR SEAL / SEALANT AND REPLACE WITH NEW.	
	16e S-4.3 S-4.3.A	PAINT FLAKING AT SOFFIT CEILING (240 SF + 240) = 480 Sf	WATERBLAST EXISTING CEILING, SCRAPE OFF PAINT FLAKING, CLEAN AND PROVIDE NEW PAINT, PER GMHA FACILITY STANDARD.	
	17e S-4.3 S-4.3.A	DETERIORATED OVERHEAD DOOR AIR INTAKE & GRILLE	REMOVE EXISTING DOOR HEADER EXHAUST GRILLE AND REPLACE WITH NEW, REFER TO MECHANICAL DRAWINGS.	
	18e S-4.3 S-4.3.A	DETERIORATED WINDOW FRAME, GLASS, SEAL & SEALANT	REMOVE EXISTING GLASS WINDOW AND ITS ACCESSORIES AND REPLACE WITH NEW.	1 S-9.1 S-9.1

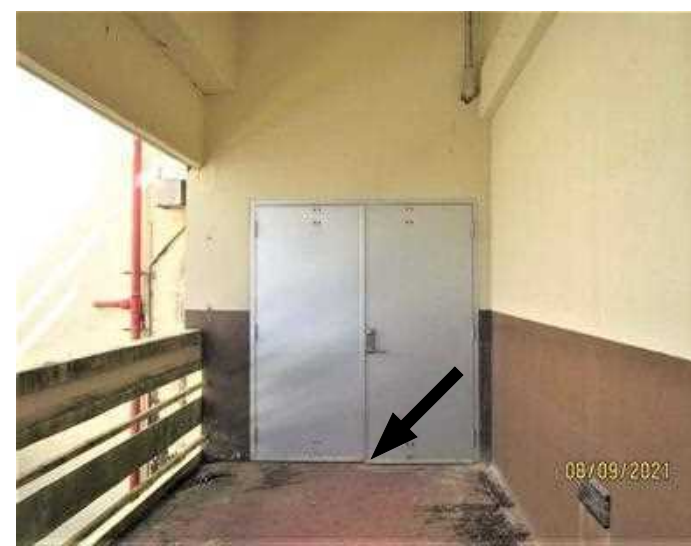
14e PHOTO
S-4.3 S-4.3.A

DETERIORATED DOOR THRESHOLD (12 Lf)

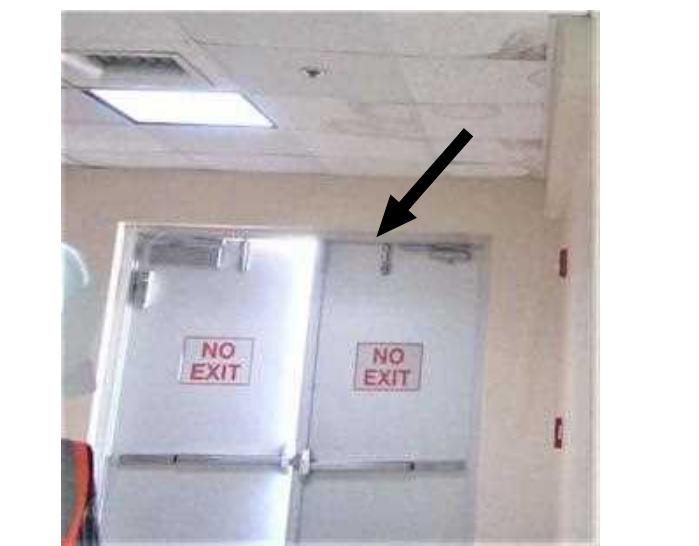
15e PHOTO
S-4.3 S-4.3.A

DETERIORATED DOOR SEAL & SEALANT (SEALANT 80 Lf) (SEAL 56 Lf)

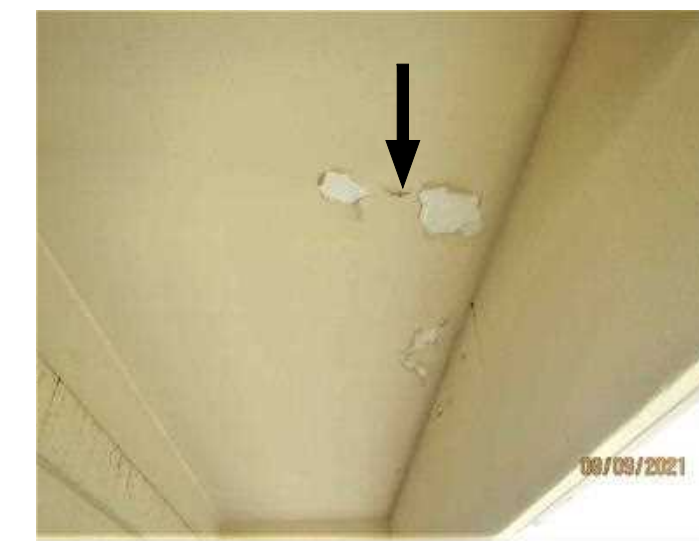
16e PHOTO
S-4.3 S-4.3.A

PAINT FLAKING AT SOFFIT CEILING (240 Sf + 240) = 480 Sf

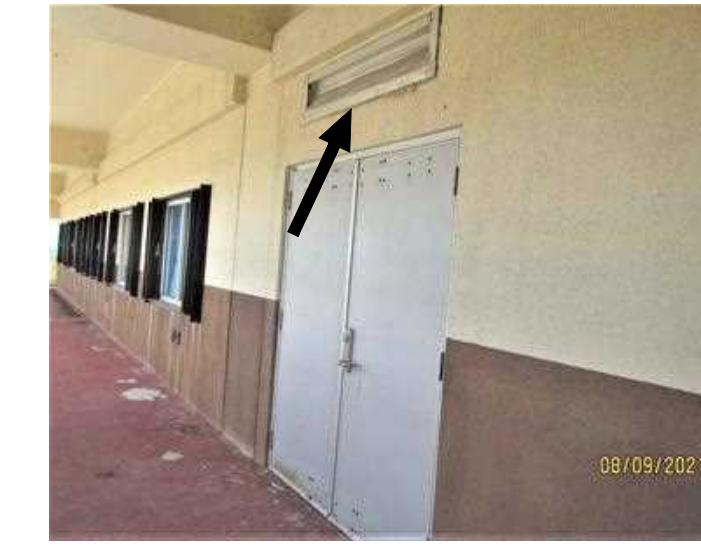
17e PHOTO
S-4.3 S-4.3.A

DETERIORATED OVERHEAD DOOR AIR INTAKE & GRILLE

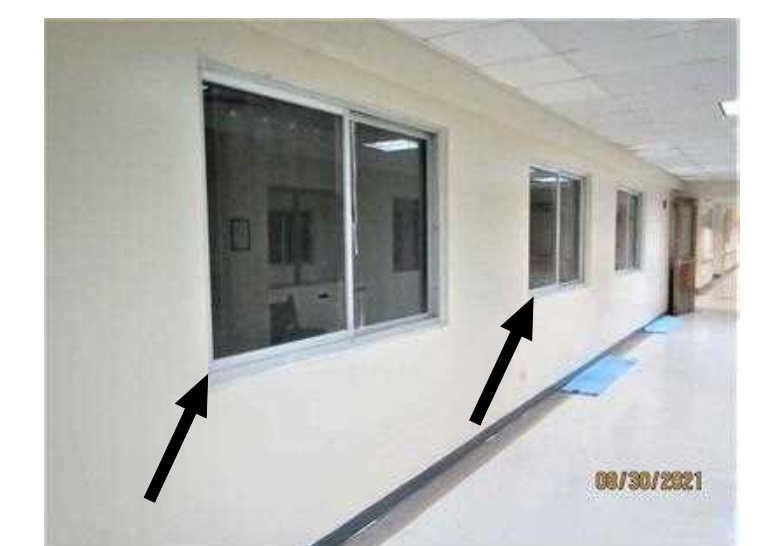
18e PHOTO
S-4.3 S-4.3.A

DETERIORATED WINDOW FRAME, GLASS, SEAL & SEALANT

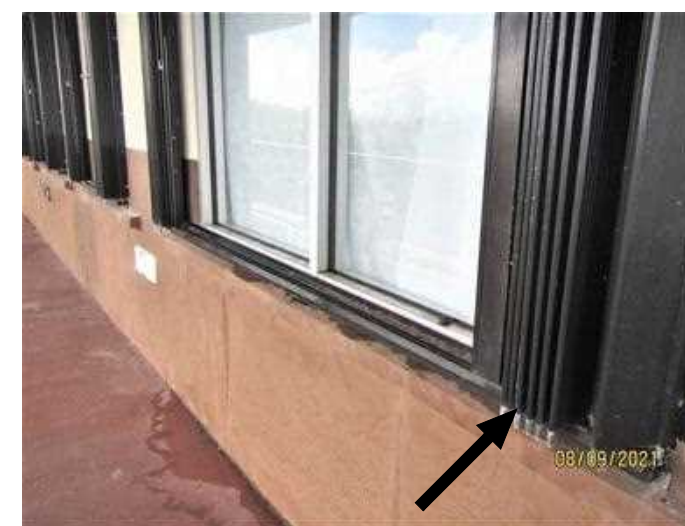
20e PHOTO
S-4.3 S-4.3.A

DETERIORATED WALL PAINT (3,510 Sf)

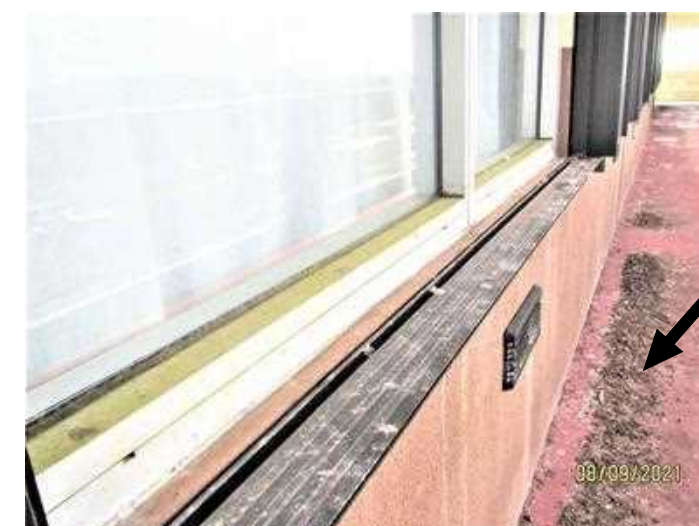
21e PHOTO
S-4.3 S-4.3.A

BIRD DROPPINGS FROM SHUTTER HEAD AND BEAM LEDGES, ETC.

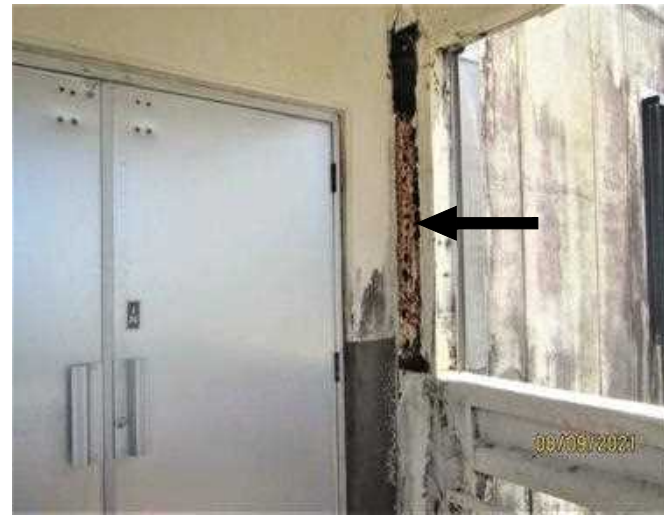
1e PHOTO
S-4.4 | S-4.4.A

DETERIORATED STEEL PILASTER (10 lf).

PHOTO KEY NOTES:		SCOPE OF REPAIR WORKS:		
WING	PHOTO No.	DAMAGED DESCRIPTION	REPAIR METHODS	DETAIL SHOWN
B - WING _ 4TH FLOOR (EXTERIOR)	1e	DETERIORATED STEEL PILASTER (10 lf).	WIRE BRUSH OR GRIND EXISTING STEEL PILASTER, CLEAN AND PROVIDE NEW EPOXY MORTAR PATCH, PAINTED.	
	2e	COLUMN SPALLS (2 sf).	SAWCUT DAMAGED SPALLS, CHIP OFF TO SOUND CONCRETE CLEAN & PATCH w/ EPOXY MORTAR, TYPICAL.	10 S-11.1 S-11.1
	3e	SPALLS ON CEILING (14sf).	SAWCUT DAMAGED SPALLS, CHIP OFF TO SOUND CONCRETE CLEAN & PATCH w/ EPOXY MORTAR, TYPICAL.	10 S-11.1 S-11.1
	4e	DETERIORATED DOOR SEALANT & SEAL (160lf SLNT, 112lf SEAL).	REMOVE EXISTING DOOR SEAL / SEALANT AND REPLACE WITH NEW.	
	5e	WALL CRACKS (16lf).	GRIND TRACES OF CRACKS, CLEAN AND INJECT WITH EPOXY MORTAR, SEE DETAIL.	8 S-11.1 S-11.1
	6e	BIRD DROPPINGS (135sf).	WATERBLAST EXISTING AFFECTED FLOOR AREAS, CLEAN AND PROVIDE NEW POLYURETHANE FLOOR COATING, TYPICAL.

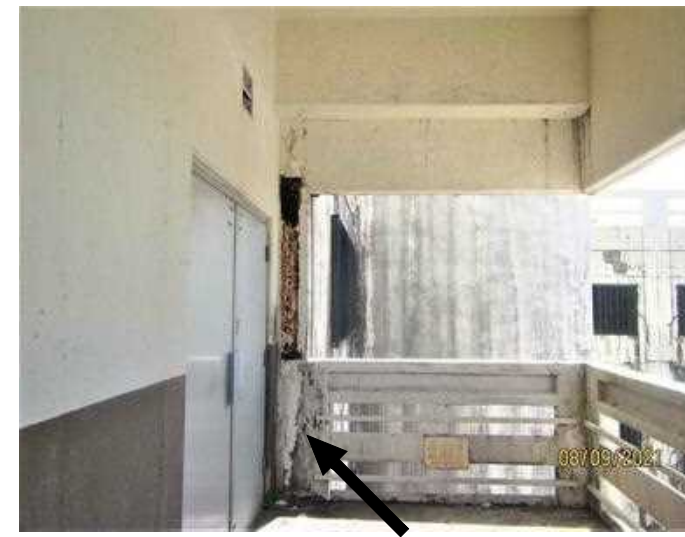
2e PHOTO
S-4.4 | S-4.4.A

COLUMN SPALLS (2 sf).

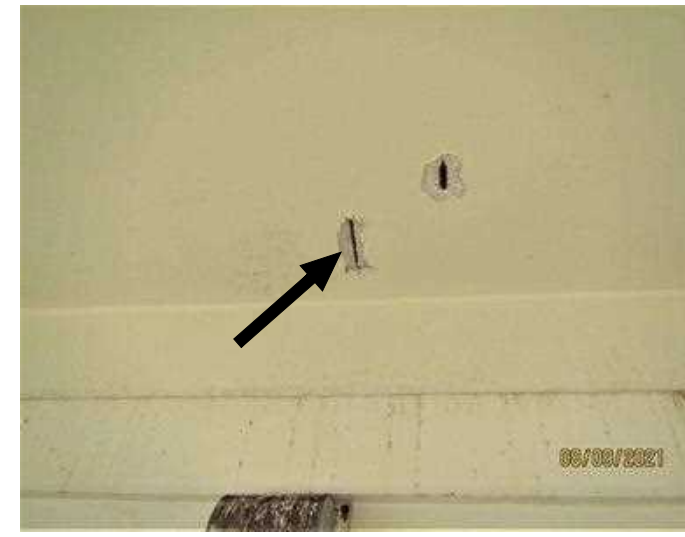
3e PHOTO
S-4.4 | S-4.4.A

SPALLS ON CEILING (14sf).

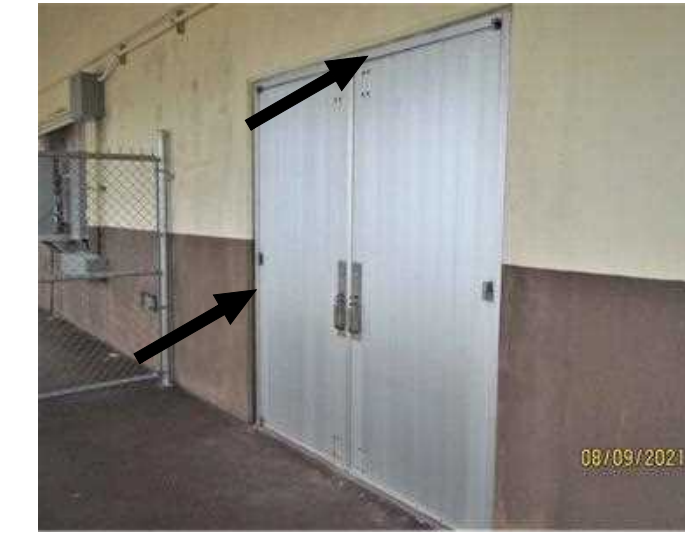
4e PHOTO
S-4.4 | S-4.4.A

DETERIORATED DOOR SEALANT & SEAL (160lf SLNT, 112lf SEAL).

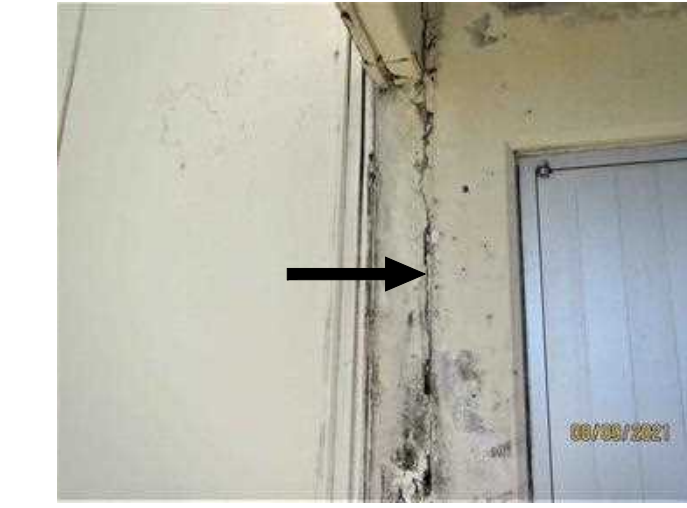
5e PHOTO
S-4.4 | S-4.4.A

WALL CRACKS (16lf).

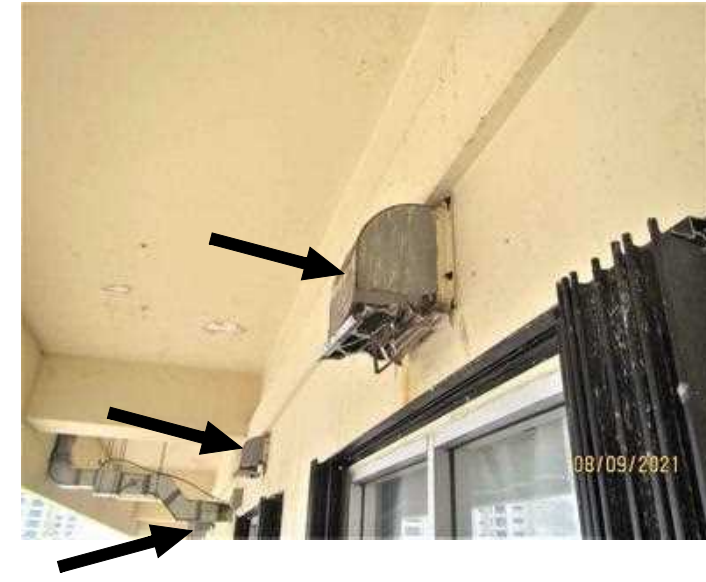
7e PHOTO
S-4.4 | S-4.4.A

DETERIORATED WALL EXHAUST HOOD (3ea.).

7e	DETERIORATED WALL EXHAUST HOOD (13 ea.).	REMOVE EXISTING WALL EXHAUST HOOD AND REPLACE WITH NEW, REFER TO MECHANICAL DRAWINGS.	
	8e	PAINT FLAKING ON WALL (50sf).	WATERBLAST EXISTING WALL, SCRAPE OFF PAINT FLAKING, CLEAN AND PROVIDE NEW PAINT, PER GMHA FACILITY STANDARD.	
	9e	FLOOR PONDING (810sf)	WATERBLAST EXIST AFFECTED AREAS, ROUGHEN SURFACES TO 1/4 AMPLITUDE, CLEAN & PROVIDE NEW CONCRETE CEMENT TOPPING. PROVIDE SLOPE ON NEW TOPPING TO DIRECT WATER TO EXISTING ROOF DRAIN OR SCUPPER DRAIN.	
	10e	FLOOR DIRT WITH GREEN ALGAE (50sf).		
	11e	PAINT FLAKING ON CEILING (70sf).	WATERBLAST EXISTING CEILING, SCRAPE OFF PAINT FLAKING, CLEAN AND PROVIDE NEW PAINT, PER GMHA FACILITY STANDARD.	
	12e	FLOOR CRACKS (16lf).	GRIND TRACES OF CRACKS, CLEAN AND INJECT WITH EPOXY MORTAR, SEE DETAIL.	8 S-11.1 S-11.1
	13e	CONCRETE FLOOR SPALLS (12sf).	SAWCUT DAMAGED SPALLS, CHIP OFF TO SOUND CONCRETE CLEAN & PATCH w/ EPOXY MORTAR, TYPICAL.	10 S-11.1 S-11.1

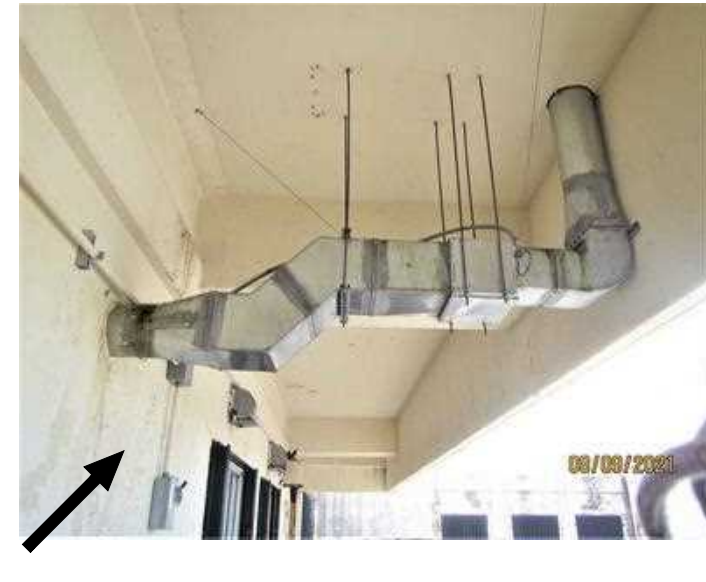
8e PHOTO
S-4.4 | S-4.4.A

PAINT FLAKING ON WALL (50sf).

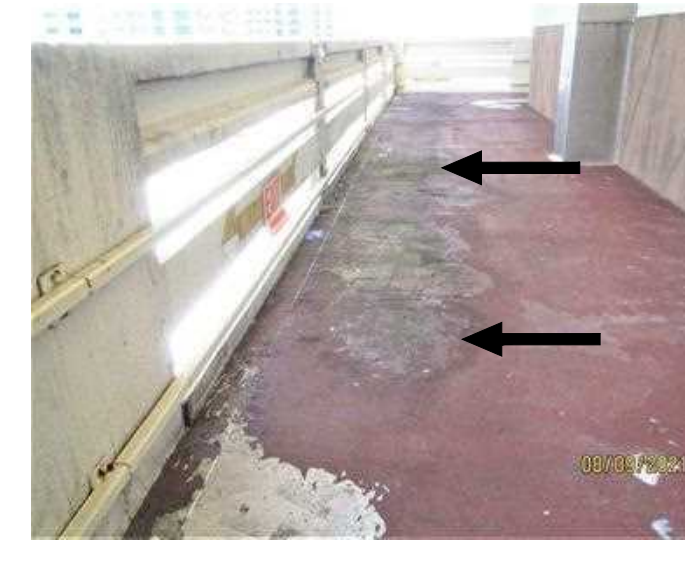
9e PHOTO
S-4.4 | S-4.4.A

FLOOR PONDING (810sf)

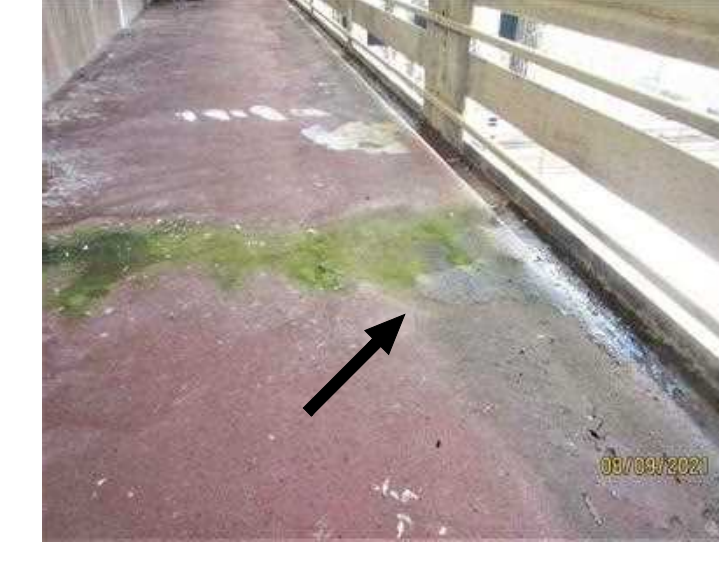
10e PHOTO
S-4.4 | S-4.4.A

FLOOR DIRT WITH GREEN ALGAE (50sf).

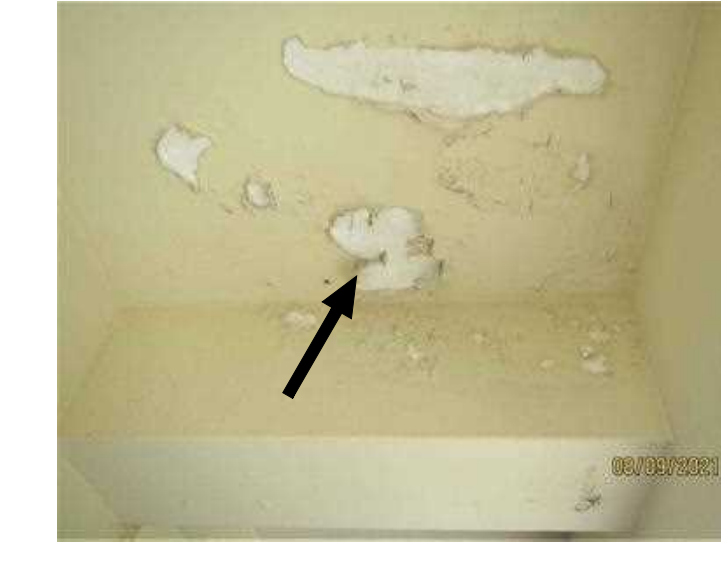
11e PHOTO
S-4.4 | S-4.4.A

PAINT FLAKING ON CEILING (70sf).

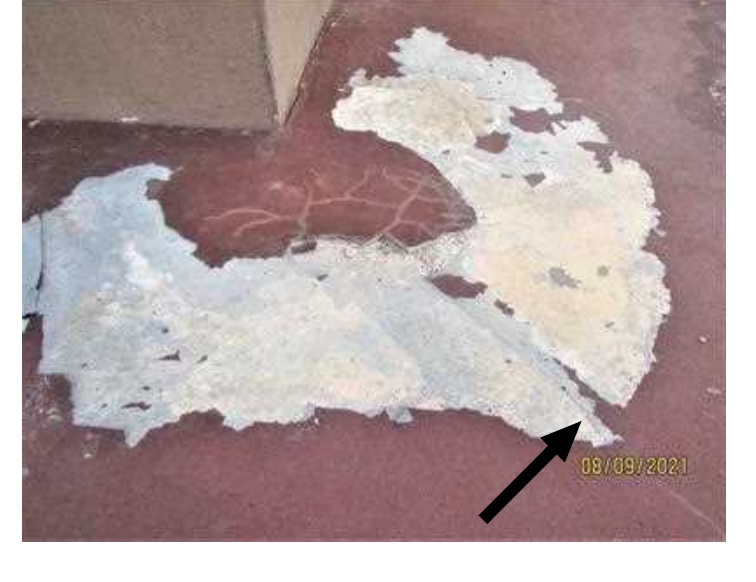
12e PHOTO
S-4.4 | S-4.4.A

FLOOR CRACKS (16lf).

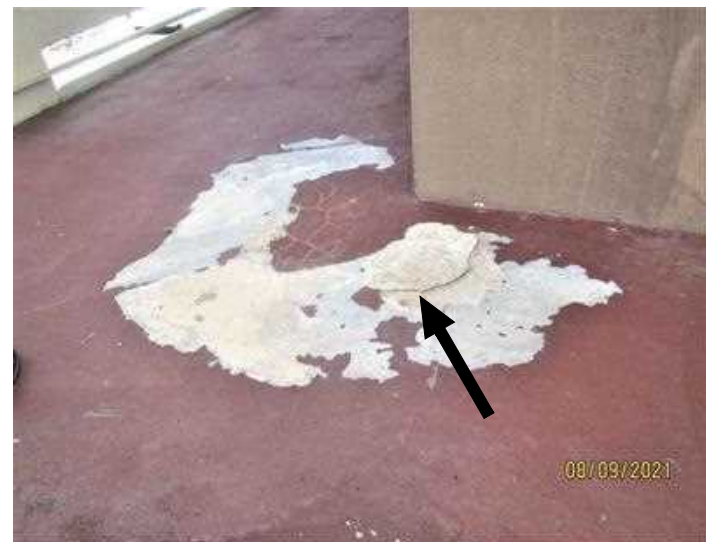
13e PHOTO
S-4.4 | S-4.4.A

CONCRETE FLOOR SPALLS (12sf).

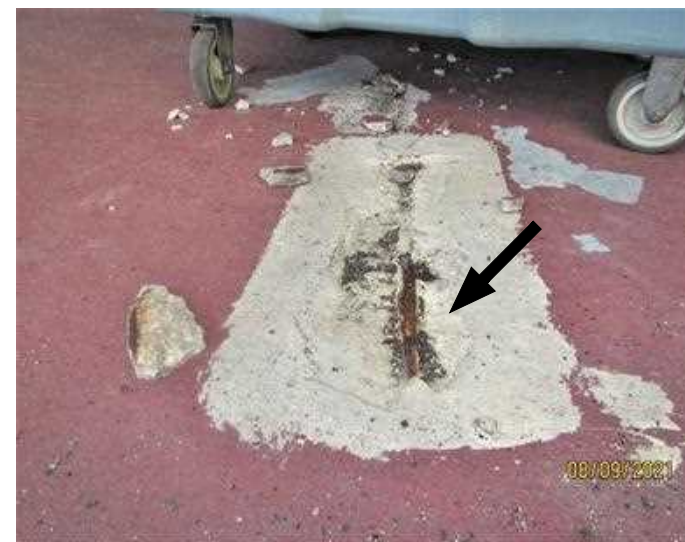
14e PHOTO
S-4.4 | S-4.4.A

FLOOR SPALL WITH EXPOSED REBAR (20sf).

14e	CONCRETE SPALLS w/ EXPOSED REBAR (20sf).	SAWCUT DAMAGED SPALLS, CHIP OFF TO SOUND CONCRETE, GRIND REBAR TO SOUND STEEL, CLEAN & PATCH w/ EPOXY MORTAR, TYPICAL.	9 S-11.1 S-11.1
	15e	DETERIORATED PAINT & FLAKING ON CONCRETE RAILING/ PARAPET (1080sf).	WATERBLAST EXISTING CONC RAILING SCRAPE OFF PAINT FLAKING, CLEAN AND PROVIDE NEW PAINT, PER GMHA FACILITY STANDARD.	
	16e	MILDEW ON WINDOW SILL WITH GREEN ALGAE (TYP. - 15ea.).	WATERBLAST EXISTING DAMAGED WINDOWS AND CLEAN ALL REMAINING DIRT, WIPE OFF TO RESTORE SURFACE.	
	17e	DETERIORATED WINDOW SEALANT & SEAL (573lf SEALANT, 573lf SEAL).	REMOVE EXISTING WINDOW SEAL / SEALANT AND REPLACE WITH NEW.	
	18e	DETERIORATED WINDOW SHUTTERS (TYP 16 PLACES).	REMOVE EXISTING WINDOW ACCORDION SHUTTERS AND ITS ACCESSORIES AND REPLACE WITH NEW ALUMINUM ACCORDION SHUTTER, TYPICAL AT EXTERIOR CORRIDORS. REFER TO GMHA FOR COLOR SELECTION.	
	19e	BIRDS DROPPINGS FROM LIGHT TO HEAVILY INFESTED NARROW TO EXTRA WIDE AREAS.	PROVIDE STAINLESS STEEL ANTI BIRD SPIKES ON ALL LEDGES SUCH AS PIPES, SPRINKLER SYSTEMS, STEEL BEAMS, WINDOW SHUTTERS HEAD, HVAC EXHAUST HOODS, AC UNITS, ETC. and PVC AviAngle LEDGE SHIELD ON CONCRETE BEAM LEDGES. SEE SHEET S-9.1 FOR PVC AviAngle LEDGE SHIELD and ANTI BIRD SPIKES SPECIFICATIONS.	5 S-9.1 S-9.1

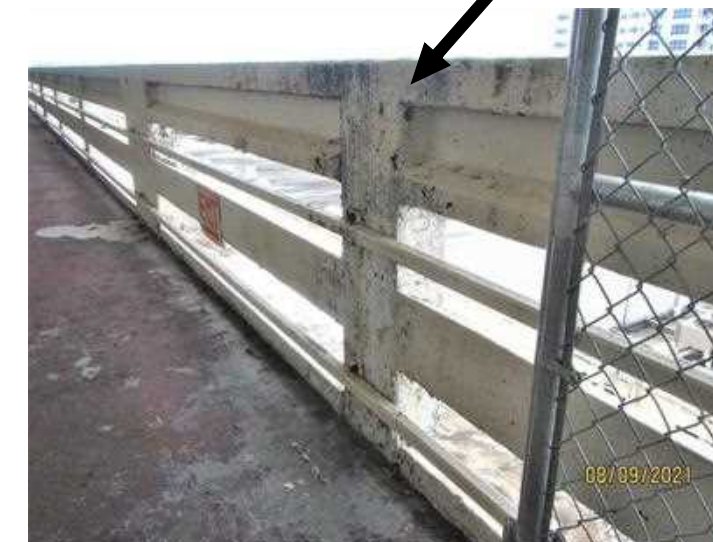
15e PHOTO
S-4.4 | S-4.4.A

DETERIORATED PAINT & FLAKING ON CONCRETE RAILING/ PARAPET (1080sf).

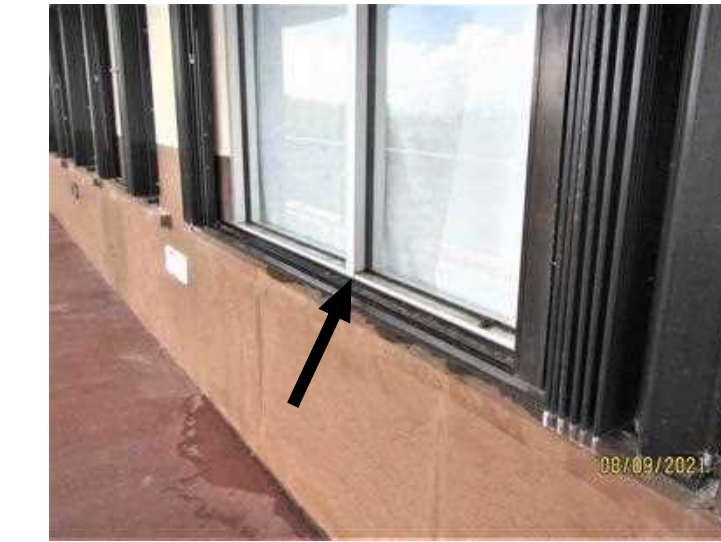
17e PHOTO
S-4.4 | S-4.4.A

DETERIORATED WINDOW SEALANT & SEAL (573lf SEALANT, 573lf SEAL).

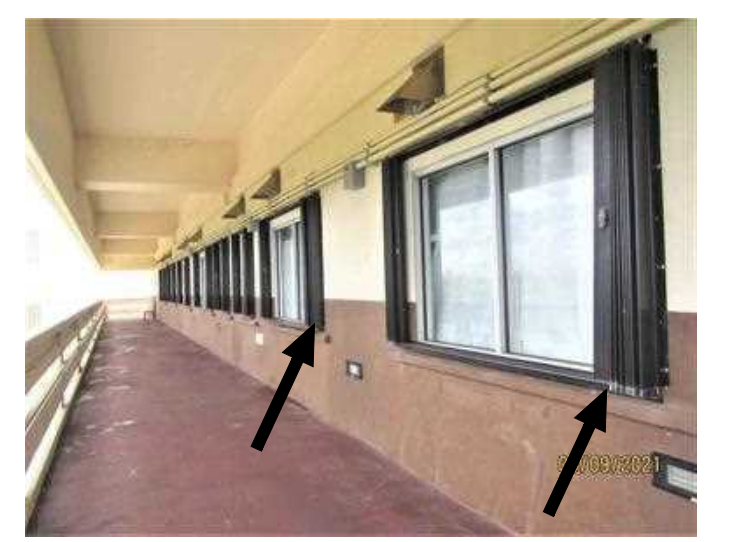
18e PHOTO
S-4.4 | S-4.4.A

DETERIORATED WINDOW SHUTTERS (TYP 16 PLACES).

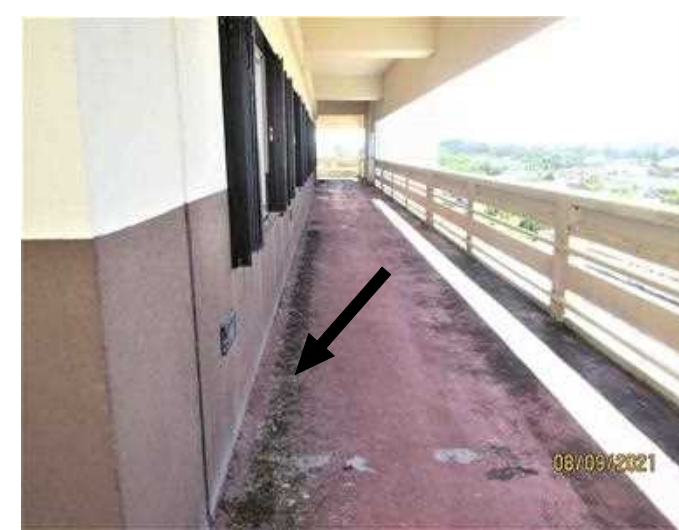
19e PHOTO
S-4.3 | S-4.3.A

BIRD DROPPINGS FROM SHUTTER HEAD OR BEAM LEDGES LIGHT TO HEAVY INFESTED NARROW TO EXTRA WIDE AREAS.

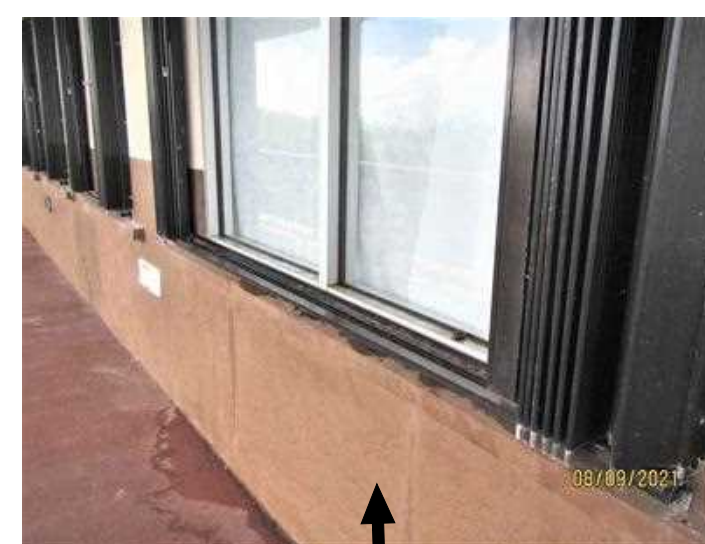
20e PHOTO
S-4.4 | S-4.4.A

DETERIORATED WALL PAINT (3,510 Sf)

20e	DETERIORATED WALL PAINT (1,170+1,170+1,170 sf) = 3,510 sf.	PRESSURE-WASH EXISTING WALL TO REMOVE DIRT, STAIN, MILDEW, ALGAE AND REPAIR ANY AREAS WITH MINOR DAMAGED AND PATCH WITH EPOXY MORTAR. PROVIDE NEW PAINT ON ALL WALL, CONC RAILINGS SURFACES, PER GMHA FACILITY STANDARD, TYPICAL.	
	21e	DETERIORATED CORRIDOR FLOOR COATING MEMBRANE (2,480 Sf).	WATERBLAST EXISTING ENTIRE CORRIDOR FLOOR SURFACES, CLEAN AND PROVIDE 60 MIL POLYURETHANE FLOOR COATING, TYPICAL.

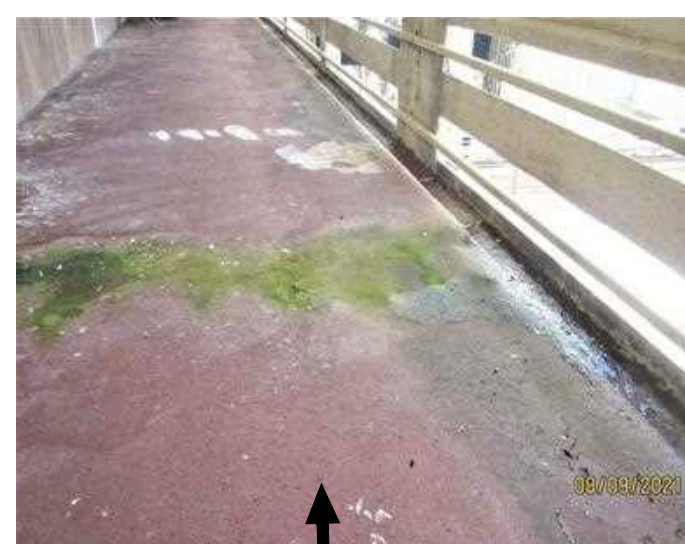
21e PHOTO
S-4.4 | S-4.4.A

DETERIORATED CORRIDOR FLOOR COATING MEMBRANE (2,480 SF)

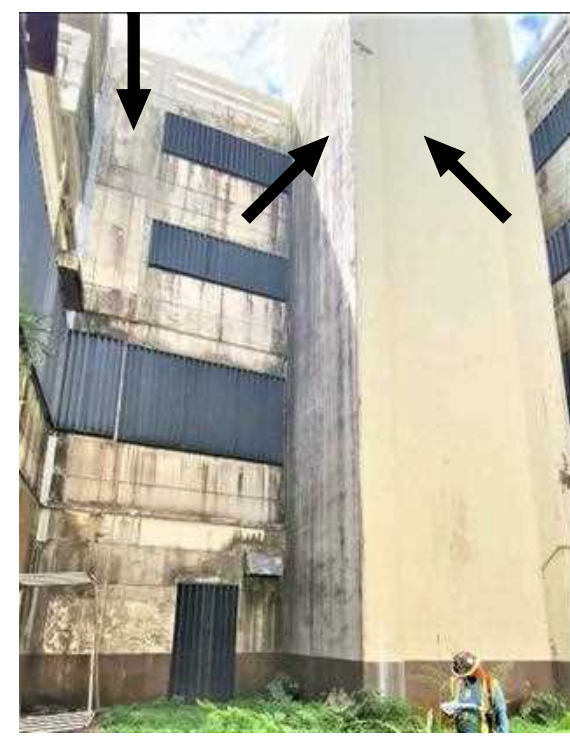
1e PHOTO
S-4.5 S-4.5.A

DETERIORATED EXISTING WALL PAINTS (900 sf).

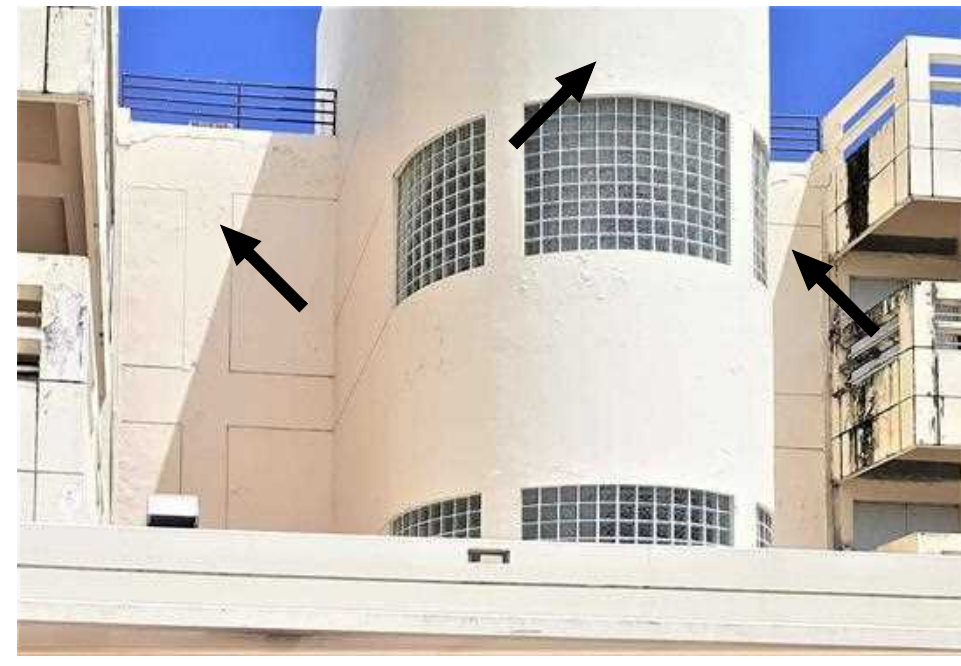
DETERIORATED EXISTING WALL PAINTS (1118 sf).

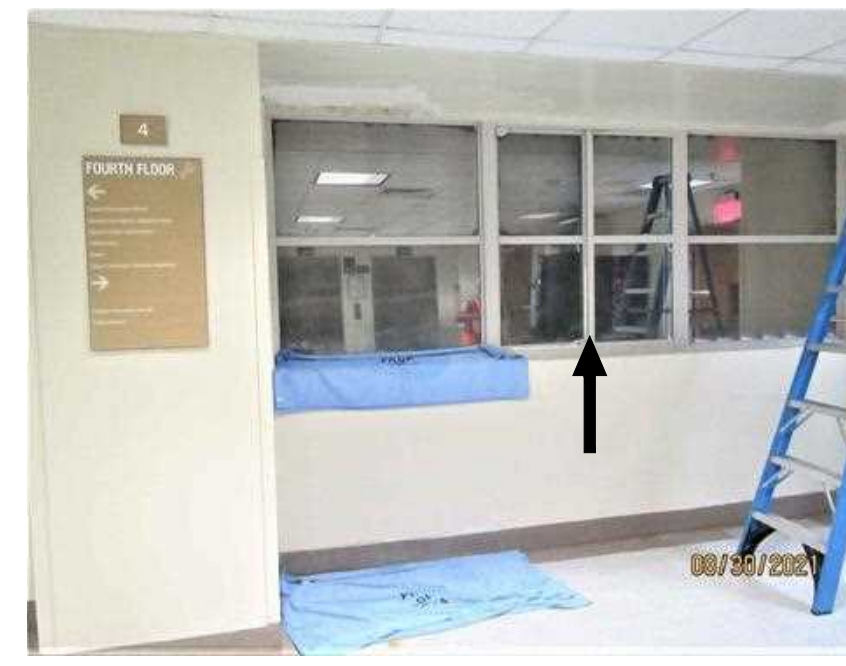
2e PHOTO
S-4.5 S-4.5.A

DETERIORATED GLASS WINDOW AND FRAMES

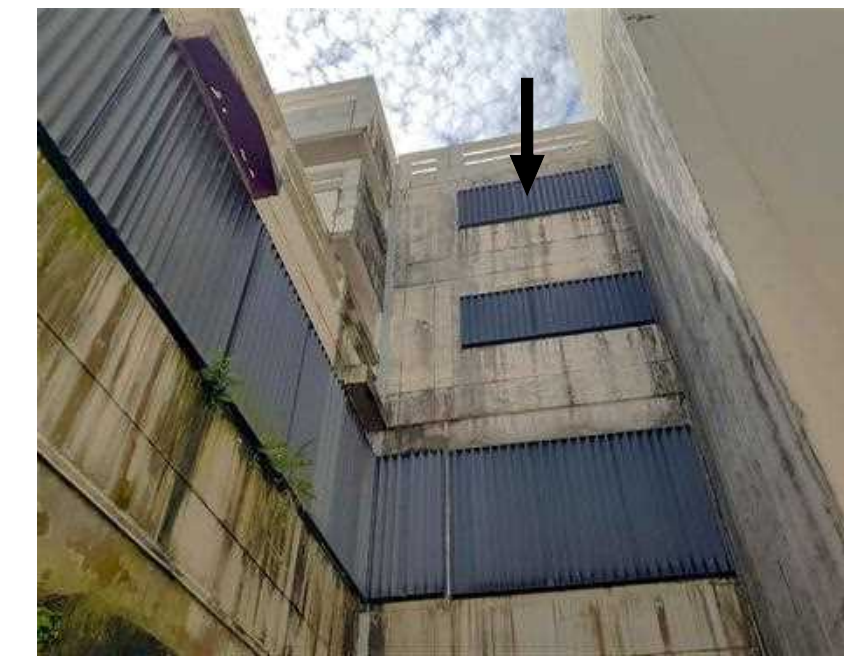
3e PHOTO
S-4.5 S-4.5.A

DETERIORATED ACCORDION WINDOW SHUTTER

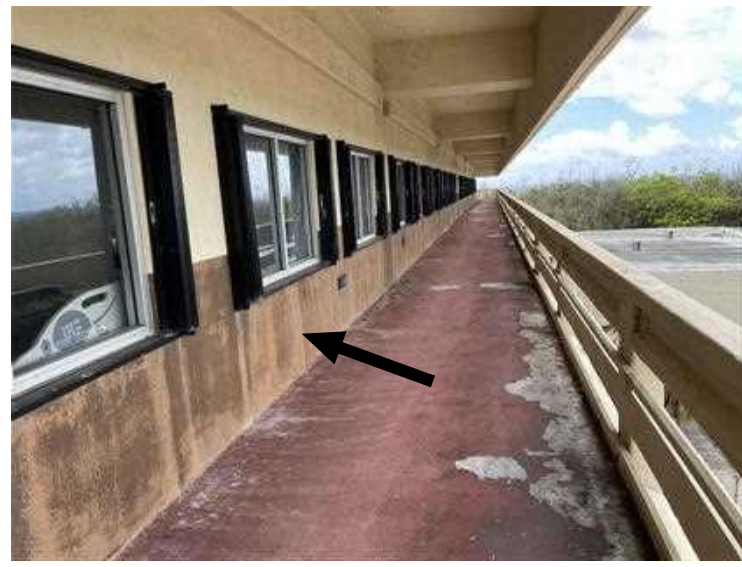
1e PHOTO
S-6.1 | S-6.1.A

DETERIORATED WALL, and PARAPET WALL PAINTS.

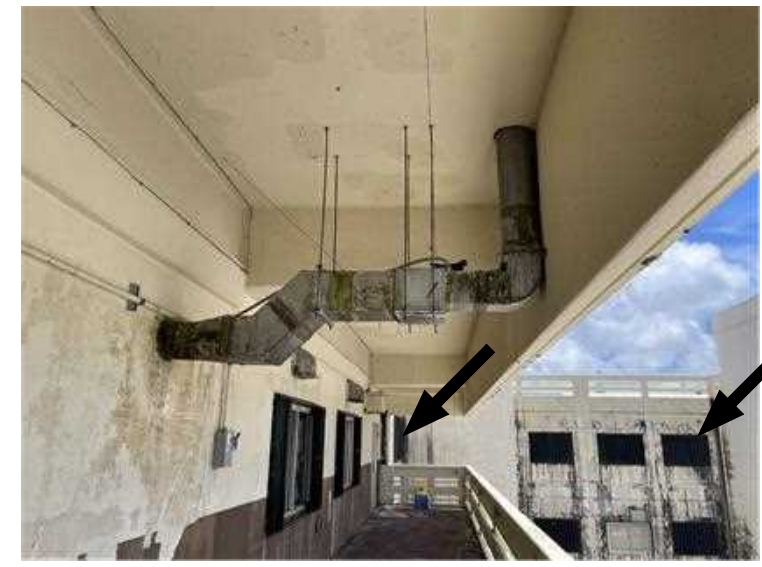
2e PHOTO
S-6.1 | S-6.1.A

DETERIORATED WINDOW SHUTTERS (TYP 10 PLACES).

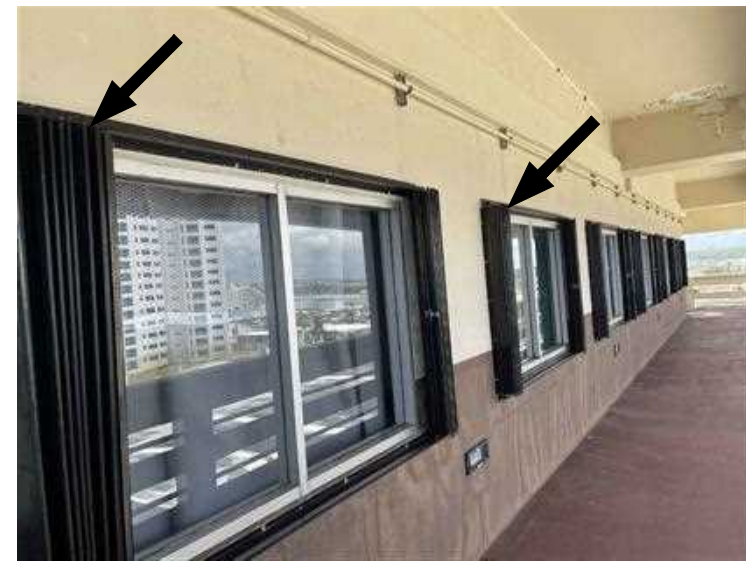
3e PHOTO
S-6.1 | S-6.1.A

DETERIORATED WINDOW ACCORDION SHUTTERS (TYP 30 PLACES).

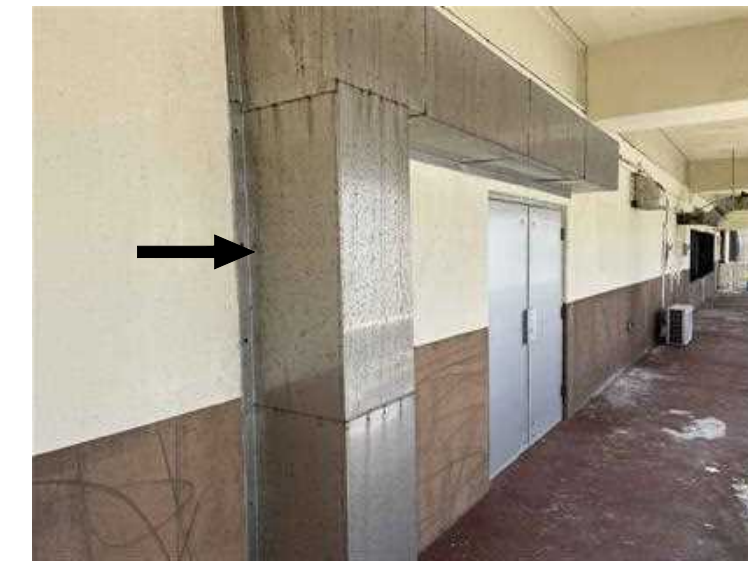
4e PHOTO
S-6.1 | S-6.1.A

DETERIORATED WALL EXHAUST DUCT WORK.

4e S-6.1 S-6.1.A	DETERIORATED WALL EXHAUST DUCT WORK.	REMOVE EXISTING WALL EXHAUST DUCT WORK AND REPLACE WITH NEW TO MATCH EXISTING, SEE MECHANICAL PLAN AND DETAIL.	
	5e S-6.1 S-6.1.A	DETERIORATED WALL EXHAUST HOOD.	REMOVE EXISTING WALL EXHAUST HOOD AND REPLACE WITH NEW STAINLESS STEEL HOOD TO MATCH EXISTING, SEE MECHANICAL PLAN AND DETAIL.	
	6e S-6.1 S-6.1.A	DETERIORATED EXHAUST DUCT WORK.	REMOVE EXISTING EXHAUST DUCT WORK AND REPLACE WITH NEW TO MATCH EXISTING, SEE MECHANICAL PLAN AND DETAIL.	
	7e S-6.1 S-6.1.A	DETERIORATED WALL EXHAUST HOOD.	REMOVE EXISTING WALL EXHAUST HOOD AND REPLACE WITH NEW STAINLESS STEEL HOOD TO MATCH EXISTING, SEE MECHANICAL PLAN AND DETAIL.

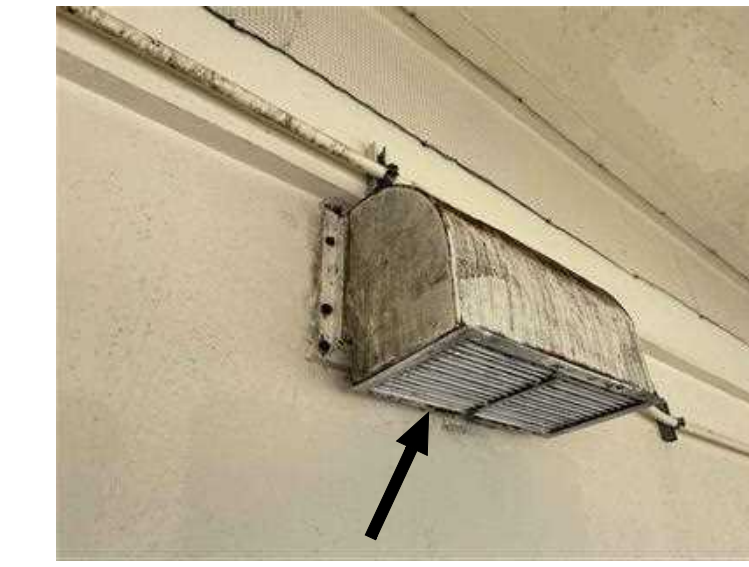
5e PHOTO
S-6.1 | S-6.1.A

DETERIORATED WALL EXHAUST HOOD.

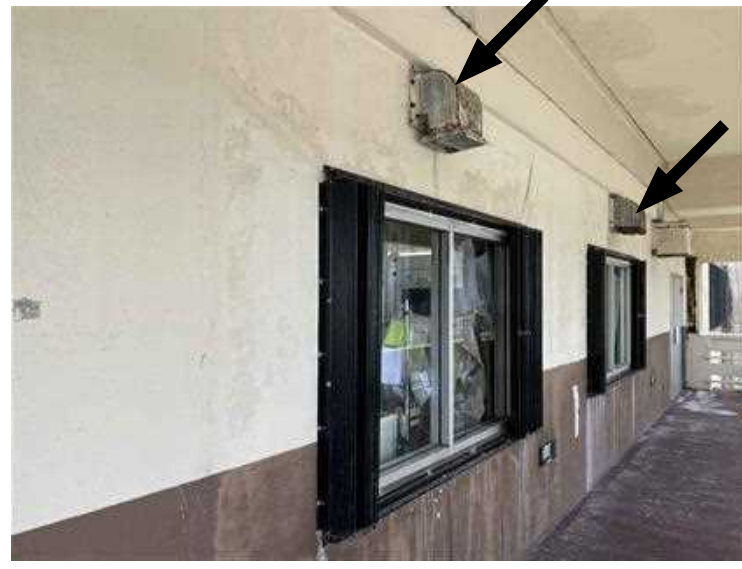
7e PHOTO
S-6.1 | S-6.1.A

DETERIORATED WALL EXHAUST HOOD.

6	REMOVE EXISTING EXHAUST DUCT WORK AND REPLACE WITH NEW TO MATCH EXISTING, SEE MECHANICAL PLAN AND DETAIL.	
	7	REMOVE EXISTING WALL EXHAUST HOOD AND REPLACE WITH NEW STAINLESS STEEL HOOD TO MATCH EXISTING, SEE MECHANICAL PLAN AND DETAIL.

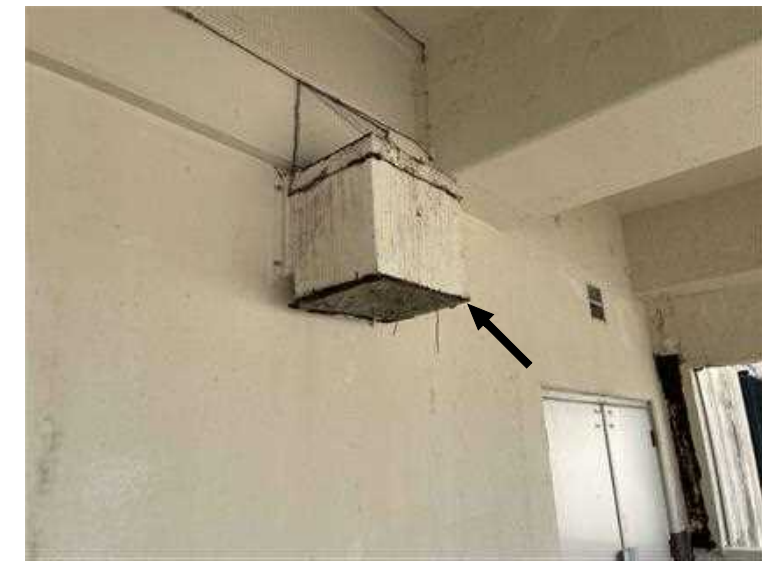
8e PHOTO
S-6.1 | S-6.1.A

DETERIORATED WALL EXHAUST HOOD.

WING	PHOTO No.	DAMAGED DESCRIPTION	REPAIR METHODS	DETAIL SHOWN
3rd & 4th FLOOR (EXTERIOR) FRONT & LEFT ELEVATIONS	8e S-6.1 S-6.1.A	DETERIORATED WALL EXHAUST HOOD.	REMOVE EXISTING WALL EXHAUST HOOD AND REPLACE WITH NEW STAINLESS STEEL HOOD TO MATCH EXISTING, SEE MECHANICAL PLAN AND DETAIL.	
	9e S-6.1 S-6.1.A	DETERIORATED WALL OUTSIDE AIR GRILLE.	REMOVE EXISTING WALL OUTSIDE AIR GRILLE AND REPLACE WITH NEW STAINLESS STEEL GRILLE TO MATCH EXISTING, SEE MECHANICAL PLAN AND DETAIL.	
	10e S-6.1 S-6.1.A	DETERIORATED WALL OUTSIDE AIR GRILLE.	REMOVE EXISTING WALL OUTSIDE AIR GRILLE AND REPLACE WITH NEW STAINLESS STEEL GRILLE TO MATCH EXISTING, SEE MECHANICAL PLAN AND DETAIL.	
	11e S-6.1 S-6.1.A	EXISTING DUCT WORKS.	PROVIDE STAINLESS STEEL ANTI BIRD SPIKES ON ALL LEDGES SUCH AS PIPES, SPRINKLER SYSTEMS, STEEL BEAMS, WINDOW SHUTTERS HEAD, HVAC EXHAUST HOODS, AC UNITS, ETC. and PVC AviAngle LEDGE SHIELD ON CONCRETE BEAM LEDGES. SEE SHEET S-9.1 FOR PVC AviAngle LEDGE SHIELD and ANTI BIRD SPIKES SPECIFICATIONS.	5 S-9.1 S-9.1

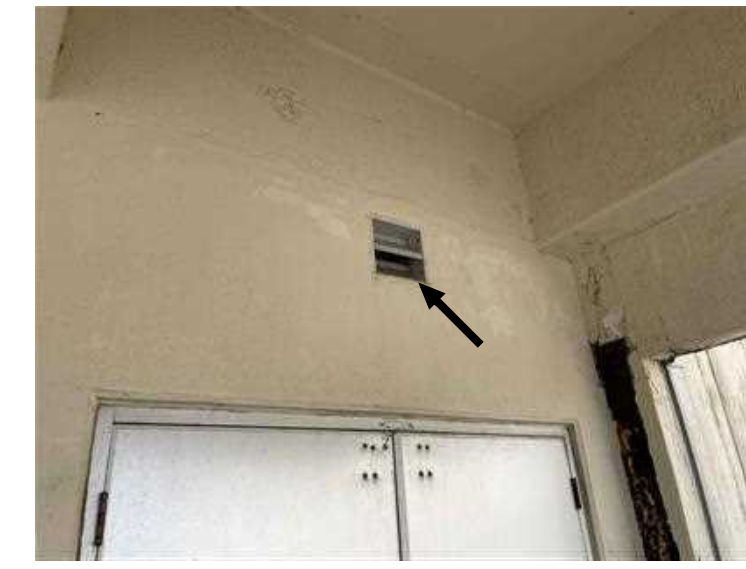
9e PHOTO
S-6.1 | S-6.1.A

DETERIORATED WALL OUTSIDE AIR GRILLE.

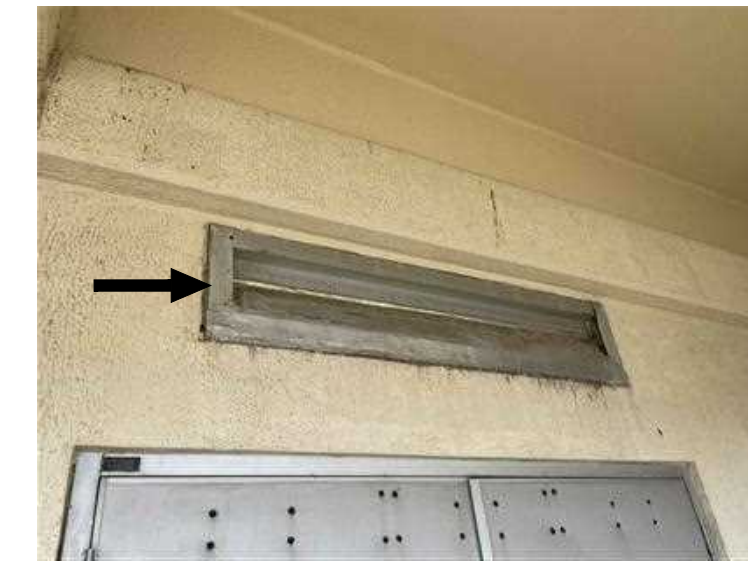
10e PHOTO
S-6.1 | S-6.1.A

DETERIORATED WALL OUTSIDE AIR GRILLE.
