GMHA HOSPITAL ROOF AND ENVELOP UPGRADE PROJECT

PACKAGE A - 3RD & 4TH FLOOR ROOF AND ENVELOP (A,B, & E-WING)

GUAM MEMORIAL HOSPITAL AUTHORITY, TAMUNING, GUAM

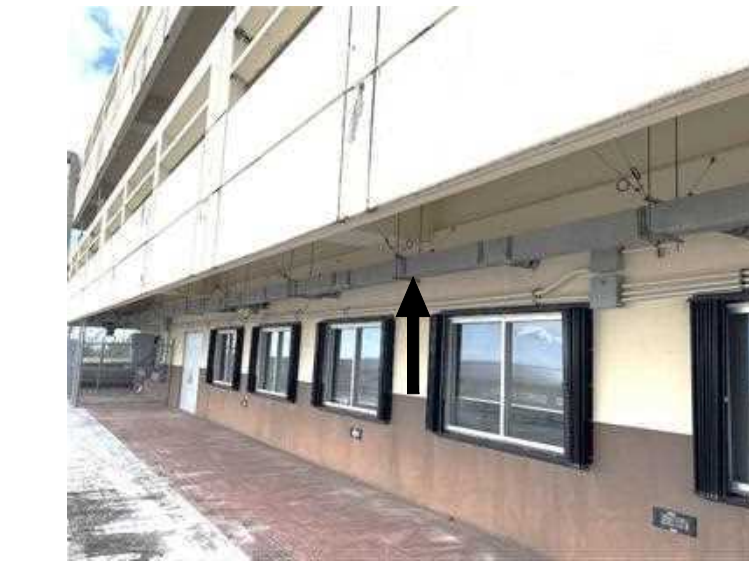
11e PHOTO
S-6.1 | S-6.1.A

EXISTING DUCT WORKS.

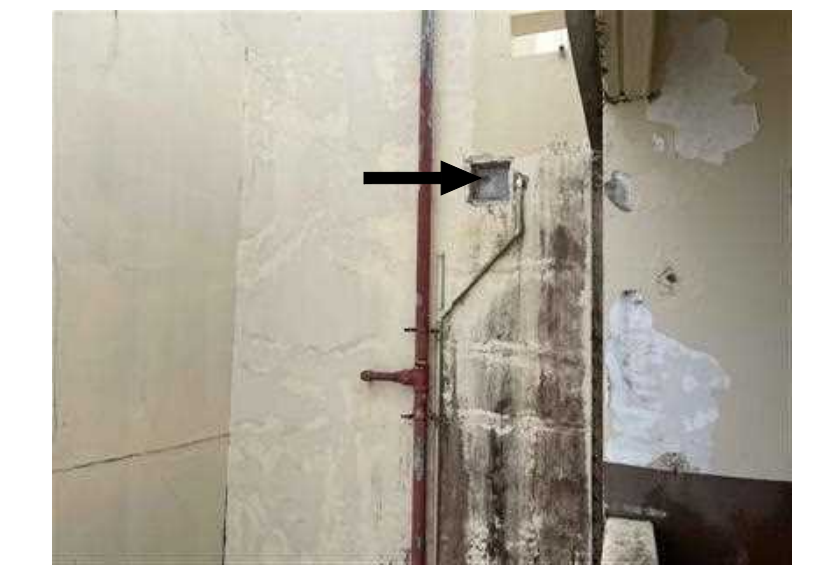
12e PHOTO
S-6.1 | S-6.1.A

EXISTING WALL, EXHAUST HOOD MISSING.

12e S-6.1 S-6.1.A	EXISTING WALL, EXHAUST HOOD MISSING.	PROVIDE NEW STAINLESS STEEL WALL EXHAUST HOOD TO MATCH EXISTING, SEE MECHANICAL PLAN AND DETAIL.	
	13e S-6.1 S-6.1.A	DETERIORATED WALL EXHAUST HOOD.	REMOVE EXISTING WALL EXHAUST HOOD AND REPLACE WITH NEW STAINLESS STEEL HOOD TO MATCH EXISTING, SEE MECHANICAL PLAN AND DETAIL.	
	14e S-6.1 S-6.1.A	BIRDS DROPPINGS PRESENT ON BEAM HOODS, PIPES, DUCT WORK, SHUTTER HEAD, ETC. FROM LIGHT TO HEAVILY INFESTED NARROW TO EXTRA WIDE AREAS.	PROVIDE STAINLESS STEEL ANTI BIRD SPIKES ON ALL LEDGES SUCH AS PIPES, SPRINKLER SYSTEMS, STEEL BEAMS, WINDOW SHUTTERS HEAD, HVAC EXHAUST HOODS, AC UNITS, ETC. and PVC AviAngle LEDGE SHIELD ON CONCRETE BEAM LEDGES. SEE SHEET S-9.1 FOR PVC AviAngle LEDGE SHIELD and ANTI BIRD SPIKES SPECIFICATIONS.	5 S-9.1 S-9.1

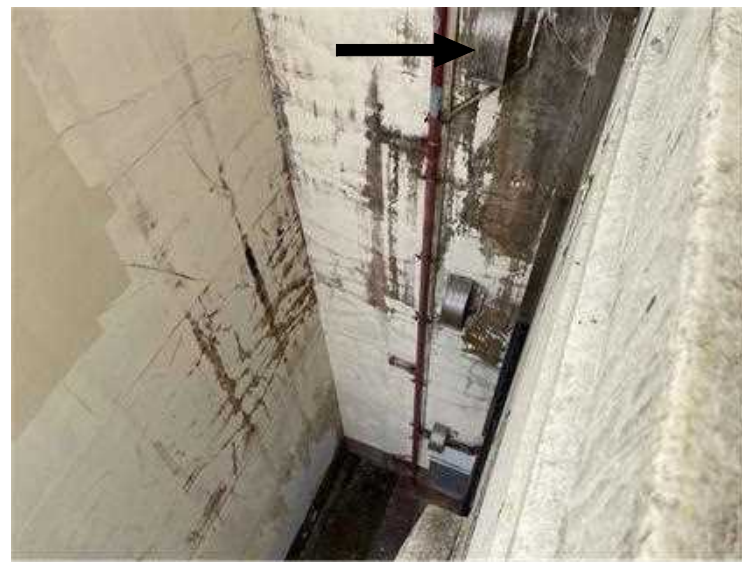
13e PHOTO
S-6.1 | S-6.1.A

DETERIORATED WALL EXHAUST HOOD.

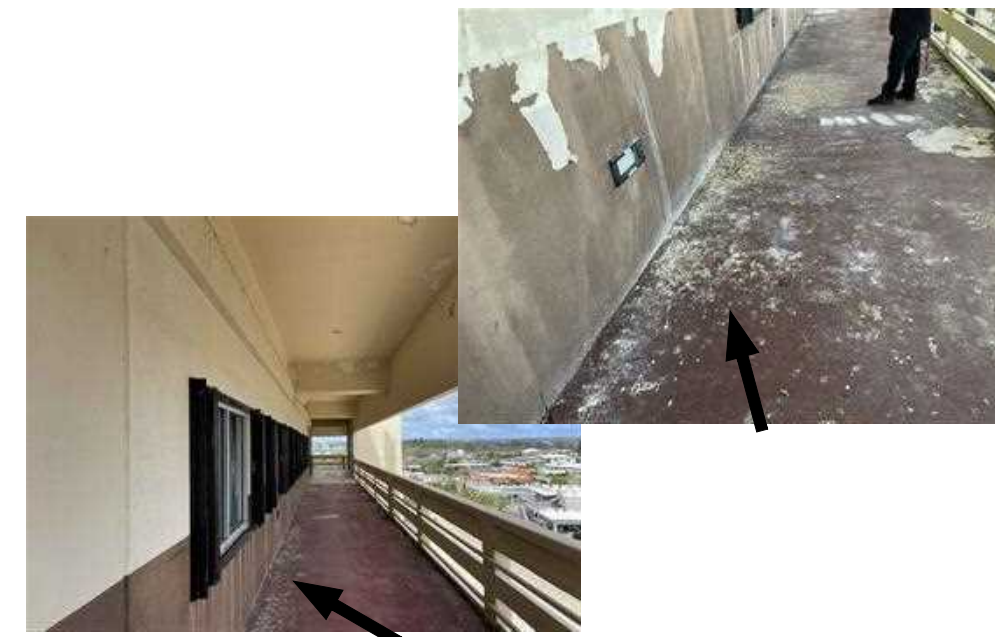
14e PHOTO
S-6.1 | S-6.1.A

BIRDS DROPPINGS PRESENT ON BEAM, HOODS, PIPES, DUCT WORK, SHUTTER HEAD, ETC. FROM LIGHT TO HEAVILY INFESTED NARROW TO EXTRA WIDE AREAS.

13	REMOVE EXISTING WALL EXHAUST HOOD AND REPLACE WITH NEW STAINLESS STEEL HOOD TO MATCH EXISTING, SEE MECHANICAL PLAN AND DETAIL.	
	14	PROVIDE STAINLESS STEEL ANTI BIRD SPIKES ON ALL LEDGES SUCH AS PIPES, SPRINKLER SYSTEMS, STEEL BEAMS, WINDOW SHUTTERS HEAD, HVAC EXHAUST HOODS, AC UNITS, ETC. and PVC AviAngle LEDGE SHIELD ON CONCRETE BEAM LEDGES. SEE SHEET S-9.1 FOR PVC AviAngle LEDGE SHIELD and ANTI BIRD SPIKES SPECIFICATIONS.	5 S-9.1 S-9.1

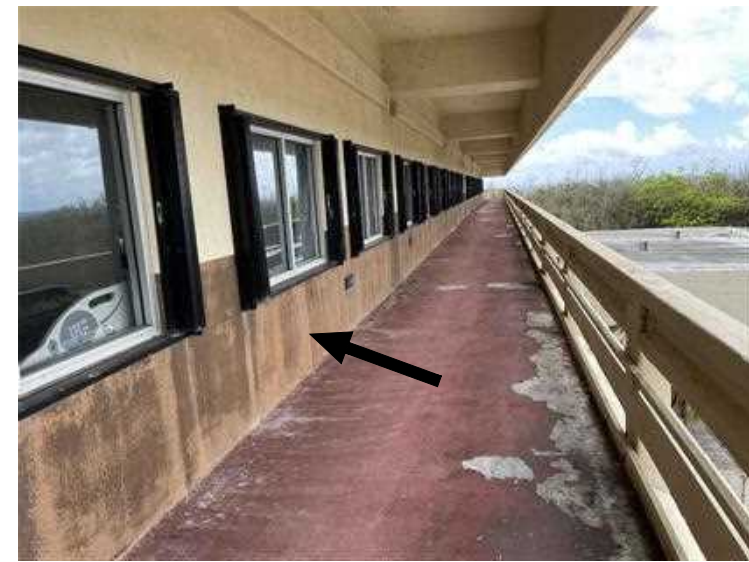
1e PHOTO
S-6.2 | S-6.2.A

DETERIORATED WALL, and PARAPET WALL PAINTS.

WING	MARK	REPAIR METHODS	DETAIL SHOWN	WING	MARK	REPAIR METHODS	DETAIL SHOWN
3rd & 4th FLOOR (EXTERIOR) REAR & RIGHT SIDE ELEVATIONS	1	PRESSURE-WASH EXISTING WALL TO REMOVE DIRT, STAIN, MILDEW, ALGAE AND REPAIR ANY AREAS WITH MINOR DAMAGED and PATCH WITH EPOXY MORTAR. PROVIDE NEW PAINT ON ALL WALL, CONC RAILINGS SURFACES, PER GMHA FACILITY STANDARD, TYPICAL.		3rd & 4th FLOOR (EXTERIOR) REAR & RIGHT SIDE ELEVATIONS	8	REMOVE EXISTING WALL EXHAUST HOOD and REPLACE WITH NEW STAINLESS STEEL HOOD TO MATCH EXISTING, SEE MECHANICAL PLAN and DETAIL.	
	2	REMOVE EXISTING WINDOW ACCORDION SHUTTERS and ITS ACCESSORIES and REPLACE WITH NEW ALUMINUM ACCORDION SHUTTER, TYPICAL AT EXTERIOR CORRIDORS. REFER TO GMHA FOR COLOR SELECTION.			9	REMOVE EXISTING WALL EXHAUST/OUTSIDE AIR GRILLE COVER and REPLACE with NEW or PROVIDE NEW UNIT AS REQUIRED, SEE MECHANICAL PLAN and DETAIL.	
	3	PROVIDE STAINLESS STEEL ANTI BIRD SPIKES ON ALL LEDGES SUCH AS PIPES, SPRINKLER SYSTEMS, STEEL BEAMS, WINDOW SHUTTERS HEAD, HVAC EXHAUST HOODS, AC UNITS, ETC. and PVC AviAngle LEDGE SHIELD ON CONCRETE BEAM LEDGES. SEE SHEET S-9.1 FOR PVC AviAngle LEDGE SHIELD and ANTI BIRD SPIKES SPECIFICATIONS.	5 S-9.1 S-9.1		10	REMOVE EXISTING WALL EXHAUST/OUTSIDE AIR GRILLE COVER and REPLACE with NEW or PROVIDE NEW UNIT AS REQUIRED, SEE MECHANICAL PLAN and DETAIL.

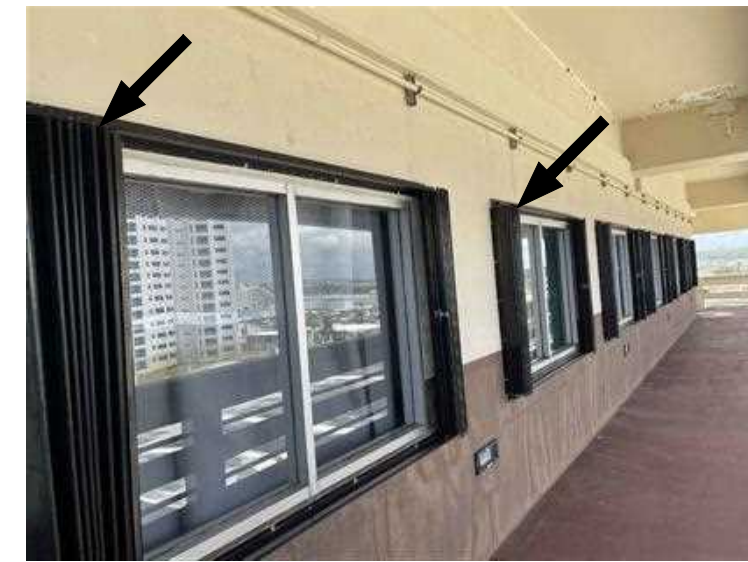
2e PHOTO
S-6.2 | S-6.2.A

DETERIORATED WINDOW ACCORDION SHUTTERS (TYP 30 PLACES).

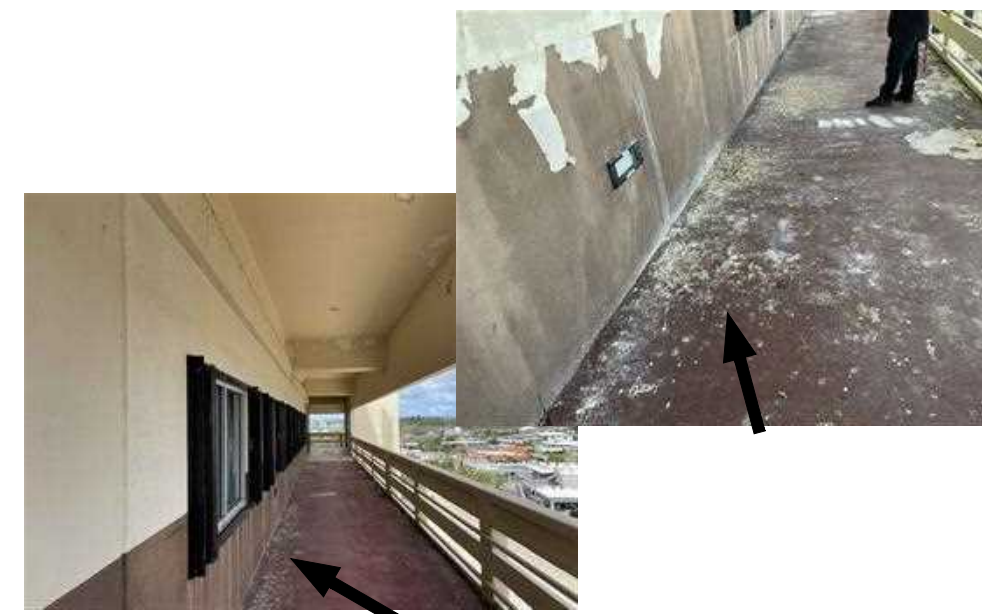
3e PHOTO
S-6.2 | S-6.2.A

BIRDS DROPPINGS PRESENT ON BEAM, HOODS, PIPES, DUCT WORK, SHUTTER HEAD, ETC. FROM LIGHT TO HEAVILY INFESTED NARROW TO EXTRA WIDE AREAS.

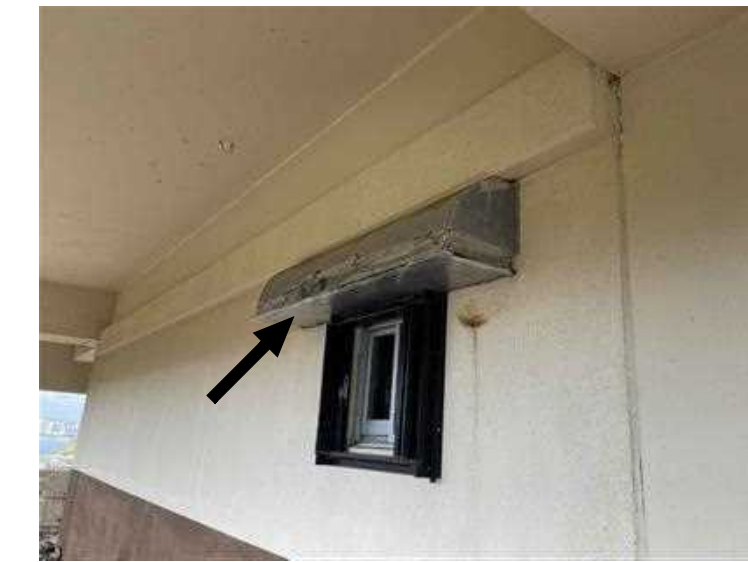
4e PHOTO
S-6.2 | S-6.2.A

DETERIORATED WALL EXHAUST HOOD.

4	REMOVE EXISTING WALL EXHAUST HOODS and REPLACE WITH NEW STAINLESS STEEL HOOD TO MATCH EXISTING, SEE MECHANICAL PLAN and DETAIL.			11	REMOVE EXISTING WALL EXHAUST OUTSIDE AIR GRILL and REPLACE WITH NEW STAINLESS STEEL GRILLE TO MATCH EXISTING, SEE MECHANICAL PLAN and DETAIL.	
	5	REMOVE EXISTING WALL EXHAUST/OUTSIDE AIR GRILLE COVER and REPLACE with NEW or PROVIDE NEW UNIT AS REQUIRED, SEE MECHANICAL PLAN and DETAIL.			12	REMOVE EXISTING WALL EXHAUST/OUTSIDE AIR GRILLE COVER and REPLACE with NEW or PROVIDE NEW UNIT AS REQUIRED, SEE MECHANICAL PLAN and DETAIL.	
	6	REMOVE EXISTING WALL EXHAUST/OUTSIDE AIR GRILLE COVER and REPLACE with NEW or PROVIDE NEW UNIT AS REQUIRED, SEE MECHANICAL PLAN and DETAIL.			13	REMOVE EXISTING WALL EXHAUST/OUTSIDE AIR GRILLE COVER and REPLACE with NEW or PROVIDE NEW UNIT AS REQUIRED, SEE MECHANICAL PLAN and DETAIL.	
	7	REMOVE EXISTING WALL EXHAUST HOODS and REPLACE WITH NEW STAINLESS STEEL HOOD TO MATCH EXISTING, SEE MECHANICAL PLAN and DETAIL.			14	REMOVE EXISTING WALL EXHAUST/OUTSIDE AIR GRILLE COVER and REPLACE with NEW or PROVIDE NEW UNIT AS REQUIRED, SEE MECHANICAL PLAN and DETAIL.

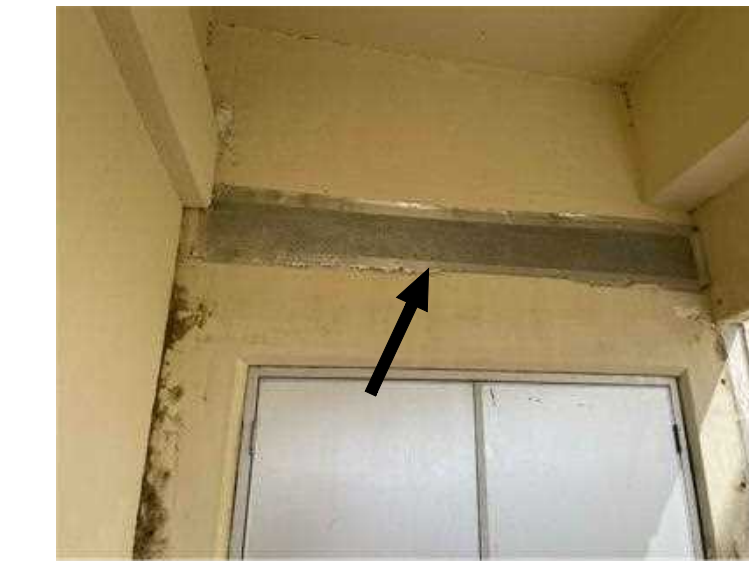
5e PHOTO
S-6.2 | S-6.2.A

DETERIORATED EXHAUST/OUTSIDE AIR GRILLE COVER.

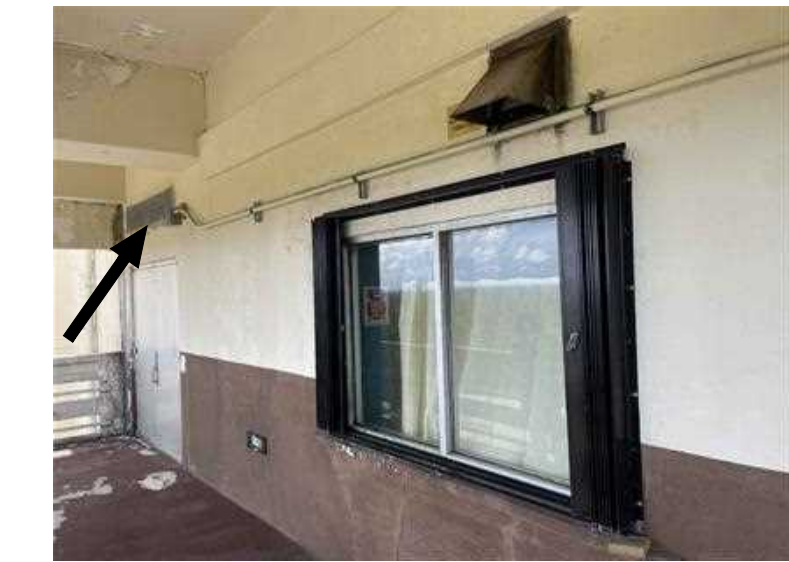
6e PHOTO
S-6.2 | S-6.2.A

DETERIORATED EXHAUST/OUTSIDE AIR GRILLE COVER.

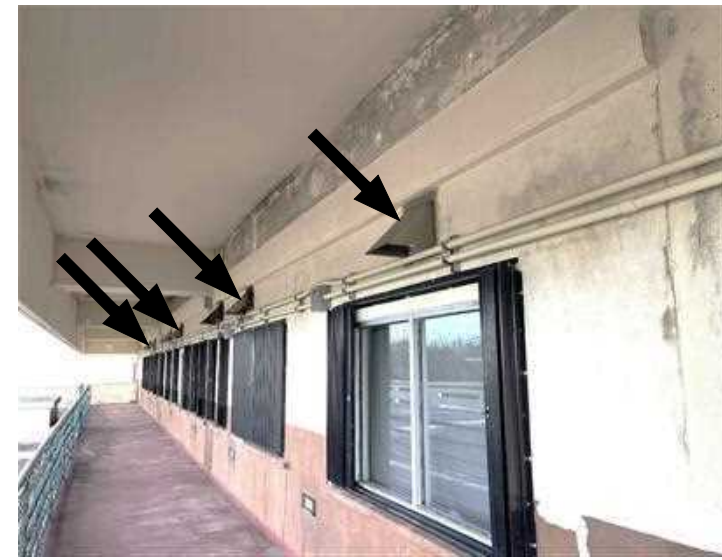
7e PHOTO
S-6.2 | S-6.2.A

DETERIORATED WALL EXHAUST HOOD.

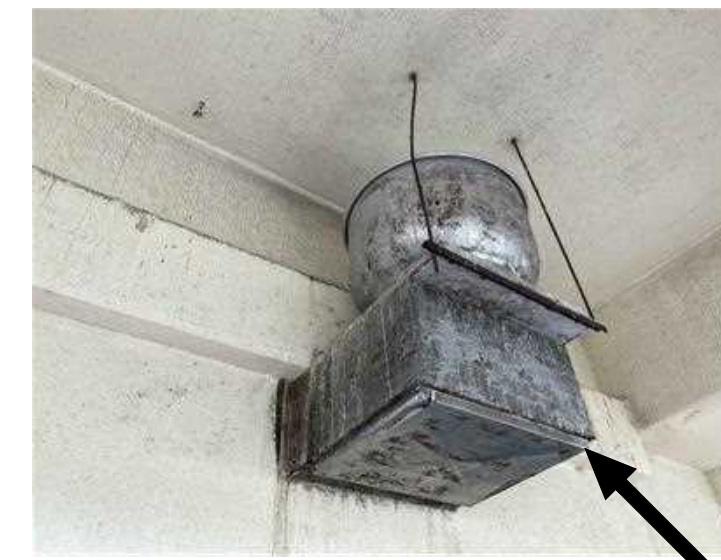
8e PHOTO
S-6.2 | S-6.2.A

DETERIORATED WALL EXHAUST HOOD.

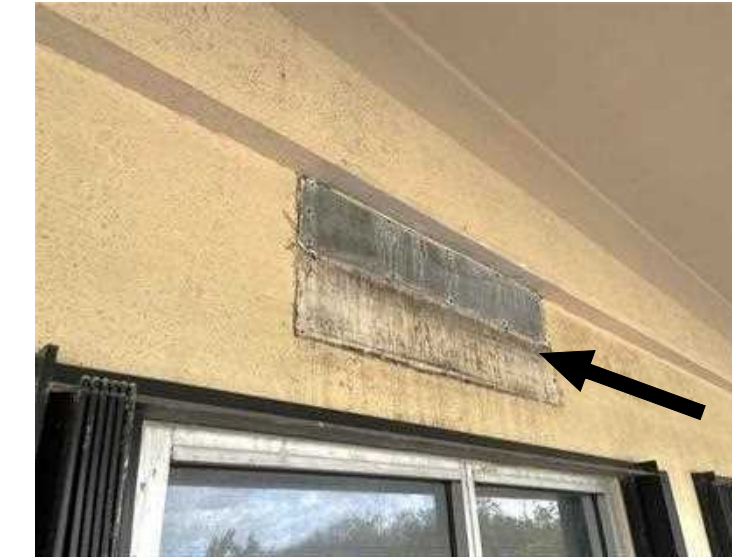
9e PHOTO
S-6.2 | S-6.2.A

DETERIORATED EXHAUST/OUTSIDE AIR GRILLE COVER.

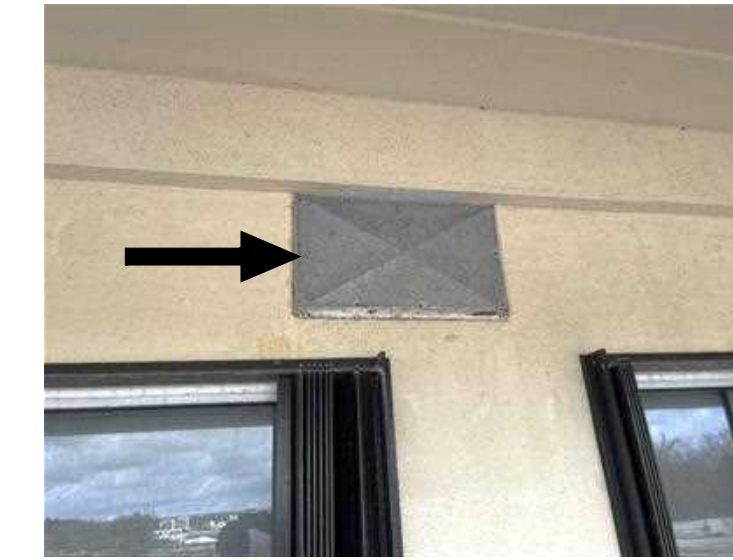
10e PHOTO
S-6.2 | S-6.2.A

DETERIORATED EXHAUST/OUTSIDE AIR GRILLE COVER.

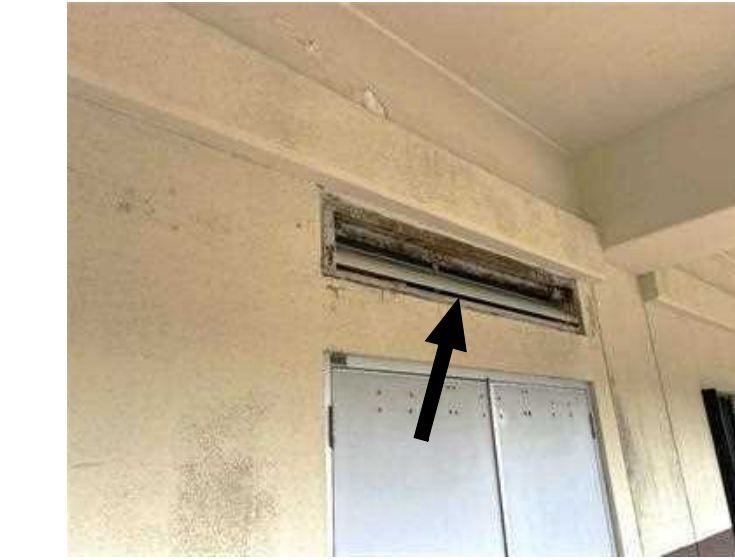
11e PHOTO
S-6.2 | S-6.2.A

DETERIORATED EXHAUST/OUTSIDE AIR GRILL

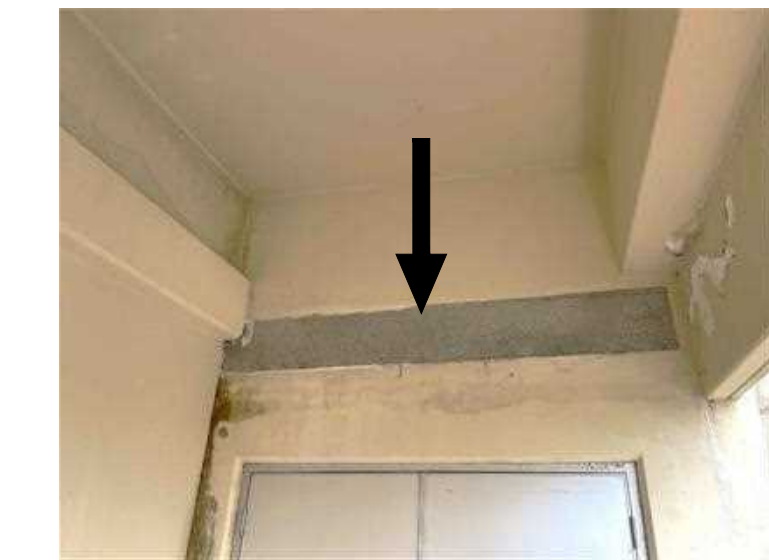
12e PHOTO
S-6.2 | S-6.2.A

EXISTING WALL, EXHAUST HOOD MISSING.

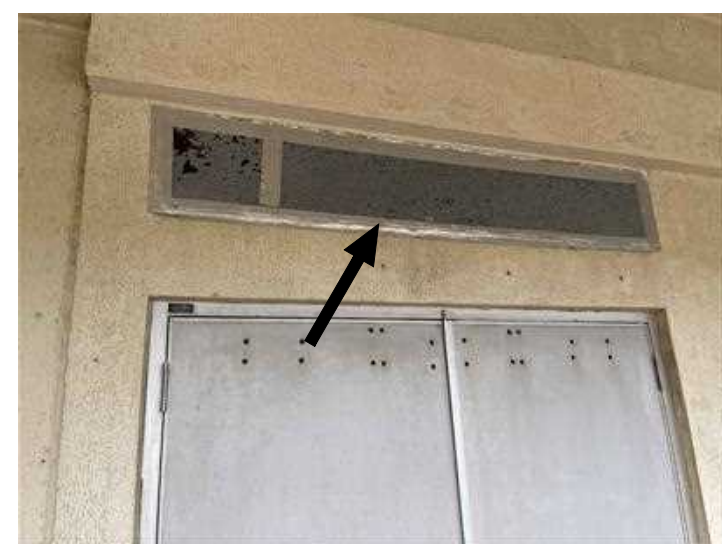
13e PHOTO
S-6.2 | S-6.2.A

DETERIORATED EXHAUST/OUTSIDE AIR GRILLE COVER.

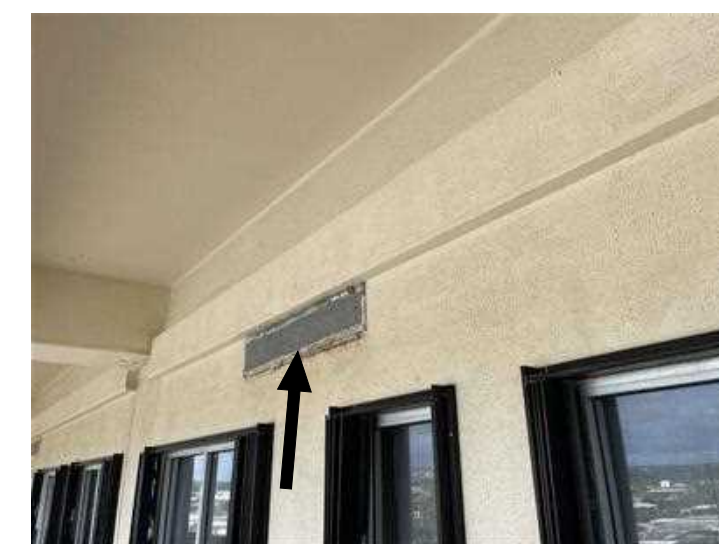
14e PHOTO
S-6.2 | S-6.2.A

DETERIORATED EXHAUST/OUTSIDE AIR GRILLE COVER.
