DRAWING INDEX

REV	DATE	BY	DESCRIPTION
GMHA NO. _____ GRANT ID NO. _____ CONTRACT NO. _____ PROJECT NO. _____		PROJECT: GMHA HOSPITAL AND ENVELOPE UPGRADE PROJECT	
DES. BY: kje DRN. BY: jl CHK. BY: rmca		CHIEF ENGR: - ENGR. SUP: - PROJ. ENGR: -	
I HEREBY CERTIFY THAT THIS PLAN WAS PREPARED BY ME OR UNDER MY DIRECT SUPERVISION DATE: 07-31-2024		CONTENTS: FIRST FLOOR PLAN _ A-WING: DAMAGED LOCATIONS, PHOTO KEY NOTES, SCOPE OF REPAIR WORKS, NOTES, and KEY PLAN	
DRAWING NO. S-1.2.1		SH. 07 OF 60

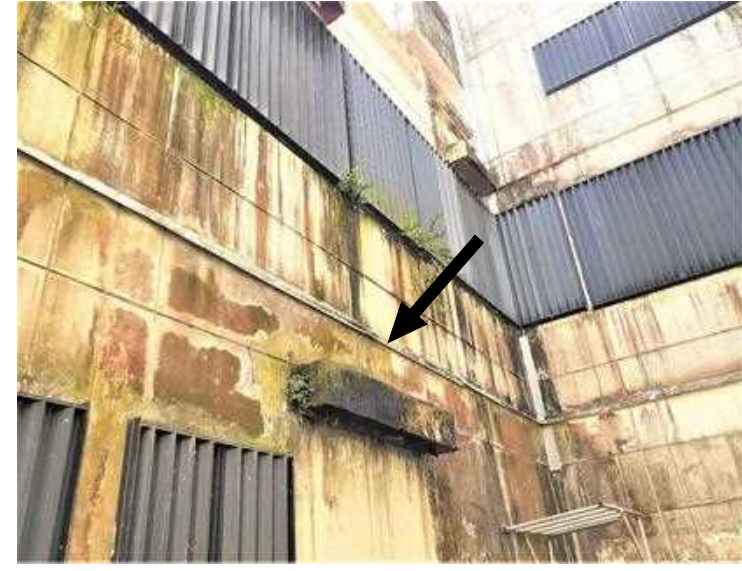
1e PHOTO
S-1.3 | S-1.3.A

DETERIORATED METAL FLASHING (30 lf).

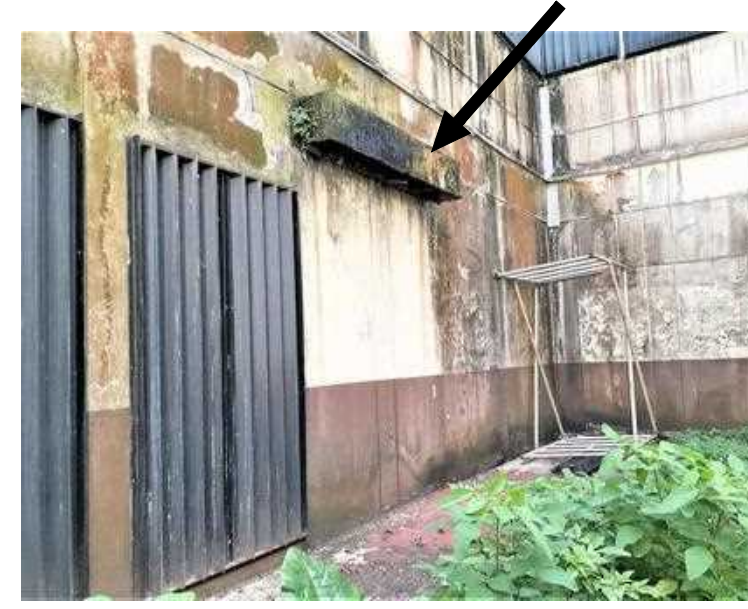
2e PHOTO
S-1.3 | S-1.3.A

DETERIORATED WALL EXHAUST HOOD w/ VEGETATION (1 ea).

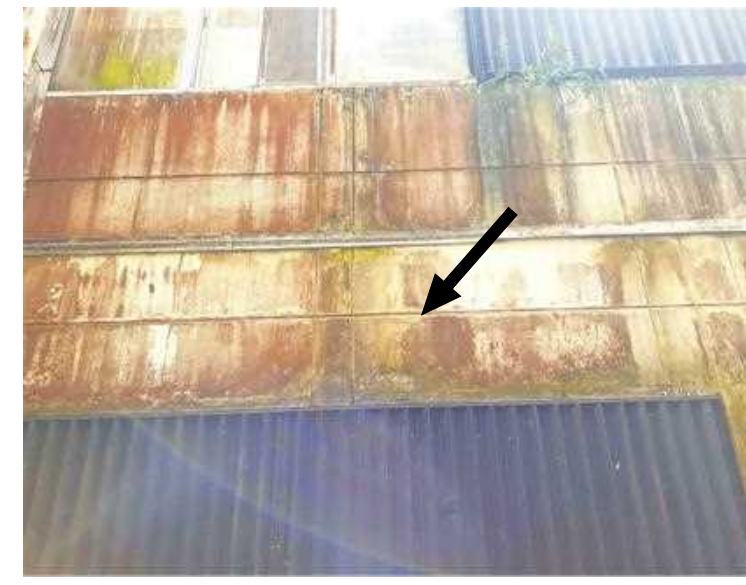
3e PHOTO
S-1.3 | S-1.3.A

DETERIORATED WALL PAINT w/ CRACKS (476 sf).

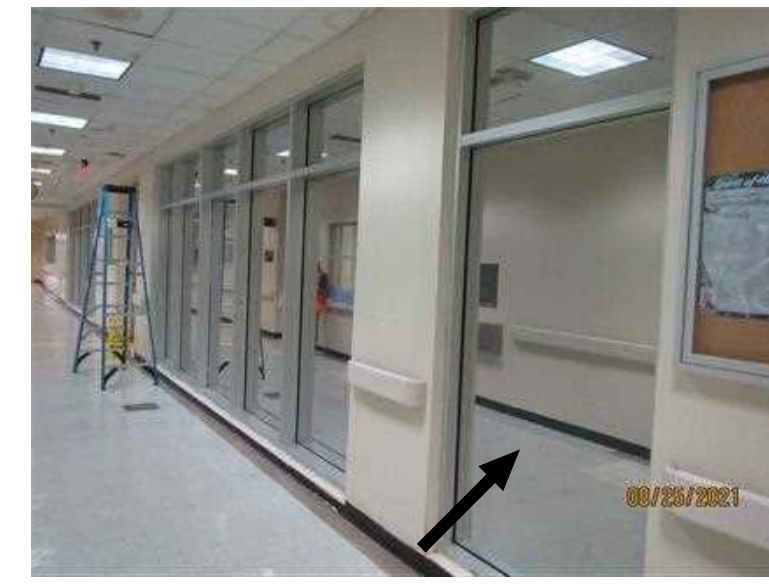
4e PHOTO
S-1.3 | S-1.3.A

DETERIORATED FIXED GLASS WINDOW CURTAIN WALL.

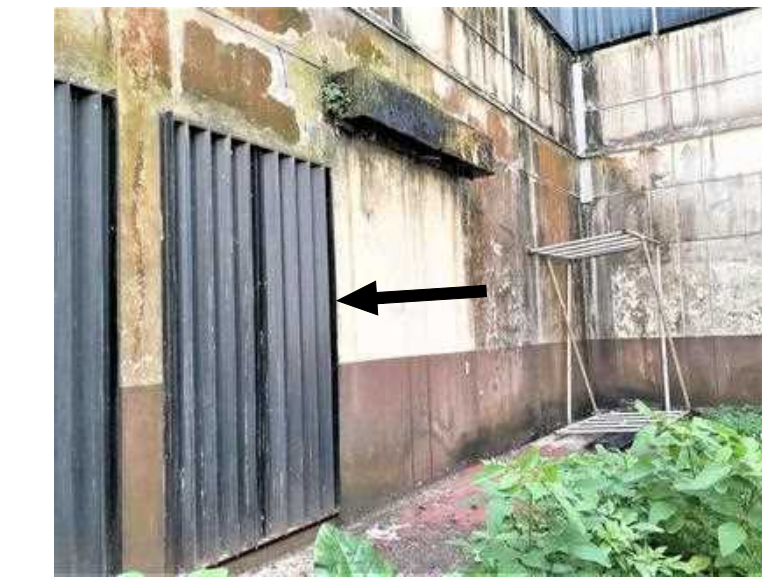
5e PHOTO
S-1.3 | S-1.3.A

DETERIORATED WINDOW SHUTTERS

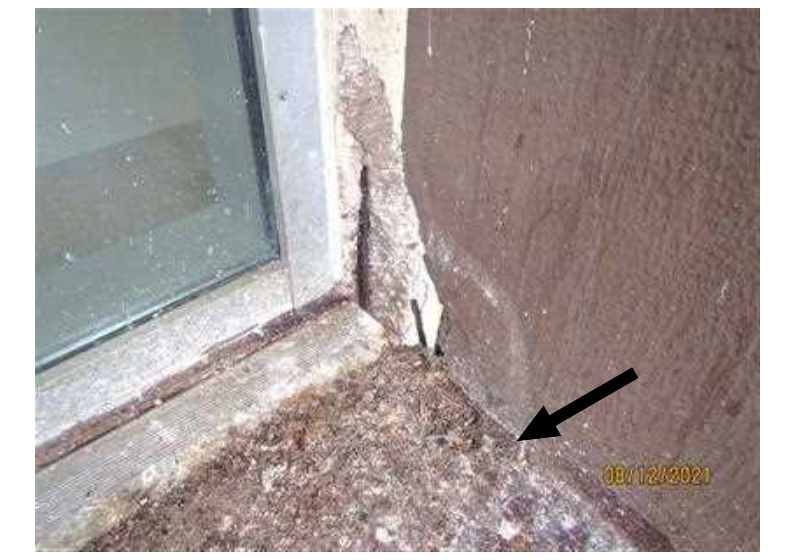
6e PHOTO
S-1.3 | S-1.3.A

BIRDS DROPPINGS PRESENT ON BEAM, HOODS, PIPES, DUCT WORK, SHUTTER HEAD, ETC. FROM LIGHT TO HEAVILY INFESTED NARROW TO EXTRA WIDE AREAS.

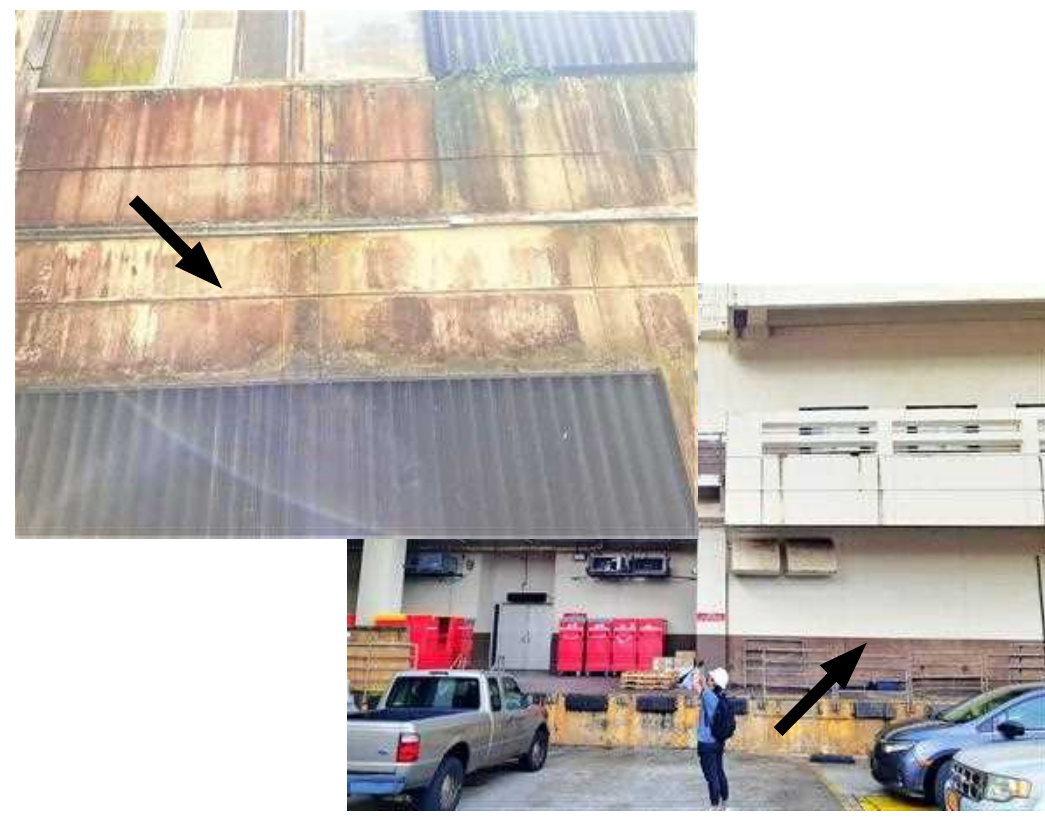
1e PHOTO
S-1.4 S-1.4.A

PHOTO KEY NOTES:		SCOPE of REPAIR WORKS:		
WING	PHOTO No.	DAMAGED DESCRIPTION	REPAIR METHODS	DETAIL SHOWN
C-WING FIRST FLOOR (EXTERIOR)	1e S-1.4 S-1.4.A	CONCRETE WALL PAINT DETERIORATED (6,239 sf).	WATERBLAST EXISTING OF WALL, GRIND TRACES OF CRACKS, CLEAN and INJECT WITH EPOXY MORTAR, and PROVIDE NEW PAINT PER GMHA FACILITY STANDARD.	3 S-12.1 S-12.1
	2e S-1.4 S-1.4.A	MOLD AND MILDEW ON FASCIA (1024 SF).	WATERBLAST TO CLEAN EXISTING FASCIA and PROVIDE NEW PAINT PER GMHA FACILITY STANDARD.	
	3e S-1.4 S-1.4.A	CEILING CRACKS (5 lf).	GRIND TRACES OF CRACKS, CLEAN and INJECT WITH EPOXY MORTAR, SEE DETAIL.	5 S-12.1 S-12.1
	4e S-1.4 S-1.4.A	DETERIORATED WINDOW SEAL (644 lf).	REMOVE and REPLACE EXISTING WINDOW SEAL, TYPICAL.	
	5e S-1.4 S-1.4.A	MECHANICAL EQUIPMENT DOOR BROKEN and RUSTED 2 ea).	REMOVE EXISTING DOOR and ITS ACCESSORIES and REPLACE WITH NEW INSULATED STEEL DOOR.	5,6 S-8.1 S-8.1
	6e S-1.4 S-1.4.A	WINDOW STAINED and MILDEW (324 sf).	REMOVE EXISTING GLASS WINDOWS & REPLACE w/ NEW, TYPICAL

DETERIORATED WALL PAINTS (6,239 sf).

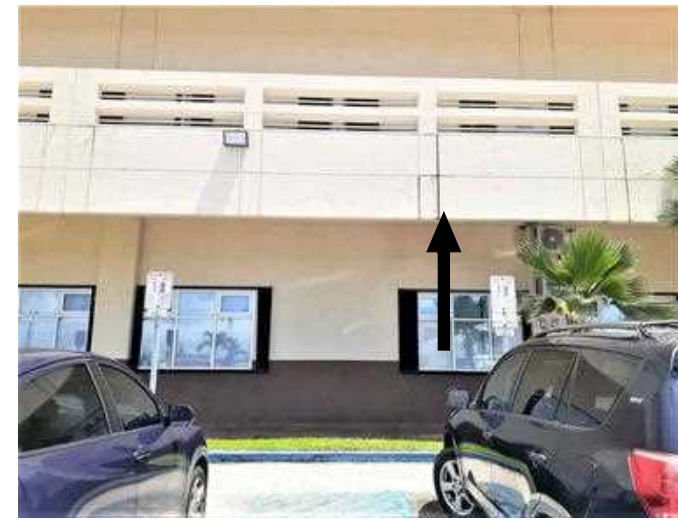
2e PHOTO
S-1.4 S-1.4.A

MOLD AND MILDEW ON FASCIA (1024 sf).

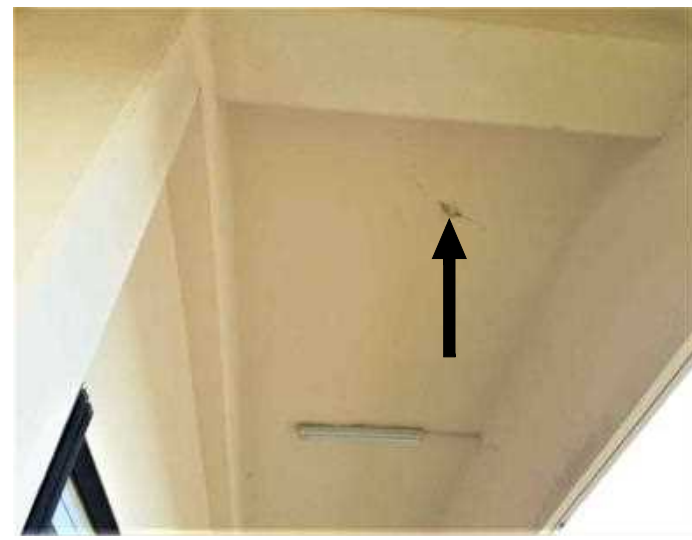
3e PHOTO
S-1.4 S-1.4.A

CEILING CRACKS (5 lf).

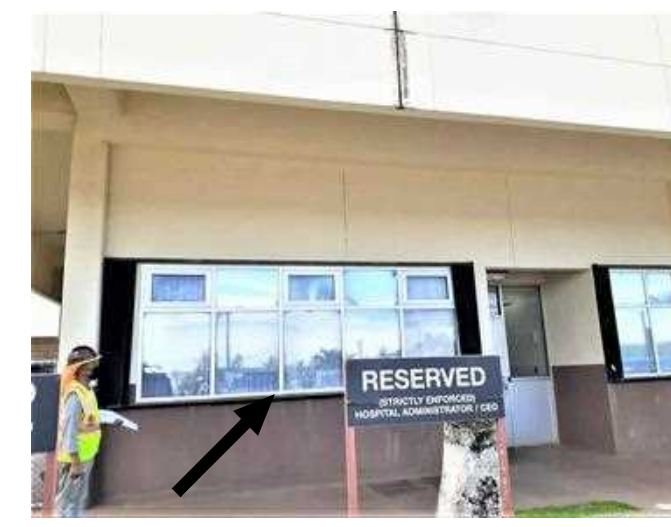
4e PHOTO
S-1.4 S-1.4.A

DETERIORATED WINDOW SeaLANT AND Seal (644 lf).

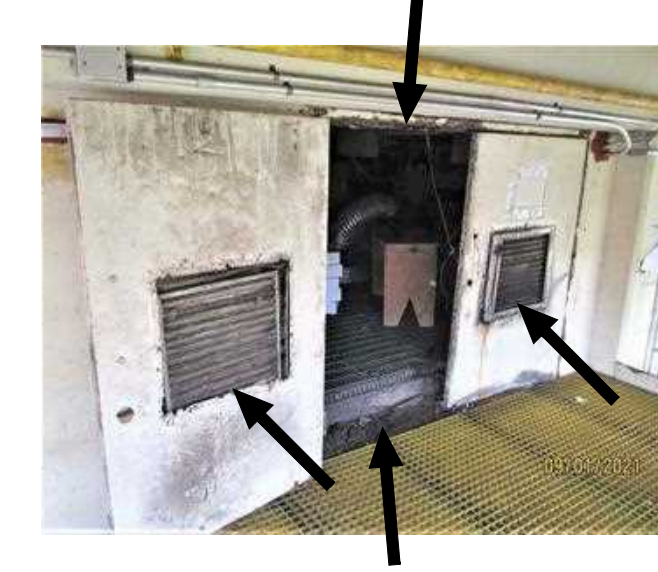
5e PHOTO
S-1.4 S-1.4.A

MECHANICAL EQUIPMENT DOOR BROKEN & RUSTED (2 ea).

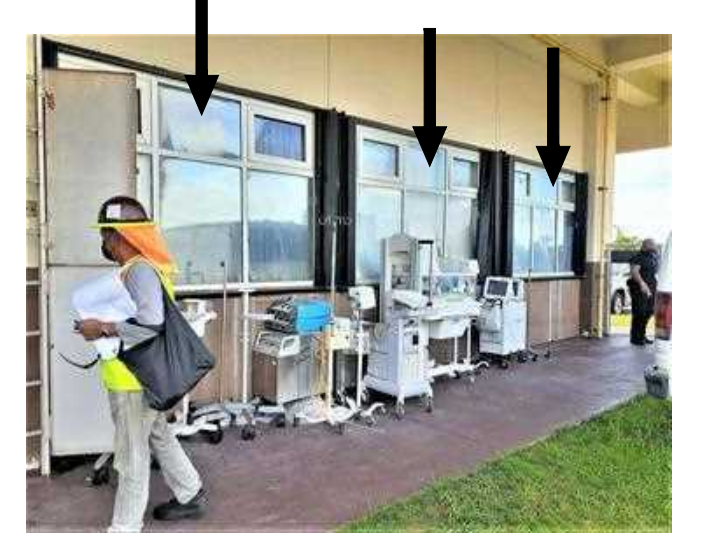
6e PHOTO
S-1.4 S-1.4.A

WINDOW STAINED AND MILDEW (324 sf).

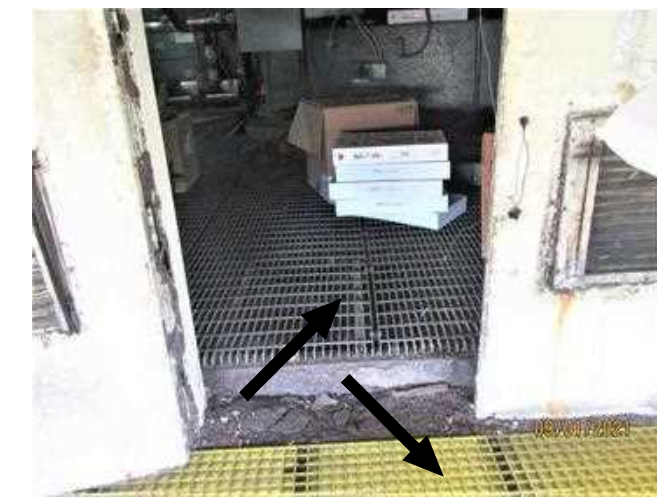
8e PHOTO
S-1.4 S-1.4.A

DETERIORATED MEZZANINE FLOOR GRATING (150 sf).

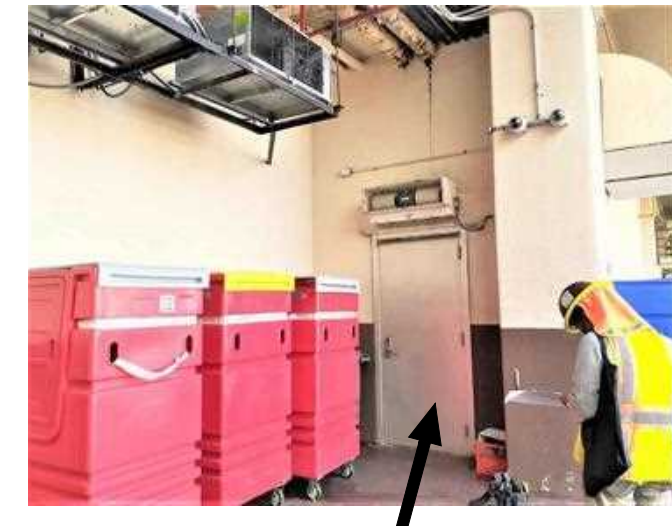
9e PHOTO
S-1.4 S-1.4.A

FAILED DOOR Seal, THRESHOLD AND SealANT (20 lf).

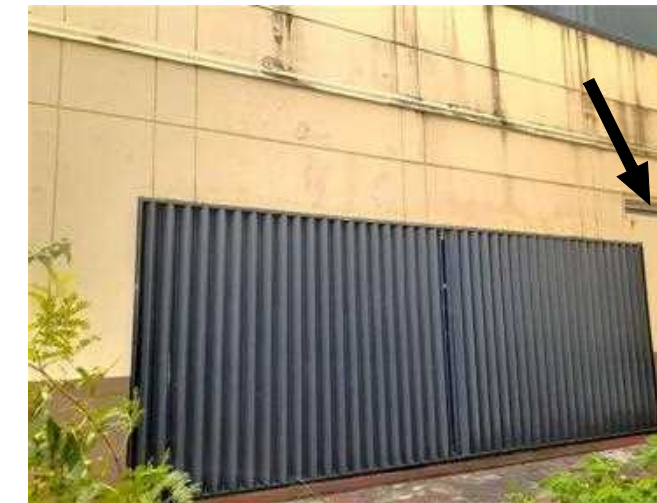
10e PHOTO
S-1.4 S-1.4.A

DETERIORATED MECHANICAL AIR INTAKE GRILLE on WALL

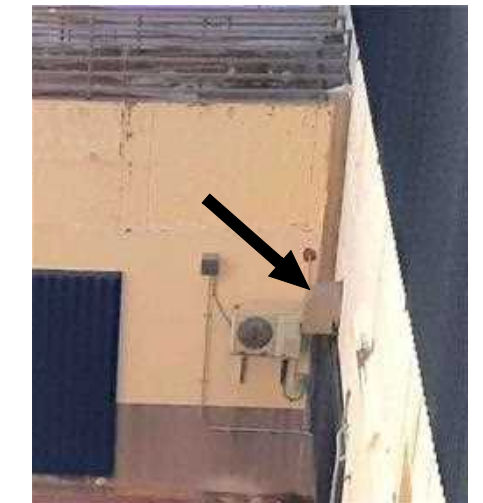
12e PHOTO
S-1.4 S-1.4.A

DETERIORATED EXHAUST HOOD

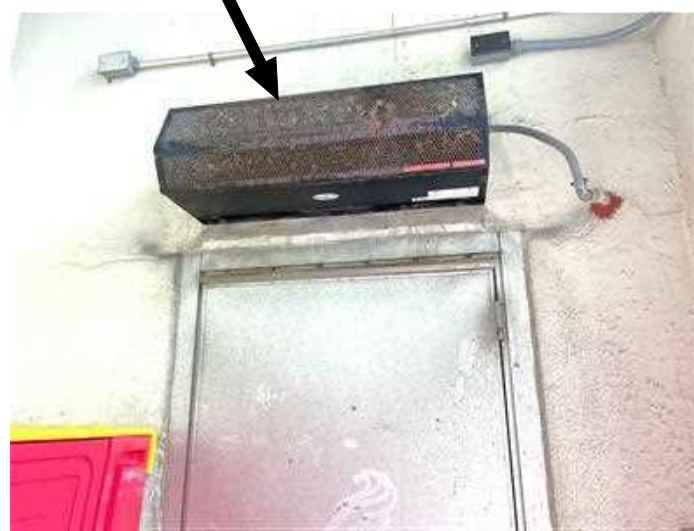
13e PHOTO
S-1.4 S-1.4.A

DETERIORATED DOOR HEAD BLOWER

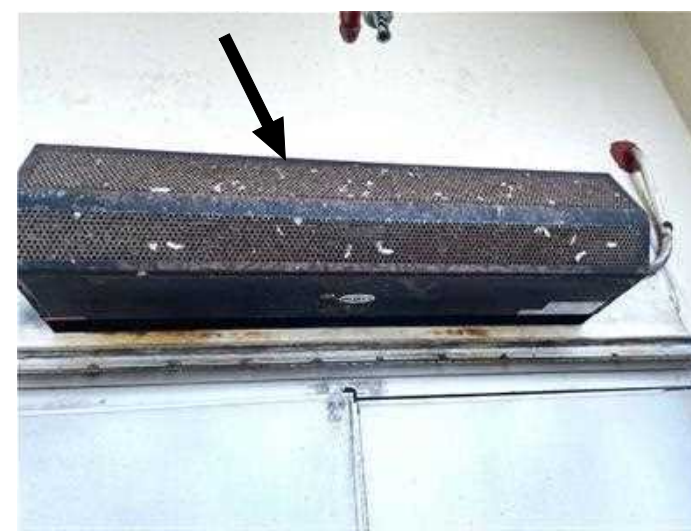
14e PHOTO
S-1.4 S-1.4.A

14e S-1.4 S-1.4.A	DETERIORATED DOOR HEAD BLOWER.	REMOVE and REPLACE EXISTING DOOR HEAD BLOWER with NEW to MATCH EXISTING, SEE MECHANICAL PLAN and DETAIL.	
	15e S-1.4 S-1.4.A	DETERIORATED DOOR with VISION PANEL.	REMOVE EXISTING DOOR with VISION PANEL and ITS ACCESSORIES and REPLACE with NEW to MATCH EXISTING.	1,2,3,9 S-8.1 S-8.1
	16e S-1.4 S-1.4.A	DETERIORATED DOOR with FIXED WINDOW SIDE PANEL.	REMOVE EXISTING DOOR with WINDOW SIDE PANEL and ITS ACCESSORIES and REPLACE with NEW to MATCH EXISTING.	1,2,3,10 S-8.1 S-8.1
	17e S-1.4 S-1.4.A	DETERIORATED FIXED GLASS WINDOW CURTAIN WALL.	REMOVE FIXED GLASS WINDOW CURTAIN WALLS and ITS ACCESSORIES and REPLACE with NEW FIXED GLASS WINDOW.	1,2,3,7 S-9.1 S-9.1
	18e S-1.4 S-1.4.A	DETERIORATED WINDOW SHUTTERS.	REMOVE EXISTING WINDOW SHUTTERS and ITS ACCESSORIES and REPLACE WITH NEW EXTERIOR MOUNTED TYPHOON RATED INTERLOCKING ALUMINUM SLATS-UP SHUTTERS WITH MANUAL OPERATING SYSTEM. VERIFY WIDTH and HEIGHT OF EXISTING WALL OPENING.	4 S-11.1 S-11.1

DETERIORATED DOOR HEAD BLOWER

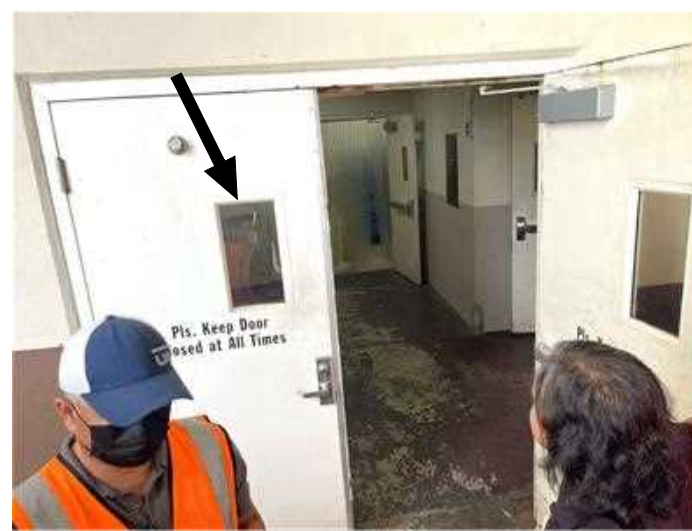
15e PHOTO
S-1.4 S-1.4.A

DETERIORATED DOOR with VISION PANEL

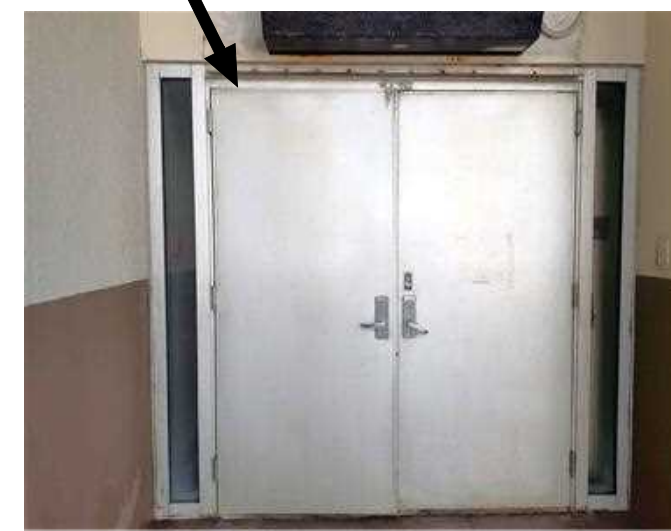
16e PHOTO
S-1.4 S-1.4.A

DETERIORATED DOOR with FIXED WINDOW SIDE PANEL

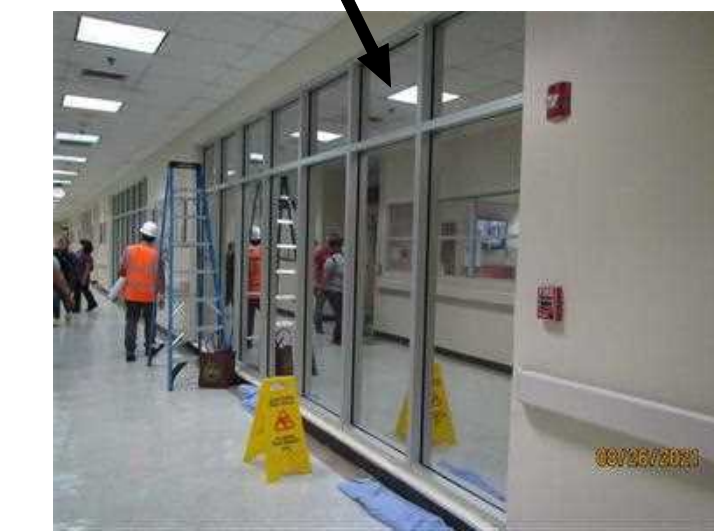
17e PHOTO
S-1.4 S-1.4.A

DETERIORATED DOOR with FIXED GLASS WINDOW CURTAIN WALL

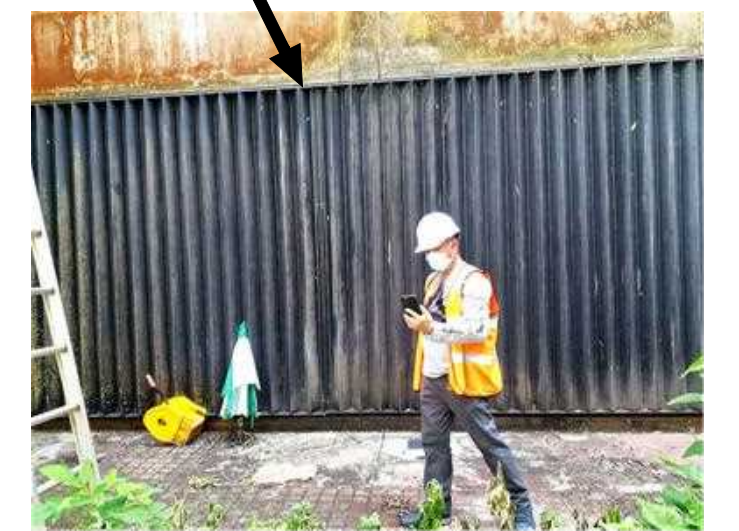
18e PHOTO
S-1.4 S-1.4.A

DETERIORATED WINDOW SHUTTERS

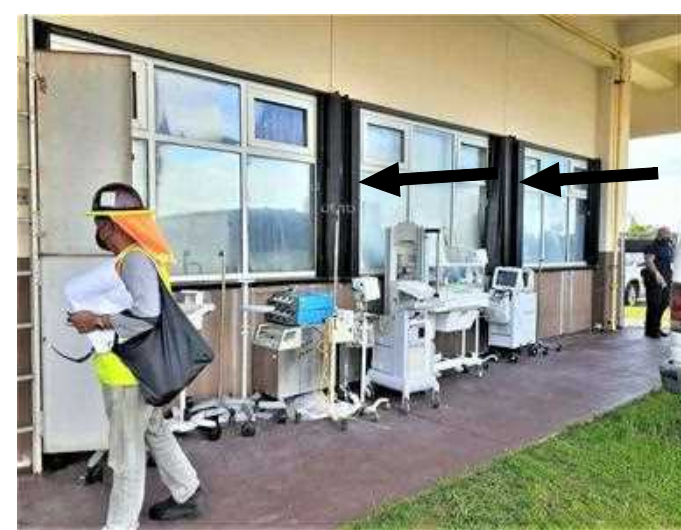
19e PHOTO
S-1.4 S-1.4.A

DETERIORATED WINDOW ACCORDION SHUTTERS

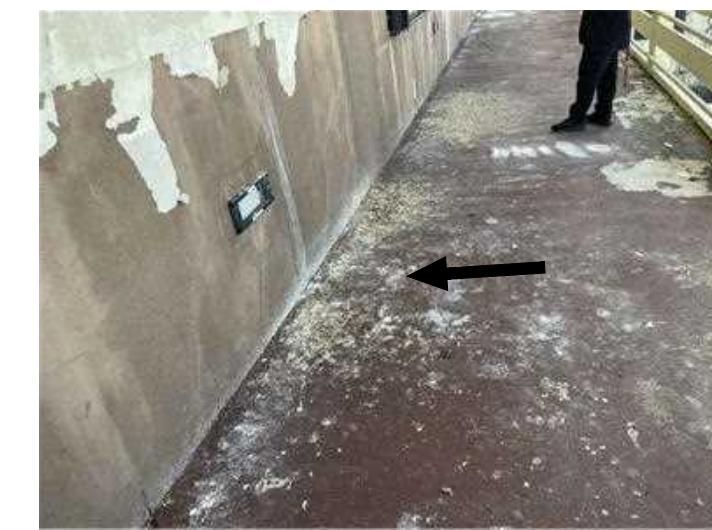
20e PHOTO
S-1.4 S-1.4.A

BIRDS DROPPINGS PRESENT ON BEAM, HOODS, PIPES, DUCT WORK, SHUTTER HEAD, ETC. FROM LIGHT TO HEAVILY INFESTED NARROW TO EXTRA WIDE AREAS.

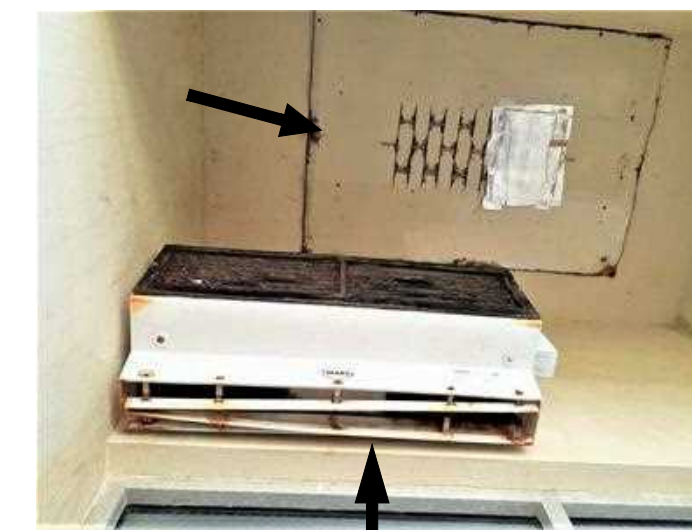
21e PHOTO
S-1.4 S-1.4.A

DETERIORATED DOOR HEAD BLOWER, and CEILING ACCESS DOOR HATCH.

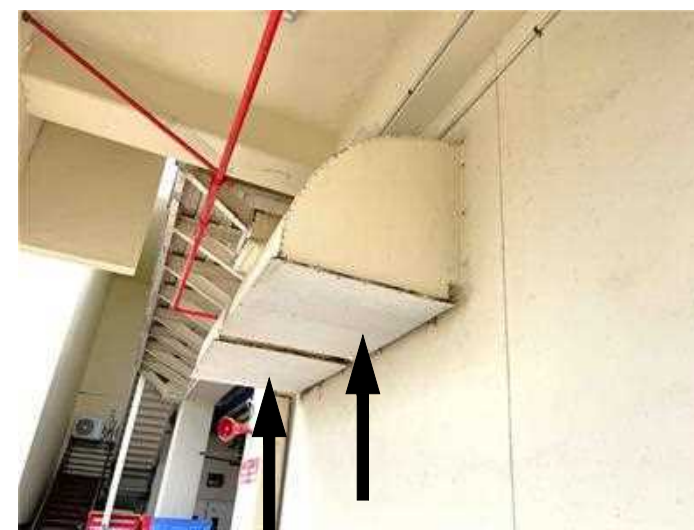
22e PHOTO
S-1.4 S-1.4.A

DETERIORATED EXHAUST HOOD

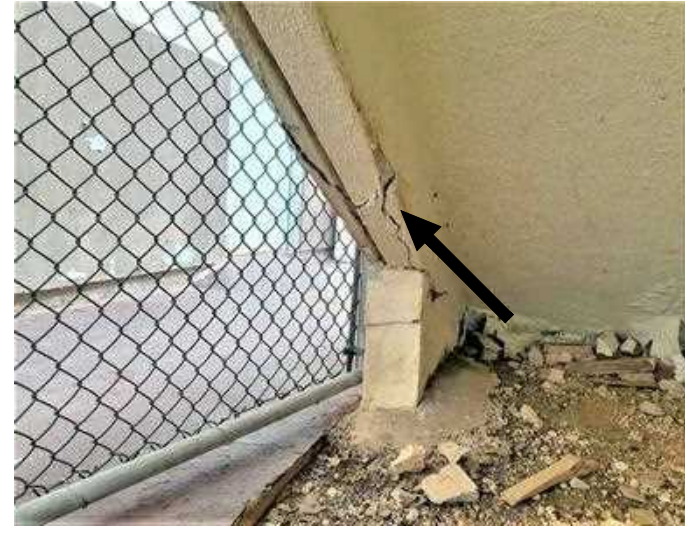
2e PHOTO
S-1.5.A S-1.5.A

CONCRETE DAMAGED ON WALL (14 Sf).

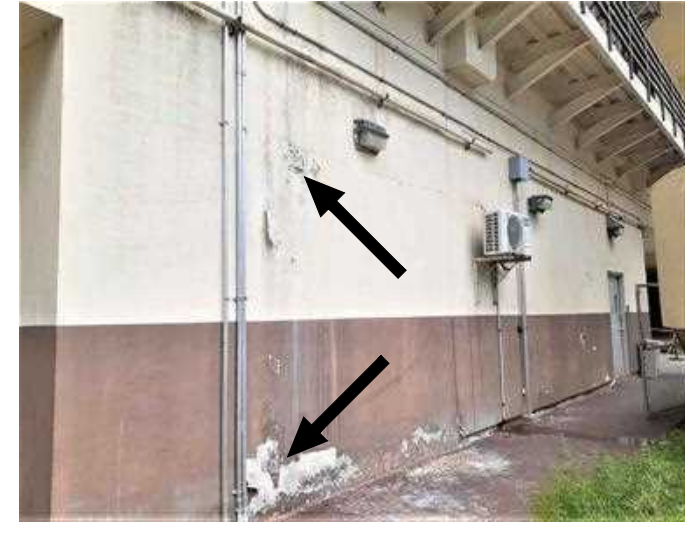
3e PHOTO
S-1.5.A S-1.5.A

CONCRETE WALL CRACKS (12 Lf).

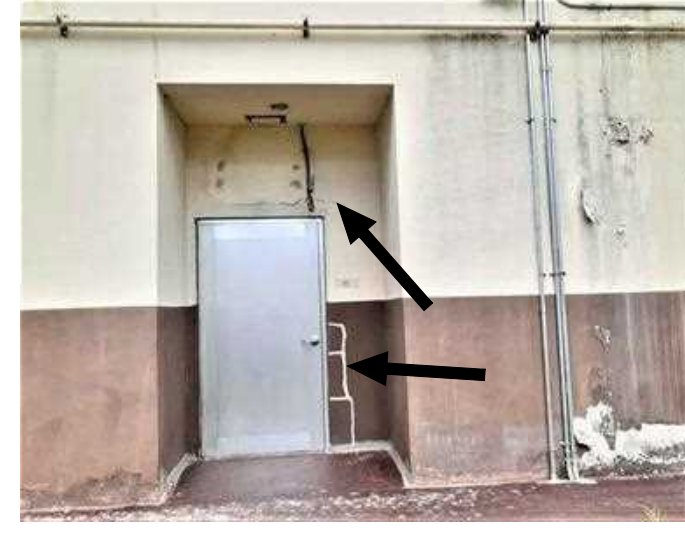
4e PHOTO
S-1.5.A S-1.5.A

DETERIORATED WALL PAINT (780 Sf).

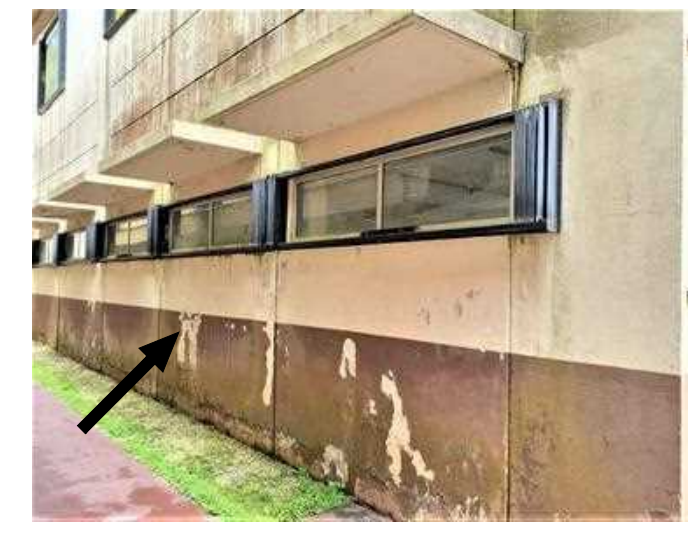
5e PHOTO
S-1.5.A S-1.5.A

WALL HAIRLINE CRACKS (8 Lf).

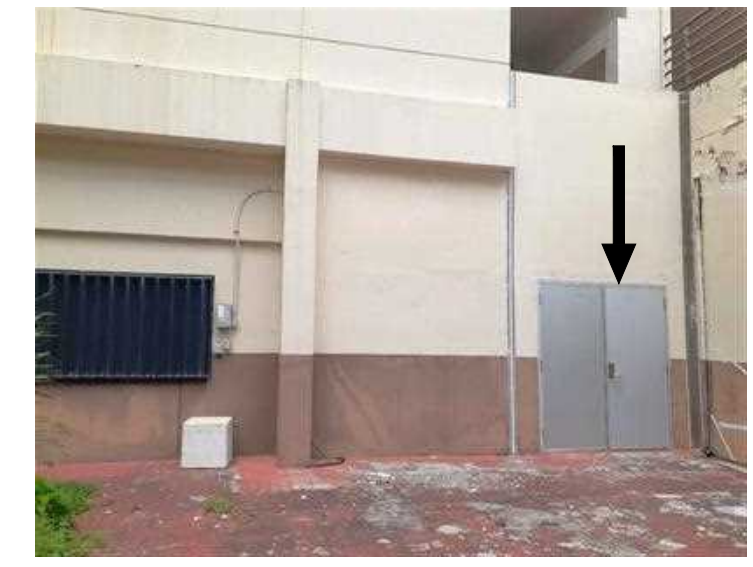
13e PHOTO
S-1.5.A S-1.5.A

DETERIORATED DOOR, SEAL, SEALANT and THRESHOLD.

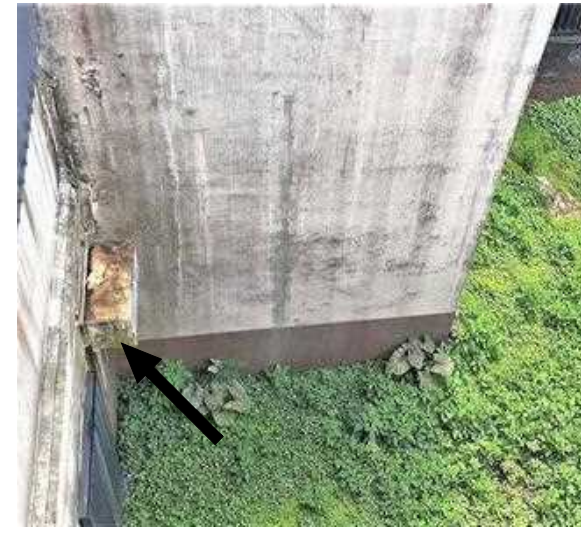
1e PHOTO
S-1.6.A S-1.6.A

DETERIORATED WALL MOUNTED EXHAUST HOOD.

PHOTO KEY NOTES:			SCOPE of REPAIR WORKS:	
WING	PHOTO No.	DAMAGED DESCRIPTION	REPAIR METHODS	DETAIL SHOWN
E - WING FIRST FLOOR (EXTERIOR)	1e S-1.6 S-1.6.A	DETERIORATED WALL EXHAUST HOOD.	REMOVE EXISTING WALL EXHAUST HOOD and REPLACE with NEW STAINLESS STEEL HOOD to MATCH EXISTING, SEE MECHANICAL PLAN and DETAIL.	
	2e S-1.6 S-1.6.A	DETERIORATED WALL PAINT (900 + 1118 sf).	PRESSURE-WASH EXISTING WALL TO REMOVE DIRT, STAIN, MILDEW, ALGAE and REPAIR ANY AREAS WITH MINOR DAMAGED and PATCH WITH EPOXY MORTAR. PROVIDE NEW PAINT ON ALL WALL, CONC RAILINGS SURFACES, PER GMHA FACILITY STANDARD, TYPICAL.	3 S-12.1 S-12.1
	3e S-1.6 S-1.6.A	DETERIORATED WINDOW FRAME, SEALANT & SEAL (14 sf).	REMOVE EXISTING WINDOW, FRAME & ITS ACCESSORIES and REPLACE WITH NEW. SEE SCHEDULE and DETAILS.	1,2,3 S-9.1 S-9.1
	4e S-1.6 S-1.6.A	DETERIORATED EXISTING TYPHOON SHUTTERS.	REMOVE EXISTING WINDOW SHUTTERS AND ITS ACCESSORIES and REPLACE WITH NEW EXTERIOR MOUNTED TYPHOON RATED INTERLOCKING ALUMINUM SLATS BOXED ROLLER SHUTTERS WITH MANUAL OPERATING SYSTEM. VERIFY WIDTH and HEIGHT OF EXISTING WALL OPENING.	4 S-11.1 S-11.1

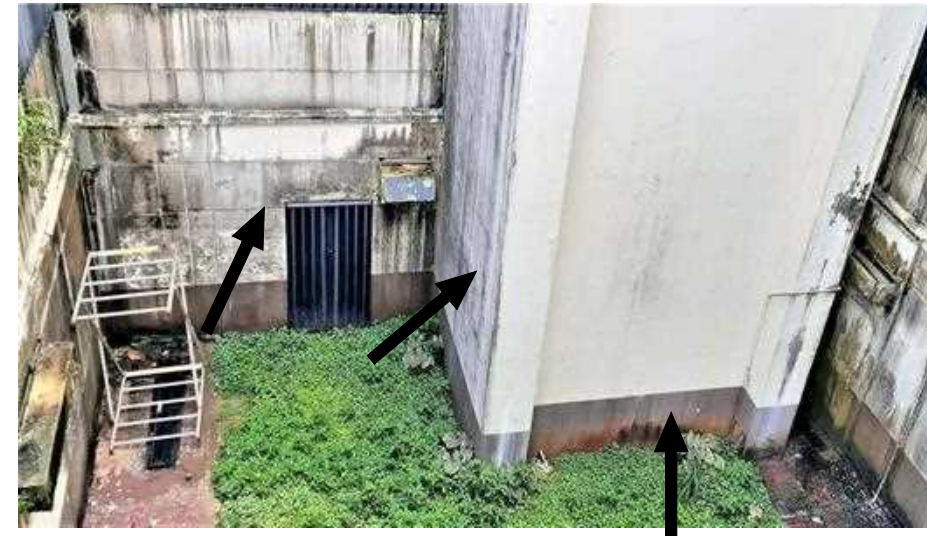
2e PHOTO
S-1.6.A S-1.6.A

DETERIORATED WALL PAINTS (850 sf).

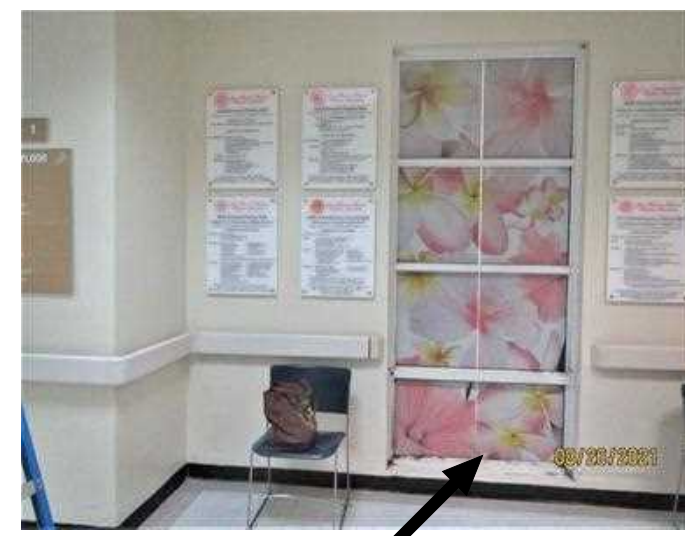
3e PHOTO
S-1.6.A S-1.6.A

DETERIORATED GYPSUM BOARD AROUND WINDOW (24 sf).

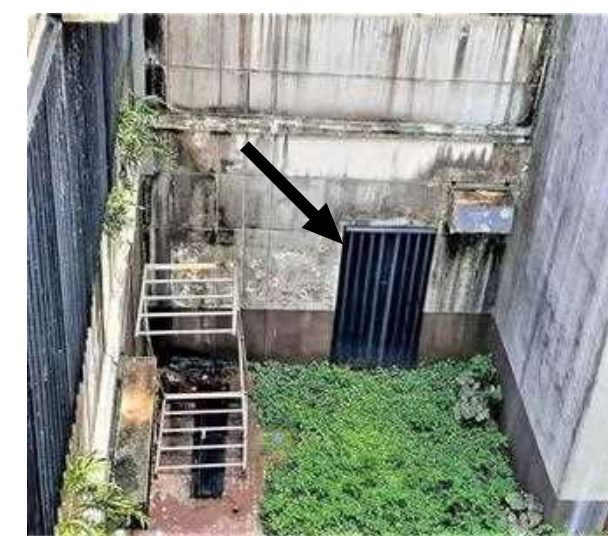
4e PHOTO
S-1.6.A S-1.6.A

DETERIORATED WINDOW SHUTTERS

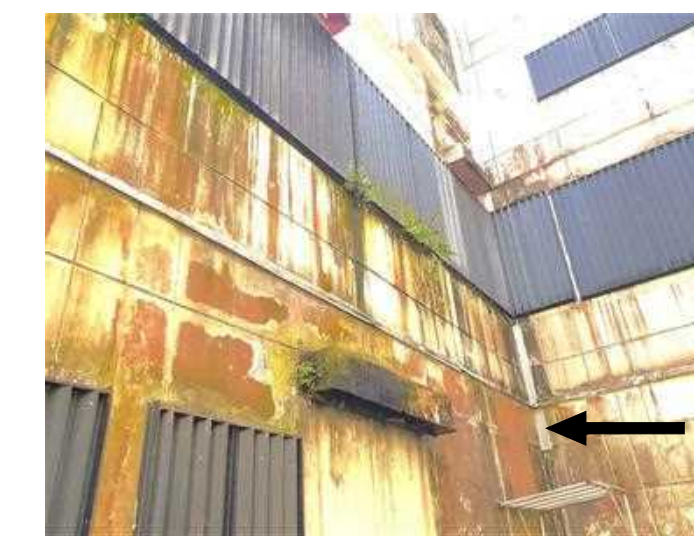
5e PHOTO
S-1.6.A S-1.6.A

DETERIORATED SEISMIC JOINT COVER (FLOOR, SIDES & CEILING) (36 lf).

5e S-1.6 S-1.6.A	DETERIORATED SEISMIC JOINT COVER (FLOOR, SIDES & CEILING) (36 lf).	REMOVE EXISTING SEISMIC JOINT COVER and REPLACE WITH NEW, SEE DETAILS ON SHEET S-12.1.	1 S-14.1 S-14.1
	6e S-1.6 S-1.6.A	BIRDS DROPPINGS PRESENT ON BEAM, HOODS, PIPES, DUCT WORK, SHUTTER HEAD, ETC. FROM LIGHT TO HEAVILY INFESTED NARROW TO EXTRA WIDE AREAS.	PROVIDE STAINLESS STEEL ANTI BIRD SPIKES ON ALL LEDGES SUCH AS PIPES, SPRINKLER SYSTEMS, STEEL BEAMS, WINDOW SHUTTERS HEAD, HVAC EXHAUST HOODS, AC UNITS, ETC. and PVC AviAngle LEDGE SHIELD ON CONCRETE BEAM LEDGES. SEE SHEET S-9.1 FOR PVC AviAngle LEDGE SHIELD and ANTI BIRD SPIKES SPECIFICATIONS.	5 S-11.1 S-11.1

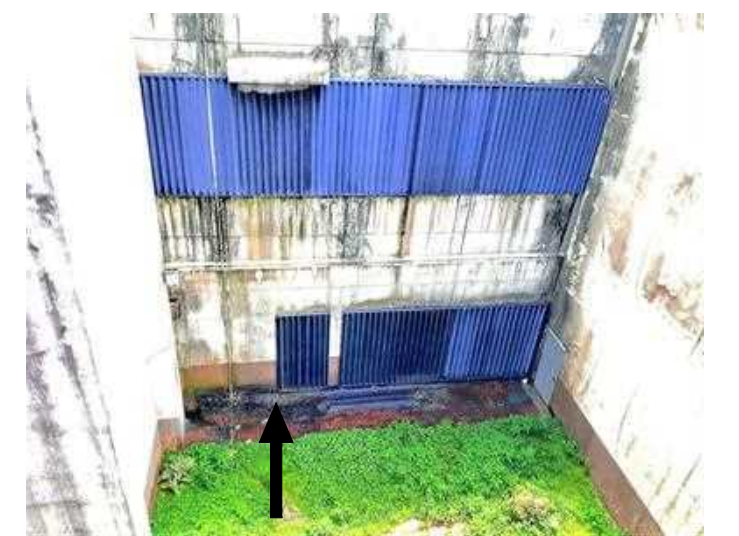
6e PHOTO
S-1.6.A S-1.6.A

BIRDS DROPPINGS PRESENT ON BEAM, HOODS, PIPES, DUCT WORK, SHUTTER HEAD, ETC. FROM LIGHT TO HEAVILY INFESTED NARROW TO EXTRA WIDE AREAS.

6	PROVIDE STAINLESS STEEL ANTI BIRD SPIKES ON ALL LEDGES SUCH AS PIPES, SPRINKLER SYSTEMS, STEEL BEAMS, WINDOW SHUTTERS HEAD, HVAC EXHAUST HOODS, AC UNITS, ETC. and PVC AviAngle LEDGE SHIELD ON CONCRETE BEAM LEDGES. SEE SHEET S-9.1 FOR PVC AviAngle LEDGE SHIELD and ANTI BIRD SPIKES SPECIFICATIONS.	5 S-11.1 S-11.1

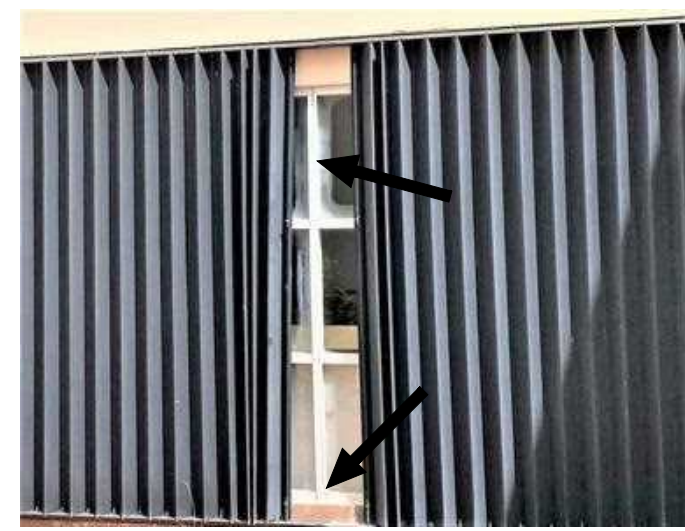
1e PHOTO
S-1.6.A S-1.6.A

DETERIORATED WINDOW SEALANT (112 lf) and SEAL (368 lf).

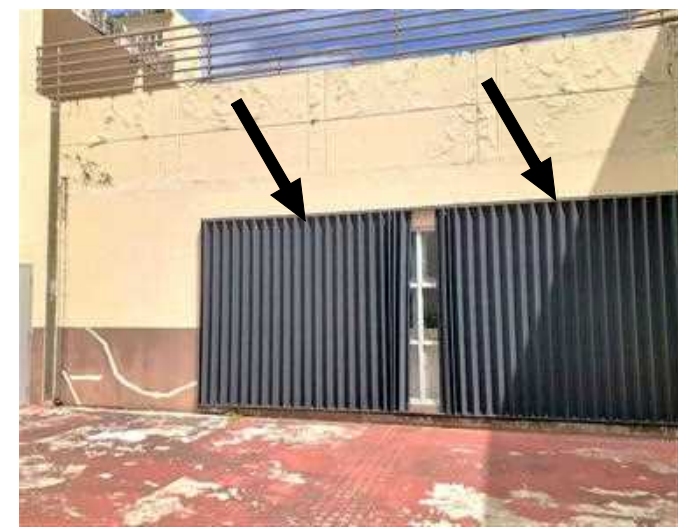
2e PHOTO
S-1.6.A S-1.6.A

DETERIORATED EXISTING TYPHOON SHUTTERS.

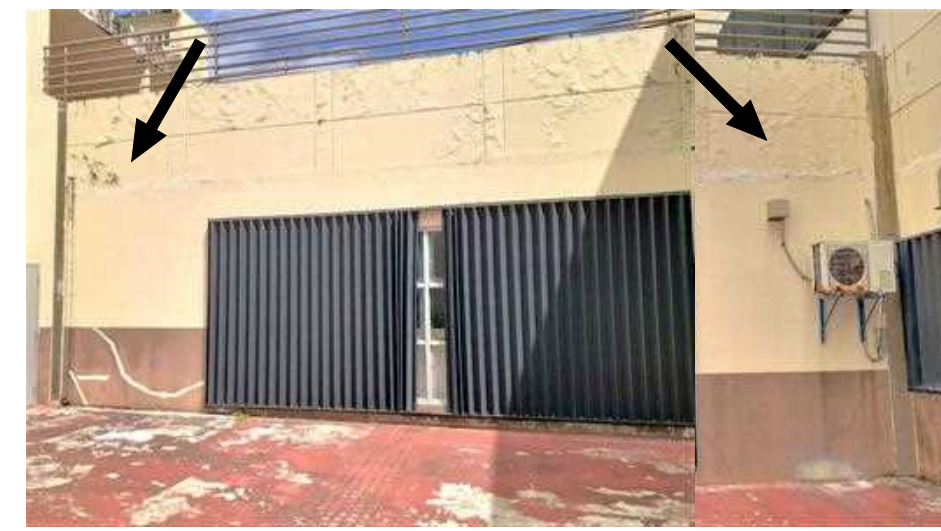
3e PHOTO
S-1.6.A S-1.6.A

DETERIORATED WALL PAINT (663 sf).

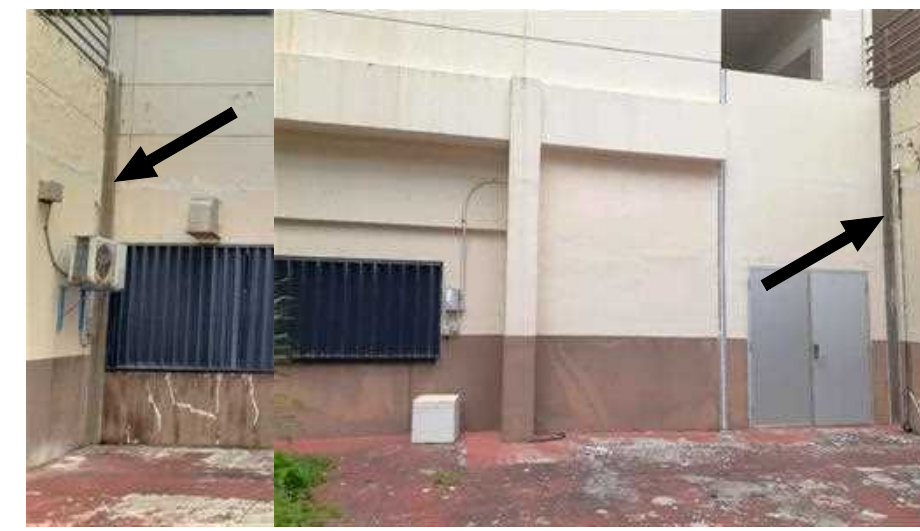
4e PHOTO
S-1.6.A S-1.6.A

DETERIORATED SEISMIC JOINT COVER (FLOOR, SIDES & CEILING) (36 lf).

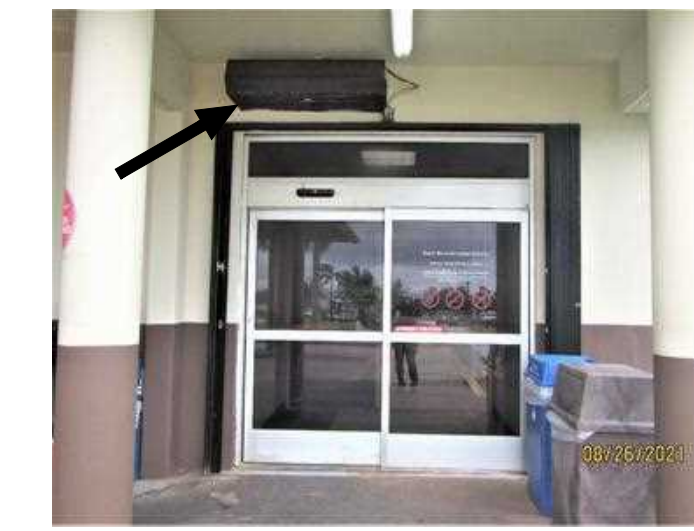
5e PHOTO
S-1.6.A S-1.6.A

DETERIORATED DOOR HEAD BLOWER.

5e S-1.6 S-1.6.A	DETERIORATED DOOR HEAD BLOWER.	REMOVE and REPLACE EXISTING DOOR HEAD BLOWER with NEW to MATCH EXISTING, SEE MECHANICAL PLAN and DETAIL.	
	6e S-1.6 S-1.6.A	DETERIORATED CEILING PAINT (12 sf).	CLEAN EXISTING SURFACES AND PROVIDE NEW PAINT ON CEILING, PER GMHA FACILITY STANDARD, TYPICAL.	
	7e S-1.6 S-1.6.A	DETERIORATED WALL PAINT AT PARAPET (544 sf).	WATERBLAST TO CLEAN EXISTING PARAPET WALL AND PROVIDE NEW PAINT, PER GMHA FACILITY STANDARD.	
	8e S-1.6 S-1.6.A	BIRDS DROPPINGS PRESENT ON BEAM, HOODS, PIPES, DUCT WORK, SHUTTER HEAD, ETC. FROM LIGHT TO HEAVILY INFESTED NARROW TO EXTRA WIDE AREAS.	PROVIDE STAINLESS STEEL ANTI BIRD SPIKES ON ALL LEDGES SUCH AS PIPES, SPRINKLER SYSTEMS, STEEL BEAMS, WINDOW SHUTTERS HEAD, HVAC EXHAUST HOODS, AC UNITS, ETC. and PVC AviAngle LEDGE SHIELD ON CONCRETE BEAM LEDGES. SEE SHEET S-9.1 FOR PVC AviAngle LEDGE SHIELD and ANTI BIRD SPIKES SPECIFICATIONS.	5 S-11.1 S-11.1

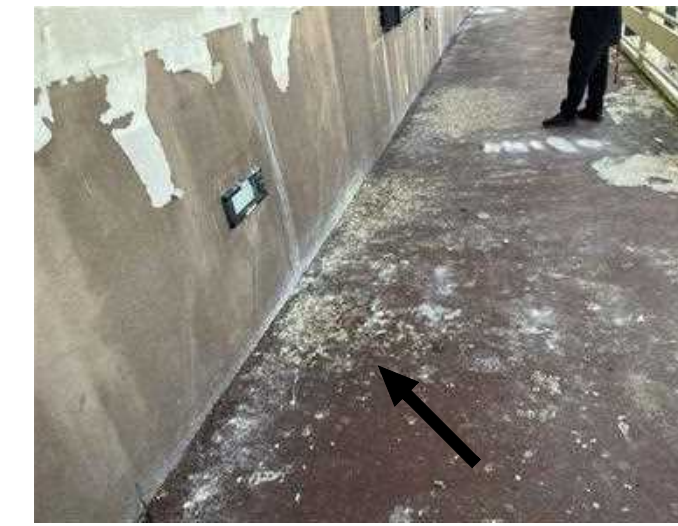
7e PHOTO
S-1.6.A S-1.6.A

DETERIORATED WALL PAINT AT PARAPET (544 sf).

7	WATERBLAST TO CLEAN EXISTING PARAPET WALL AND PROVIDE NEW PAINT, PER GMHA FACILITY STANDARD.	
	8	PROVIDE STAINLESS STEEL ANTI BIRD SPIKES ON ALL LEDGES SUCH AS PIPES, SPRINKLER SYSTEMS, STEEL BEAMS, WINDOW SHUTTERS HEAD, HVAC EXHAUST HOODS, AC UNITS, ETC. and PVC AviAngle LEDGE SHIELD ON CONCRETE BEAM LEDGES. SEE SHEET S-9.1 FOR PVC AviAngle LEDGE SHIELD and ANTI BIRD SPIKES SPECIFICATIONS.	5 S-11.1 S-11.1

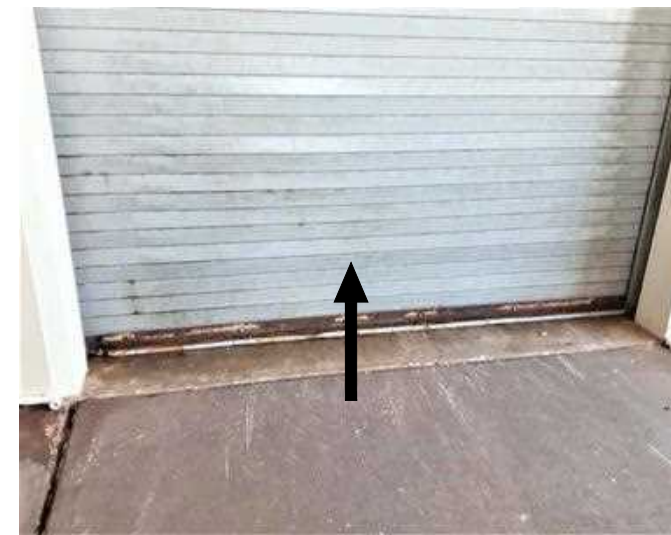
1e PHOTO
S-1.7 S-1.7.A

DETERIORATED DOORS, SEALANT (108 Lf), SEAL (62Lf) & DOOR THRESHOLD (12 Lf).

PHOTO KEY NOTES:			SCOPE of REPAIR WORKS:	
WING	PHOTO No.	DAMAGED DESCRIPTION	REPAIR METHODS	DETAIL SHOWN
F - WING FIRST FLOOR (EXTERIOR)	1e S-1.7 S-1.7.A	DETERIORATED DOORS, SEALANT (108 Lf), SEAL (62Lf) & DOOR THRESHOLD (12 Lf).	REMOVE EXISTING DOORS & REPLACE w/ NEW. SEE DOOR SCHEDULE ON SHEET S-1.7 and DETAIL.	1,2,3 S-8.1 S-8.1
	2e S-1.7 S-1.7.A	DETERIORATED ROLL-UP DOOR (128 Sf).	REMOVE EXISTING ROLL UP DOOR & REPLACE w/ NEW, SEE SCHEDULE ON SHEET S-1.7 and DETAILS.	1 S-11.1 S-11.1
	3e S-1.7 S-1.7.A	ALGAE, VEGETATION, and MILDEW on ELECTRICAL PIPE PRESENT.	WATERBLAST, CLEAN and REPAIR EXISTING CONDUIT to MATCH EXISTING, PER GMHA FACILITY STANDARD.	
	4e S-1.7 S-1.7.A	WALL OPENING DAMAGED COVER.	REMOVE EXISTING WALL OPENING COVER and REPLACE WITH NEW ORIGINAL MATERIAL COMPONENTS & ASSOCIATED ACCESSORIES.	
	5e S-1.7 S-1.7.A	WALL CORNER SPALLS w/ EXPOSED REBAR (12 Lf), (6 Sf).	SAWCUT and CHIP OFF EXISTING DAMAGED CONCRETE, WIRE BRUSH TO CLEAN EXISTING REBARS & REPAIR PATCH w/ EPOXY MORTAR, SEE DETAIL.	10 S-12.1 S-12.1

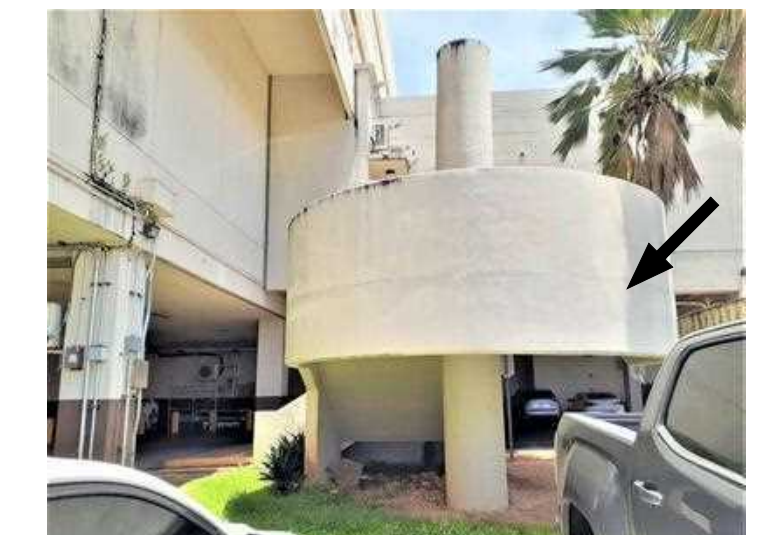
5e PHOTO
S-1.7 S-1.7.A

WALL CORNER SPALLS W/ EXPOSED REBAR (12 Lf), (6 Sf).

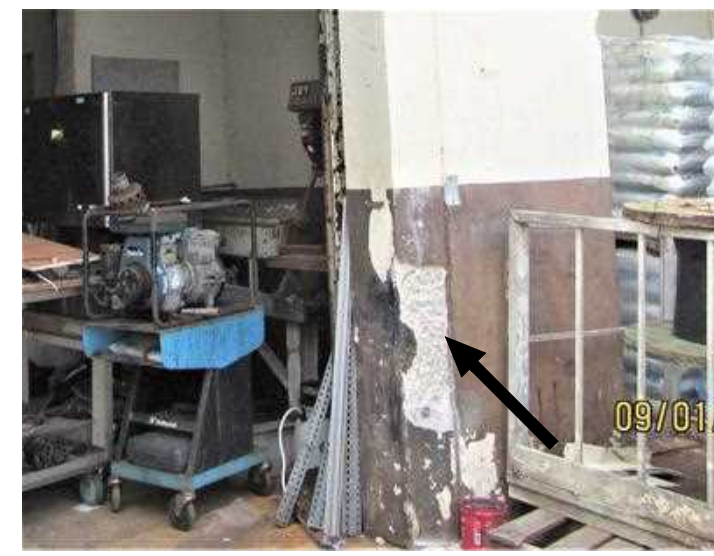
1e PHOTO
S-1.8.A S-1.8.A

DETERIORATED WALL PAINT w/ CONCRETE CORNER SPALLS (16 sf).

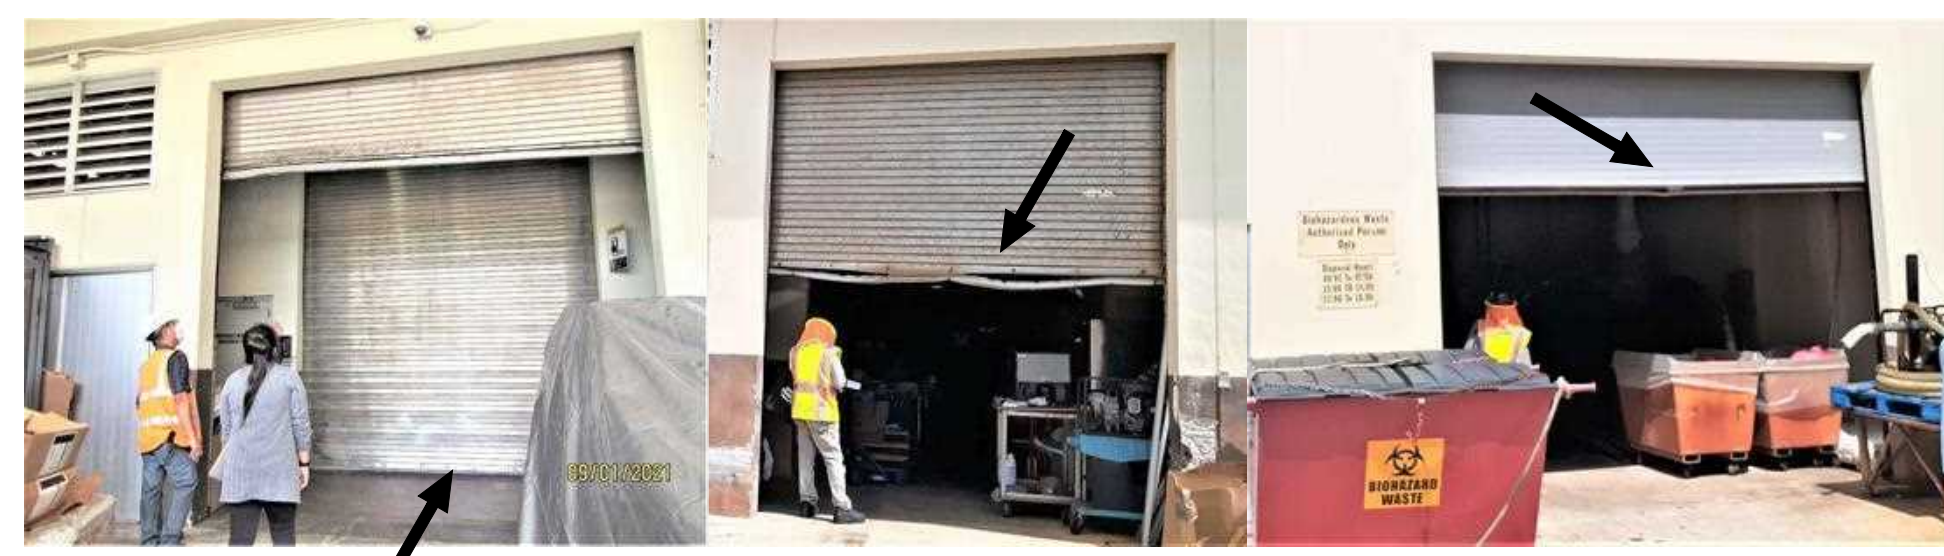
2e PHOTO
S-1.8.A S-1.8.A

DETERIORATED OR DAMAGED ROLL-UP DOORS, 5 ea (654 sf).

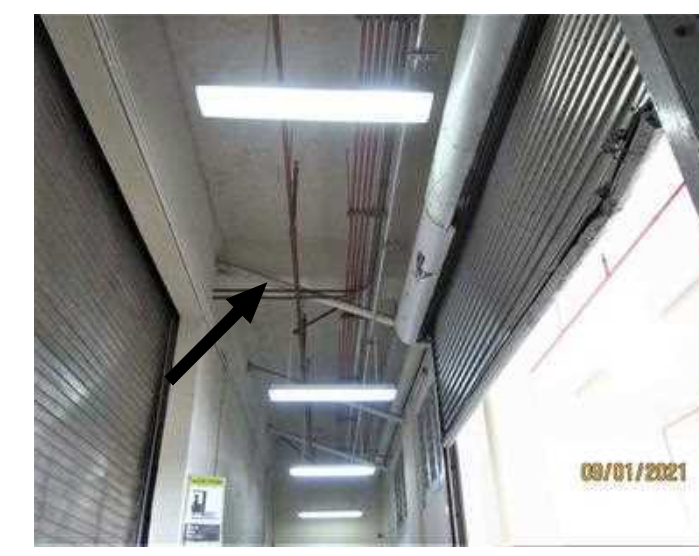
4e PHOTO
S-1.8.A S-1.8.A

DETERIORATED STEEL TUBING WALL BRACE (6 ea).

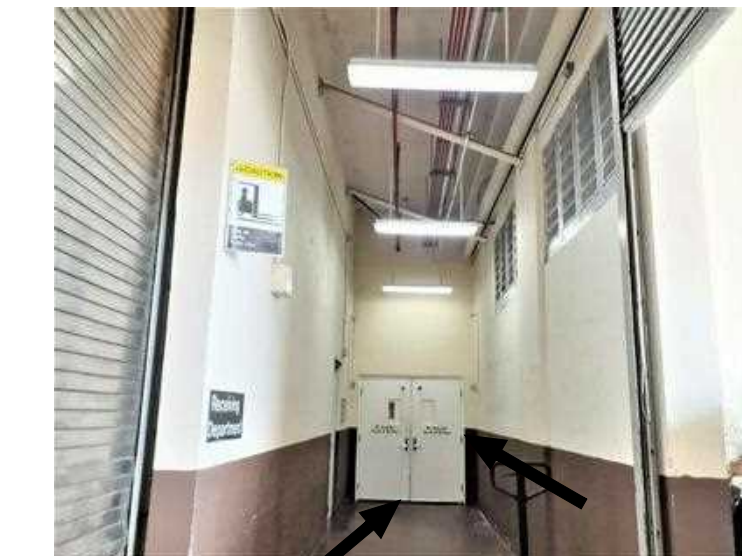
5e PHOTO
S-1.8.A S-1.8.A

DETERIORATED DOOR THRESHOLD (6 lf). FAILED DOOR SEAL (40 lf).
