DRAWING INDEX

REV	DATE	BY	DESCRIPTION
GMHA NO. _____ GRANT ID NO. _____ CONTRACT NO. _____ PROJECT NO. _____		PROJECT: GMHA HOSPITAL AND ENVELOPE UPGRADE PROJECT	
DES. BY: kje DRN. BY: jl CHK. BY: rmca		CHIEF ENGR: - ENGR. SUP: - PROJ. ENGR: -	
I HEREBY CERTIFY THAT THIS PLAN WAS PREPARED BY ME OR UNDER MY DIRECT SUPERVISION DATE: 07-31-2024		CONTENTS: FIRST FLOOR PLAN _ A-WING: DAMAGED LOCATIONS, PHOTO KEY NOTES, SCOPE OF REPAIR WORKS, NOTES, and KEY PLAN	
DRAWING NO. S-1.2.1		SH. 07 OF 60

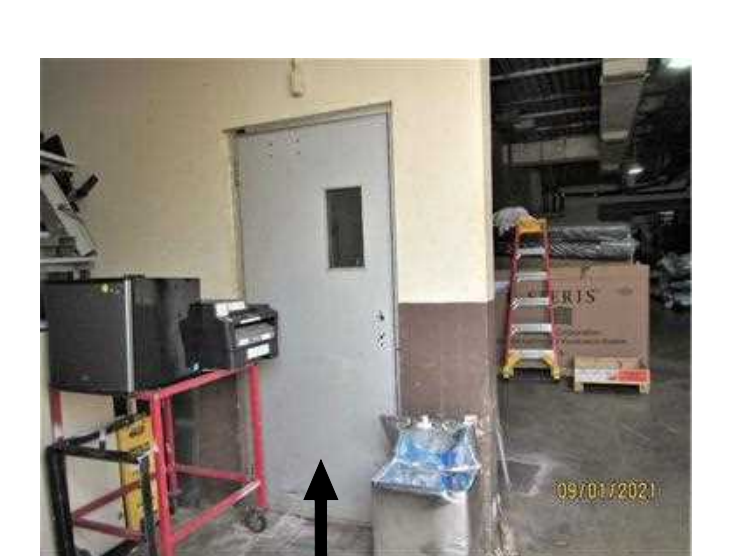
7e PHOTO
S-1.8.A S-1.8.A

DETERIORATED SINGLE DOOR INCLUDING ACCESSORIES.

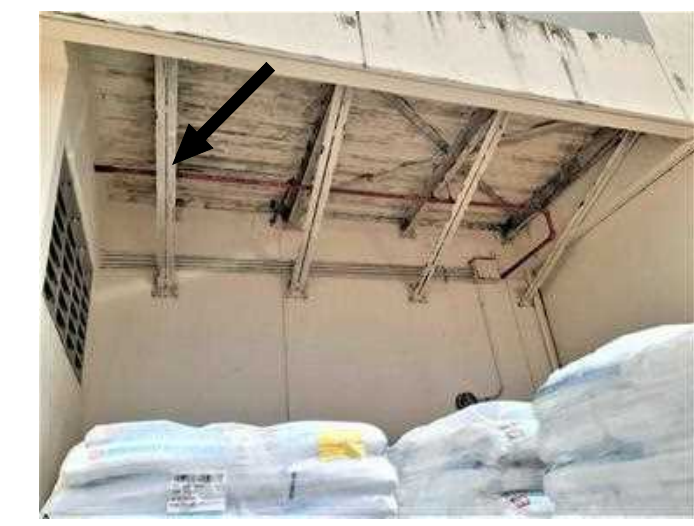
8e PHOTO
S-1.8.A S-1.8.A

DETERIORATED STEEL ROOF TRUSSES (12 ea).

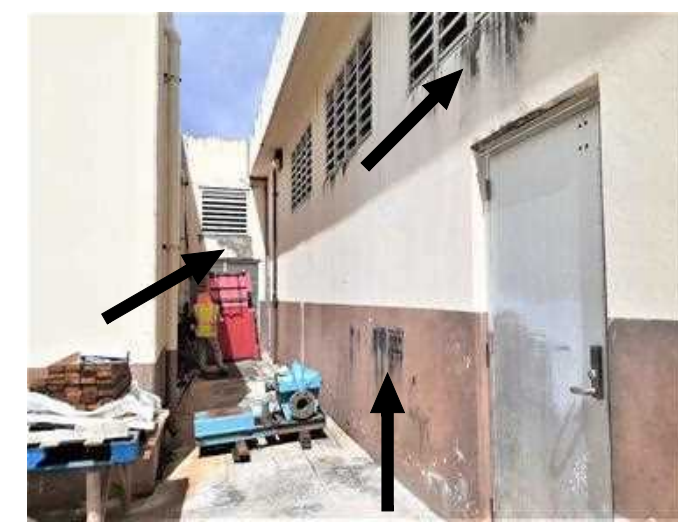
9e PHOTO
S-1.8.A S-1.8.A

DETERIORATED WALL PAINTS (900 sf).

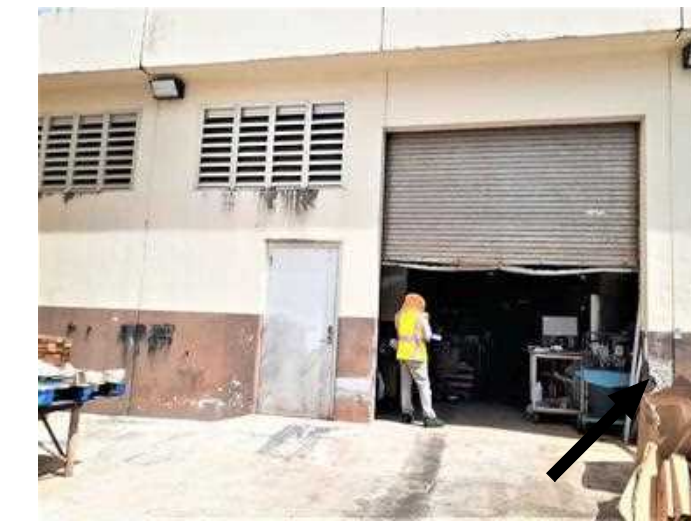
10e PHOTO
S-1.8.A S-1.8.A

CONCRETE WALL SPALLS (16 sf).

10	SAWCUT DAMAGED SPALLS, CHIP OFF TO SOUND CONCRETE CLEAN & PATCH w/ EPOXY MORTAR, TYPICAL.	(10) S-12.1 S-12.1
	11	WIRE BRUSH OR GRIND DAMAGED AREAS OF EXISTING METAL DECKING, REPAIR and APPLY with NEW EPOXY PATCH, PAINTED.	
	12	SAWCUT DAMAGED SPALLS, CHIP OFF TO SOUND CONCRETE CLEAN & PATCH w/ EPOXY MORTAR, TYPICAL.	(3,10) S-12.1 S-12.1
	13	REMOVE EXISTING WINDOW LOUVERS and ITS ACCESSORIES and REPLACE with NEW ALUMINUM TYPHOON PROOF WINDOW LOUVERS.	(4,5,6) S-9.1 S-9.1
	14	REMOVE EXISTING WINDOW EXHAUST HOOD and REPLACE with NEW SSTL HOOD to MATCH EXISTING, SEE MECHANICAL PLAN and DETAIL.	
	15	WATERBLAST TO CLEAN PARAPET WALL SURFACES and PROVIDE NEW PAINT, PER GMHA FACILITY STANDARD.	
	16	PROVIDE NEW EXHAUST HOOD COVER AS REQUIRED, REFER TO MECHANICAL DRAWINGS.	
	17	PRESSURE WASH TO CLEAN ELECTRICAL CONDUIT and PROVIDE NEW PAINT, PER GMHA FACILITY STANDARD.	
	18	WATERBLAST TO CLEAN WALL SURFACES and PROVIDE NEW PAINT, PER GMHA FACILITY STANDARD.

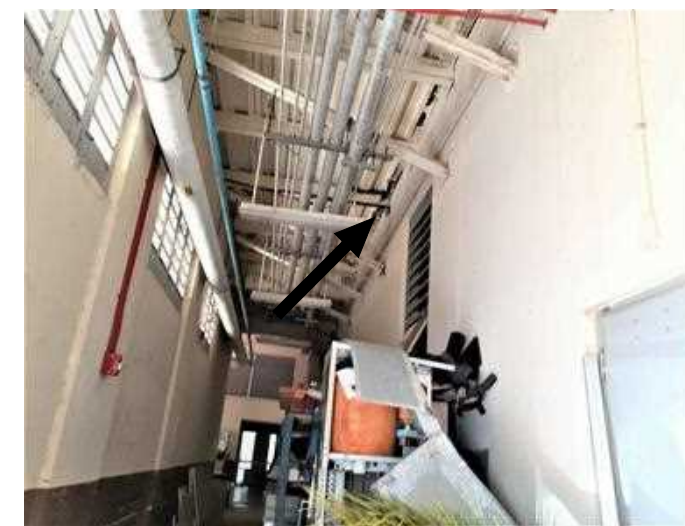
11e PHOTO
S-1.8.A S-1.8.A

DETERIORATED AND RUSTED METAL DECKING (597 sf).

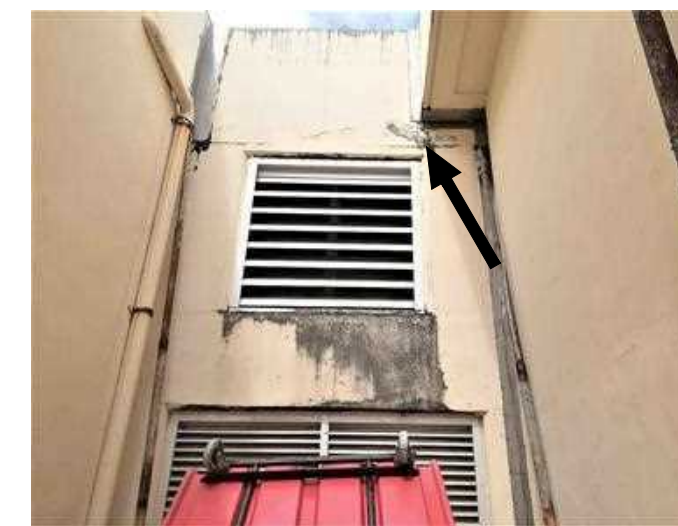
12e PHOTO
S-1.8.A S-1.8.A

CONCRETE WALL SPALLS AND CRACKS

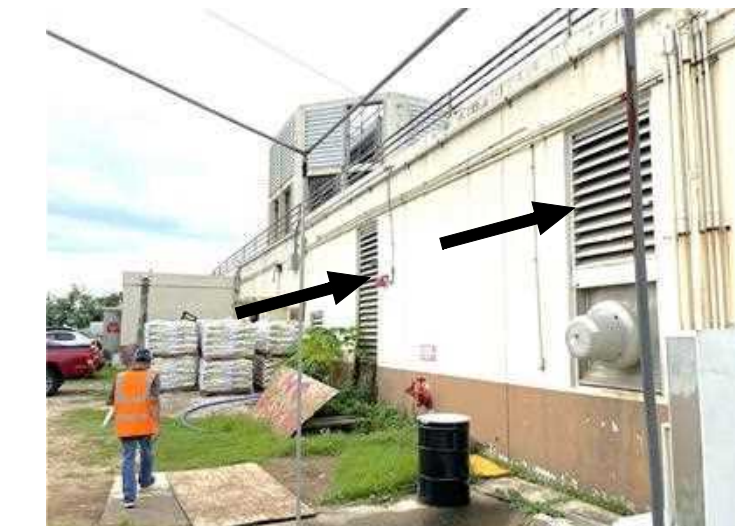
13e PHOTO
S-1.8.A S-1.8.A

DETERIORATED WINDOW LOUVERS.

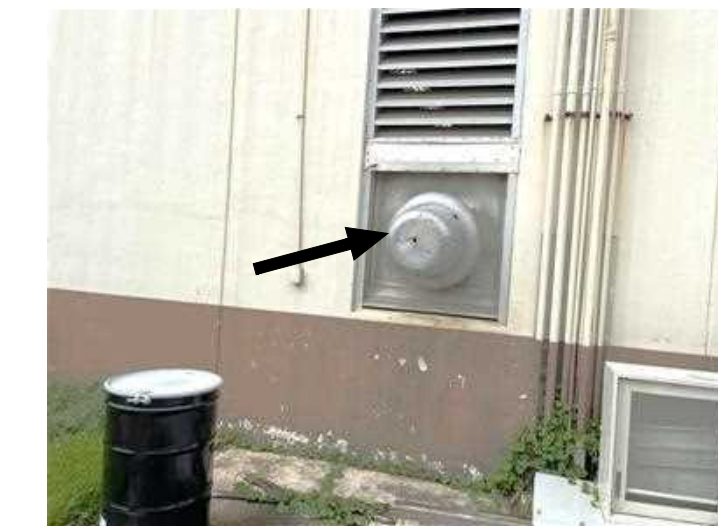
14e PHOTO
S-1.8.A S-1.8.A

DETERIORATED EXHAUST HOODS.

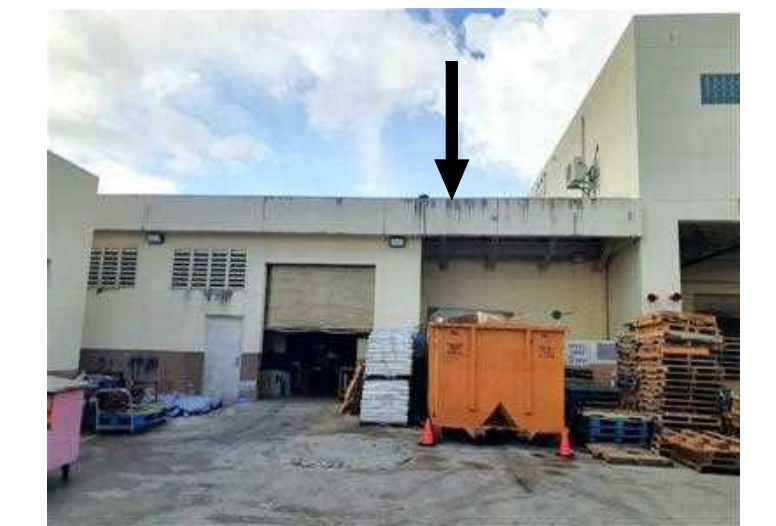
15e PHOTO
S-1.8.A S-1.8.A

DETERIORATED PERIMETER PARAPET PAINT

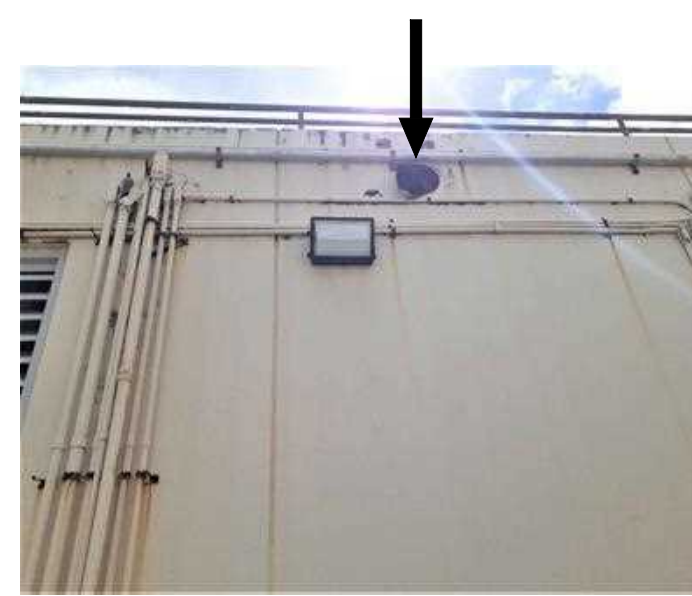
16e PHOTO
S-1.8.A S-1.8.A

WALL EXHAUST MISSING

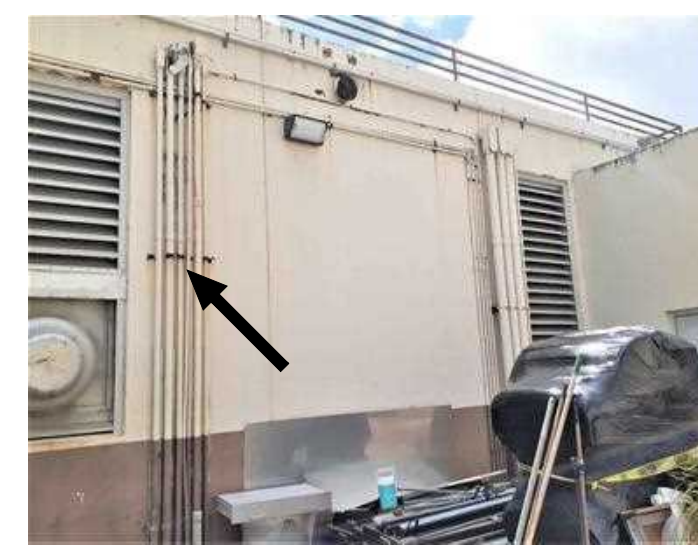
17e PHOTO
S-1.8.A S-1.8.A

DETERIORATED ELECTRICAL CONDUITS with MILDEWS.

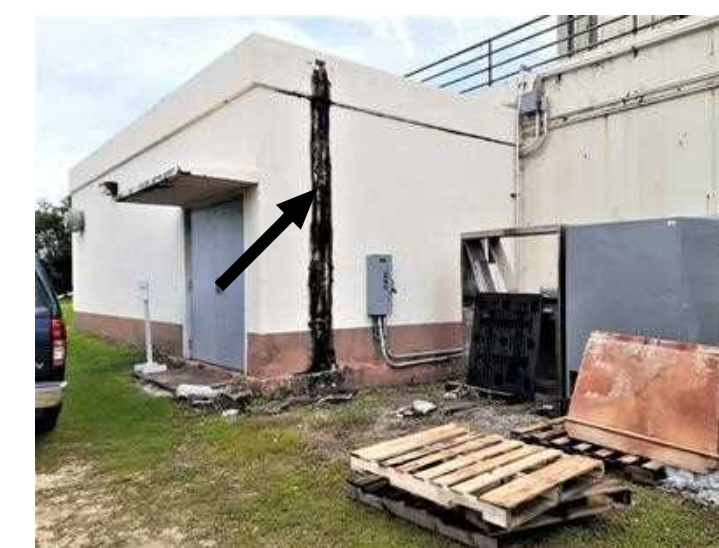
18e PHOTO
S-1.8.A S-1.8.A

SEVERE MILDEW AT WALL (180 sf).

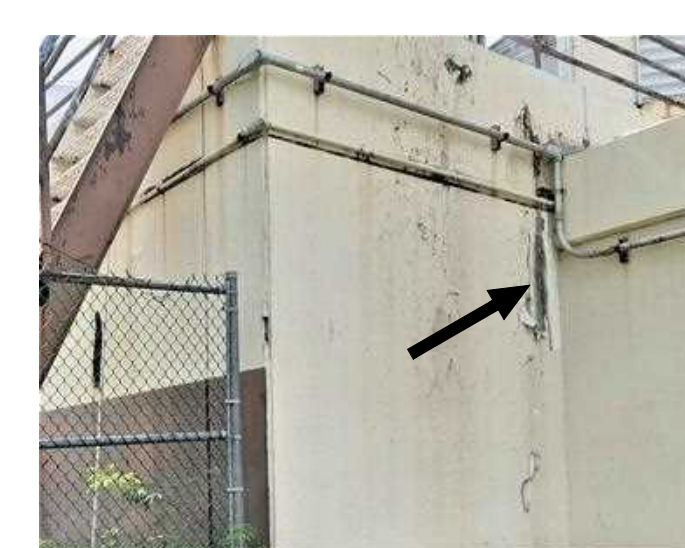
19e PHOTO
S-1.8.A S-1.8.A

WALL PAINT FLAKING (52 sf).

19	WATERBLAST SCRAPE OFF PAINT FLAKING, CLEAN and PATCH w/ EPOXY BASE SPAKING COMPOUND TO RECEIVE NEW PAINT.	
	20	SAWCUT and CHIP-OFF DAMAGED AREA TO A SOUND CONCRETE and PATCH WITH EPOXY MOTAR. PROVIDE NEW PAINT FINISH.	
	21	REMOVE EXISTING STEEL STAIRS & ITS ACCESSORIES and PROVIDE WITH NEW, SEE STAIR DETAILS.	(1) S-10.1 S-10.1
	22	REMOVE EXISTING DOOR & ITS ACCESSORIES AND REPLACE w/ NEW. CHIP-OFF DAMAGED CONCRETE SPALLS & PATCH w/ EPOXY MORTAR.	(10) S-12.1 S-12.1, (1,2,3) S-8.1 S-8.1
	23	REMOVE EXISTING DOOR & ITS ACCESSORIES and REPLACE w/ NEW. COODINATE SAFETY HARDWARE w/ HOSPITAL SECURITY SYSTEM.	(1,2,3) S-8.1 S-8.1
	24	SAWCUT and CHIP-OFF DAMAGED AREA TO A SOUND CONCRETE and PATCH WITH EPOXY MOTAR. PROVIDE NEW PAINT FINISH.	(2) S-12.1 S-12.1
	25	SAWCUT and CHIP-OFF DAMAGED AREA TO A SOUND CONCRETE and PATCH WITH EPOXY MOTAR. PROVIDE NEW PAINT FINISH.	(7) S-12.1 S-12.1
	26	WATERBLAST TO CLEAN CANOPY SURFACES and PROVIDE NEW PAINT, PER GMHA FACILITY STANDARD.

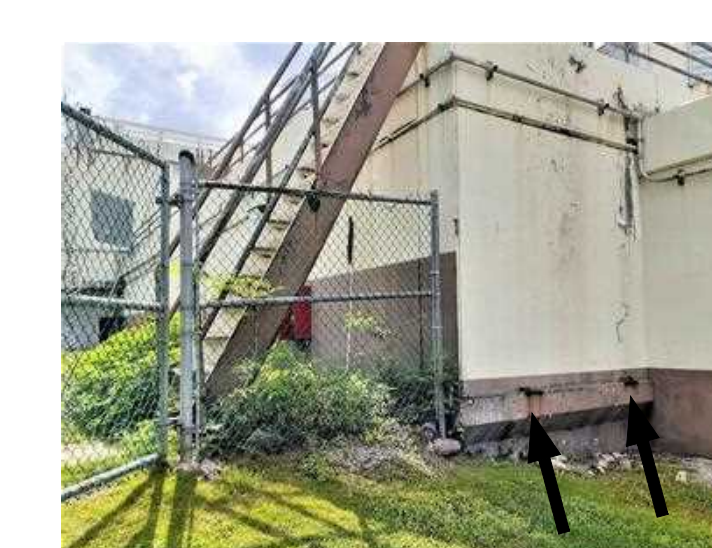
20e PHOTO
S-1.8.A S-1.8.A

FLOOR GRADE BEAM SPALLS (2 sf).

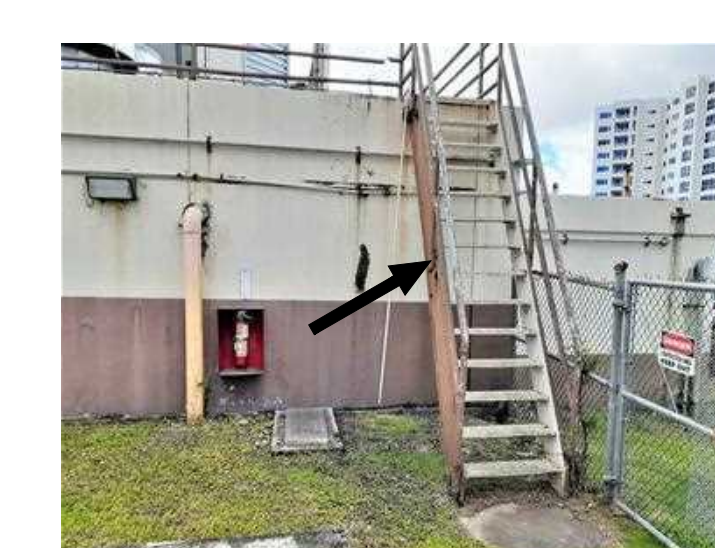
21e PHOTO
S-1.8.A S-1.8.A

DETERIORATED ACCESS STEEL STAIRS.

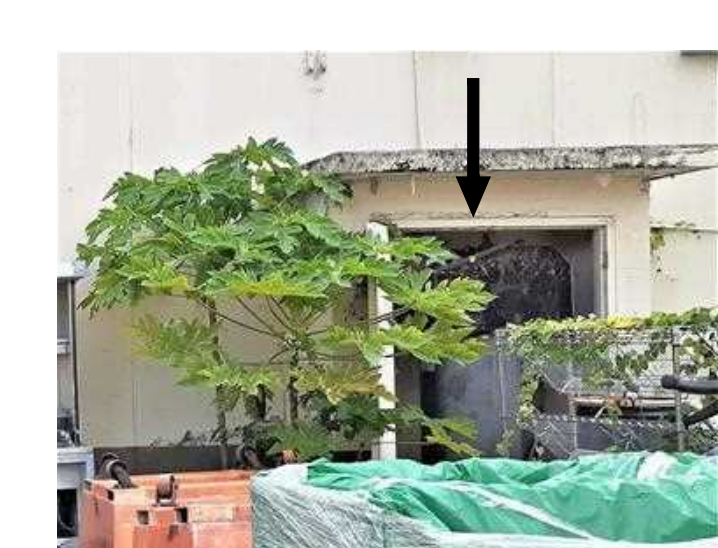
22e PHOTO
S-1.8.A S-1.8.A

DAMAGED DOOR, HEADER & ACCESSORIES w/ CONCRETE SPALLS ON WALL & ROOF CANOPY.

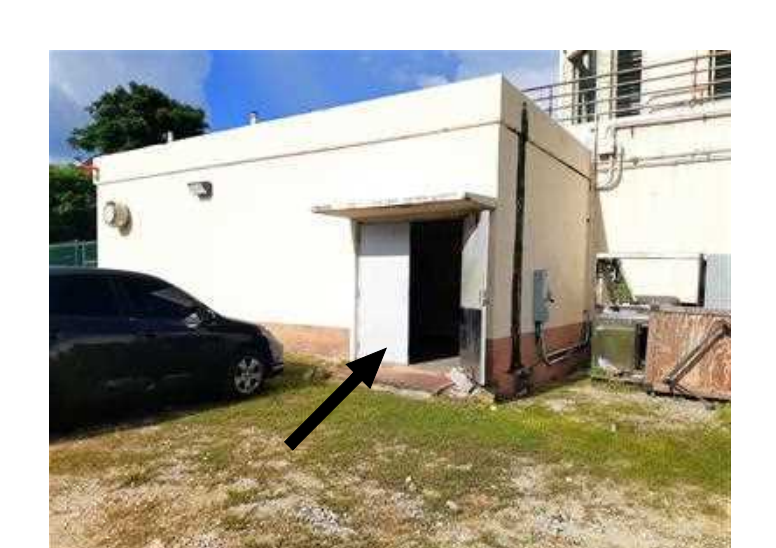
23e PHOTO
S-1.8.A S-1.8.A

FAILED DAMAGED DOOR.

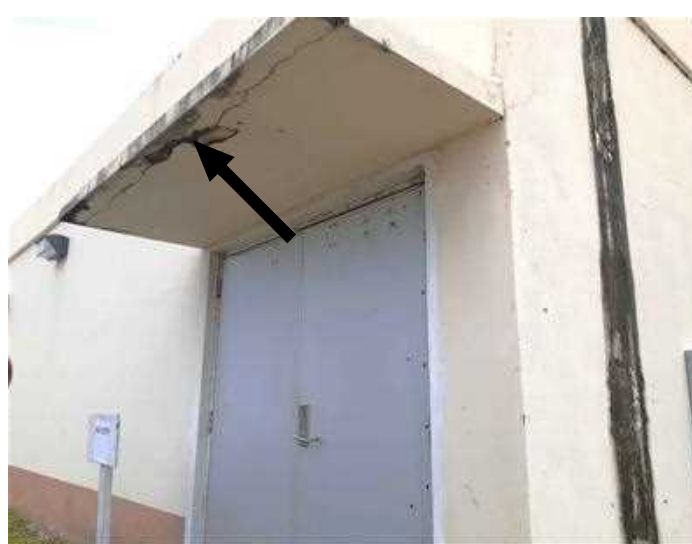
24e PHOTO
S-1.8.A S-1.8.A

CONCRETE CRACKS & SPALLS ON CANOPY.

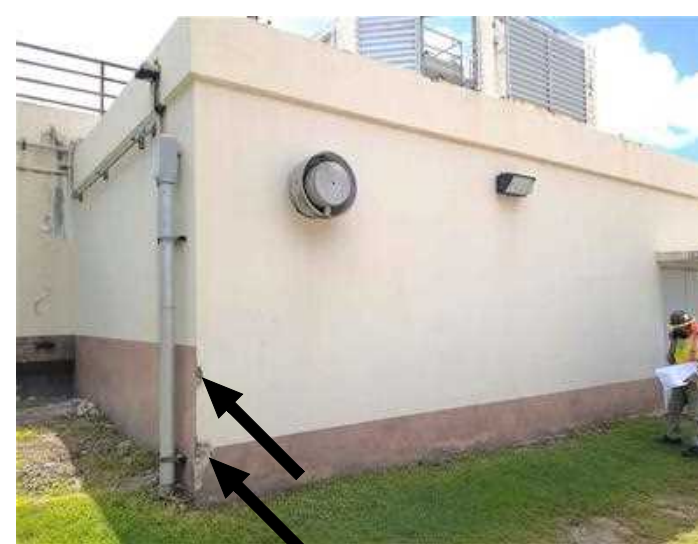
25e PHOTO
S-1.8.A S-1.8.A

CORNER SPALLS (2 lf).

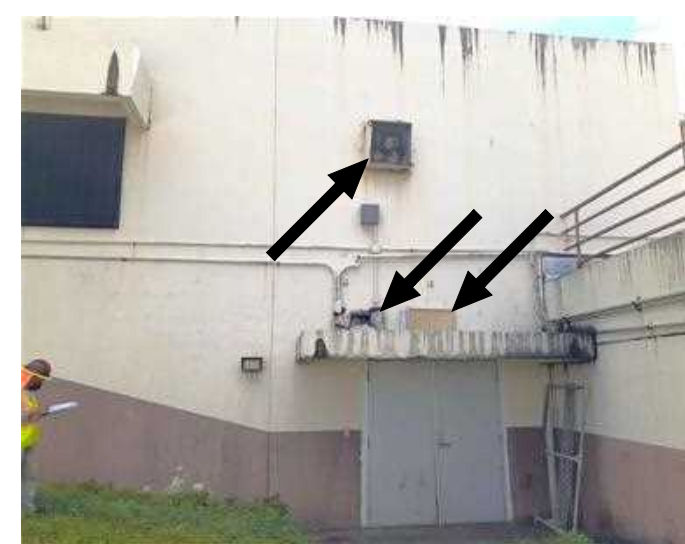
26e PHOTO
S-1.8.A S-1.8.A

DETERIORATED CANOPY PAINTS.

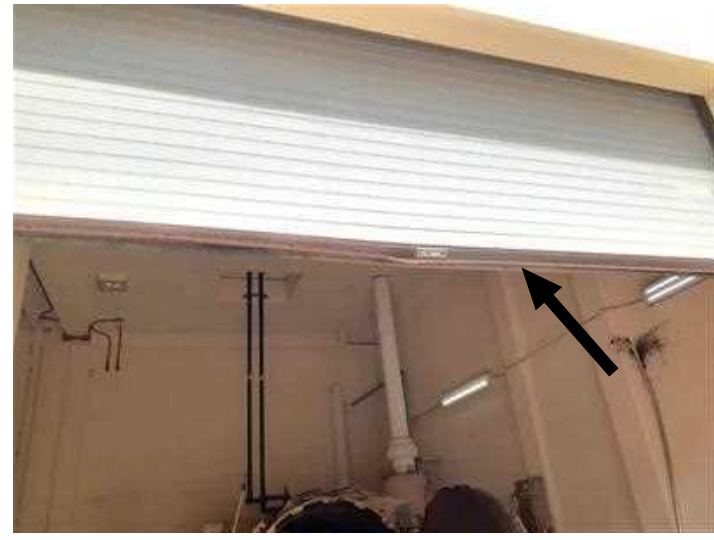
1e PHOTO
S-1.1 | S-1.9.A

DETERIORATED OR DAMAGED ROLL-UP DOORS.

PHOTO KEY NOTES:			SCOPE of REPAIR WORKS:	
WING	PHOTO No.	DAMAGED DESCRIPTION	REPAIR METHODS	DETAIL SHOWN
GEN-WING FIRST FLOOR (EXTERIOR)	1e S-1.8 S-1.8.A	DETERIORATED OR DAMAGED ROLL-UP DOORS.	REMOVE EXISTING ROLL-UP DOOR & ITS ACCESSORIES & REPLACE , TYP TO 6 PLACES, SEE SCHEDULE.	1,2,3 S-11.1 S-11.1
	2e S-1.8 S-1.8.A	DETERIORATED SINGLE DOOR INCLUDING ACCESSORIES (3 ea).	REMOVE EXISTING DOOR & ITS ACCESSORIES and REPLACE w/ NEW. COORDINATE SAFETY HARDWARE w/ HOSPITAL SECURITY SYSTEM.	1,2,3 S-8.1 S-8.1
	3e S-1.8 S-1.8.A	DETERIORATED STEEL ROOF TRUSSES (12 ea).	REMOVE EXISTING STEEL TRUSSES INCLUDING PLATE, BOLTS/WASHERS and REPLACE WITH NEW HOT-DIPPED GALVANIZED, PAINTED.	
	4e S-1.8 S-1.8.A	DETERIORATED WALL PAINTS (90 sf).	WATERBLAST TO CLEAN EXISTING WALL and PROVIDE NEW PAINT, PER GMHA FACILITY STANDARD.	
	5e S-1.8 S-1.8.A	CONCRETE WALL SPALLS AND CRACKS (24 Sf).	SAWCUT DAMAGED SPALLS, CHIP OFF TO SOUND CONCRETE CLEAN & PATCH w/ EPOXY MORTAR, TYPICAL.	3,10 S-12.1 S-12.1

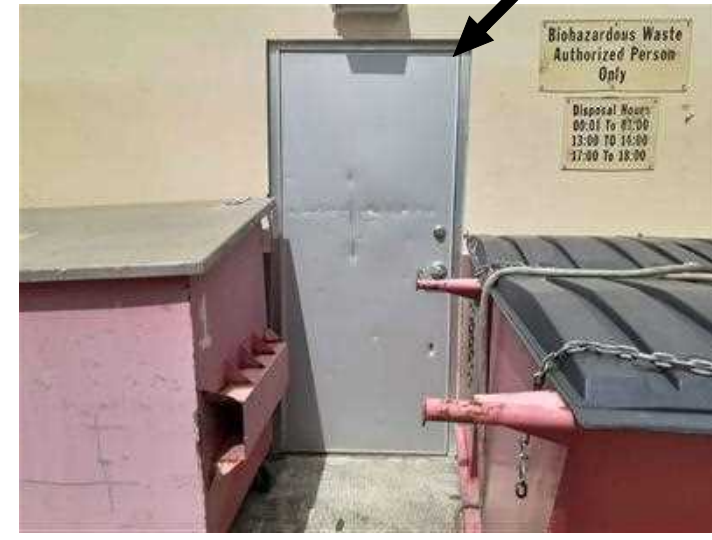
2e PHOTO
S-1.1 | S-1.9.A

DETERIORATED SINGLE DOOR INCLUDING ACCESSORIES (3 ea).

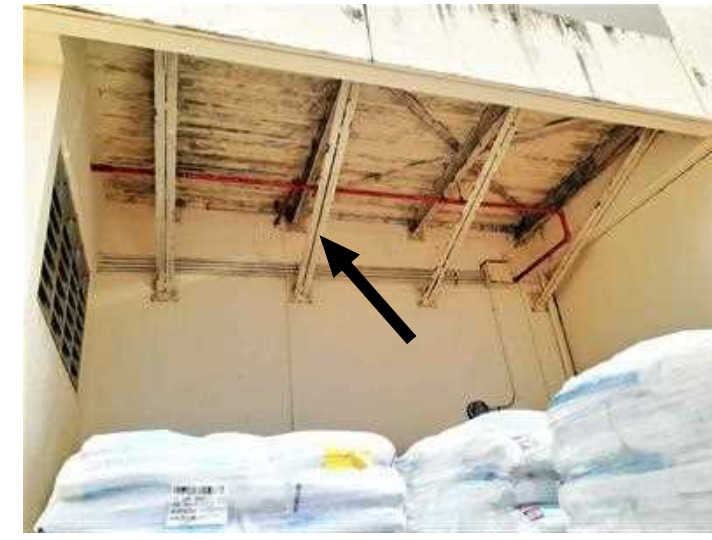
3e PHOTO
S-1.1 | S-1.9.A

DETERIORATED STEEL ROOF TRUSSES (12 ea).

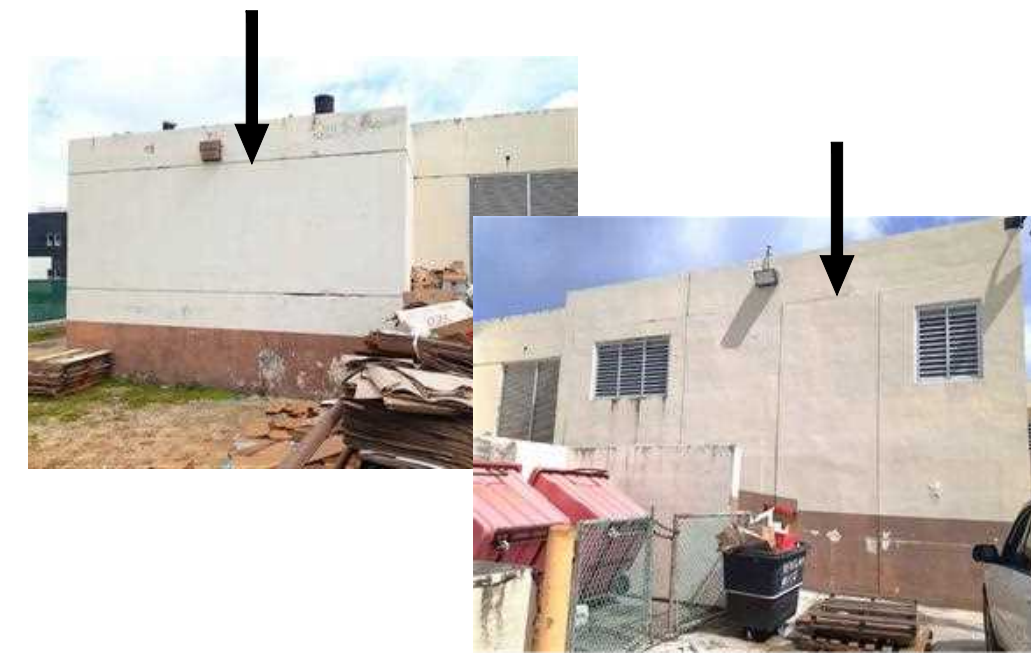
4e PHOTO
S-1.1 | S-1.9.A

DETERIORATED WALL PAINTS (90 sf).

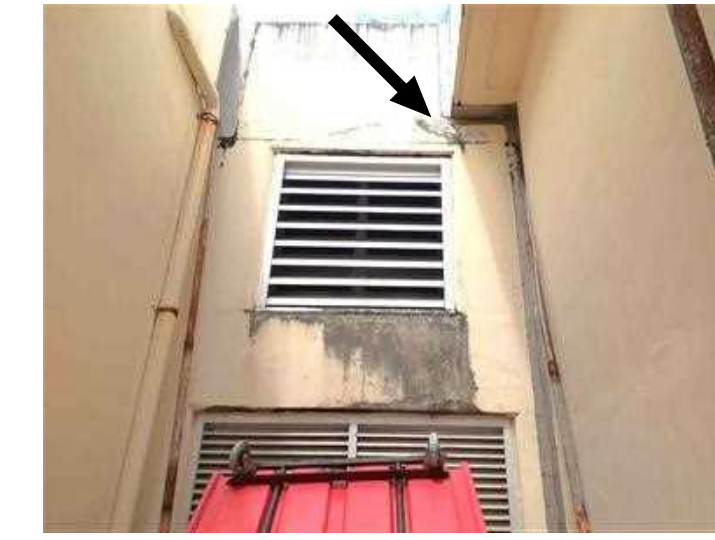
5e PHOTO
S-1.1 | S-1.9.A

CONCRETE WALL SPALLS AND CRACKS (24 Sf).

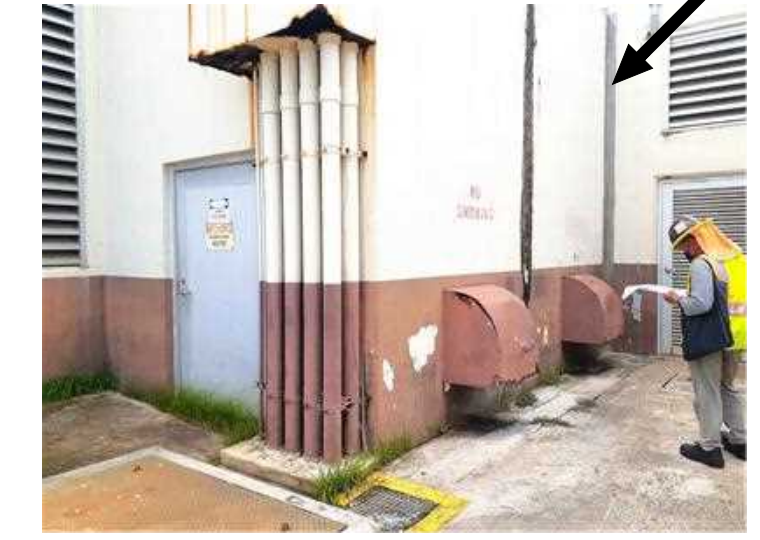
6e PHOTO
S-1.1 | S-1.9.A

DETERIORATED CONSTRUCTION JOINT COVER (10 lf).

6e S-1.8 S-1.8.A	DETERIORATED CONSTRUCTION JOINT COVER (10 lf).	REMOVE EXISTING DAMAGED JOINT COVER and REPLACE w/ NEW. SEE TYPICAL DETAIL.	1 S-14.1 S-14.1
	7e S-1.8 S-1.8.A	DETERIORATED METAL HOODS (3 ea).	REMOVE EXISTING WALL MOUNTED HOOD & PROVIDE WITH NEW, SEE MECHANICAL PLAN and DETAIL.	
	8e S-1.8 S-1.8.A	DETERIORATED LOUVERED DOOR	REMOVE EXISTING LOUVERED DOOR & ITS APPURTENANCES & PROVIDE WITH NEW, SEE DETAIL.	5,6 S-8.1 S-8.1
	9e S-1.8 S-1.8.A	DETERIORATED PERIMETER PARAPET PAINT.	WATERBLAST TO CLEAN PARAPET WALL SURFACES and PROVIDE NEW PAINT, PER GMHA FACILITY STANDARD.	
	10e S-1.8 S-1.8.A	DETERIORATED and RUSTED METAL DECKING (597 sf).	WIRE BRUSH OR GRIND DAMAGED AREAS OF EXISTING METAL DECKING REPAIR and APPLY with NEW EPOXY PATCH, PAINTED.

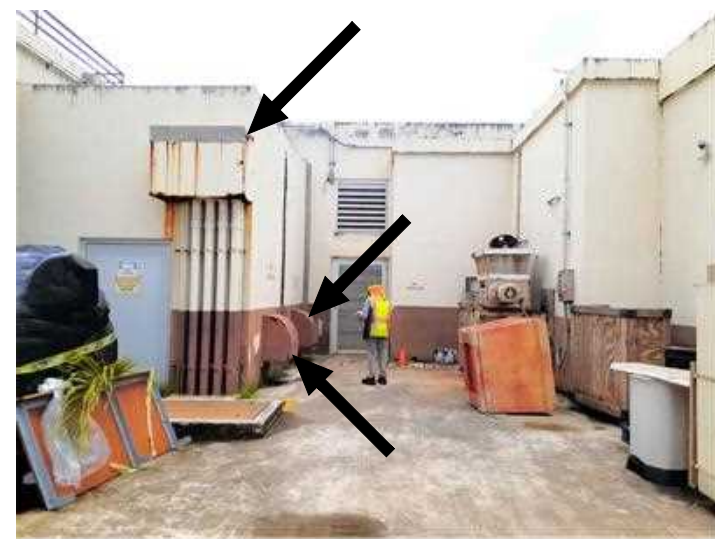
7e PHOTO
S-1.1 | S-1.9.A

DETERIORATED METAL HOODS (3 ea).

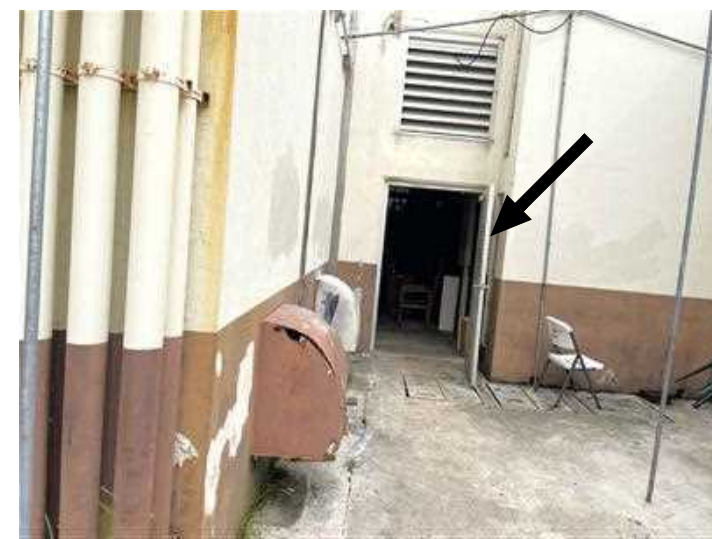
8e PHOTO
S-1.1 | S-1.9.A

DETERIORATED LOUVERED DOOR

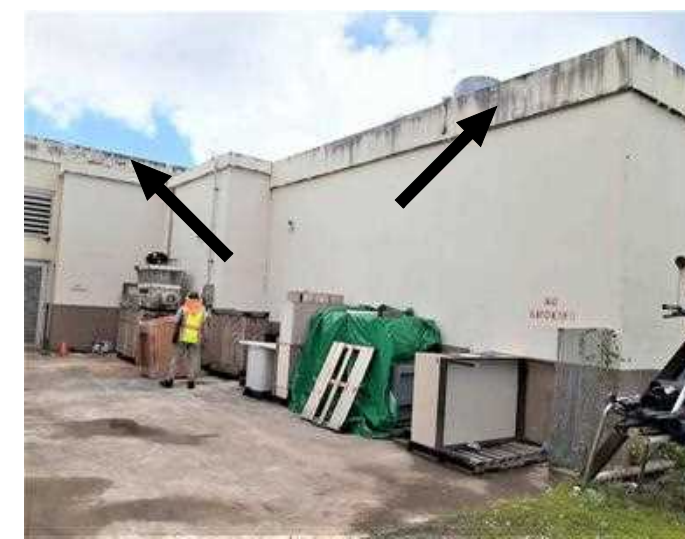
9e PHOTO
S-1.1 | S-1.9.A

DETERIORATED PERIMETER PARAPET PAINT, TYPICAL.

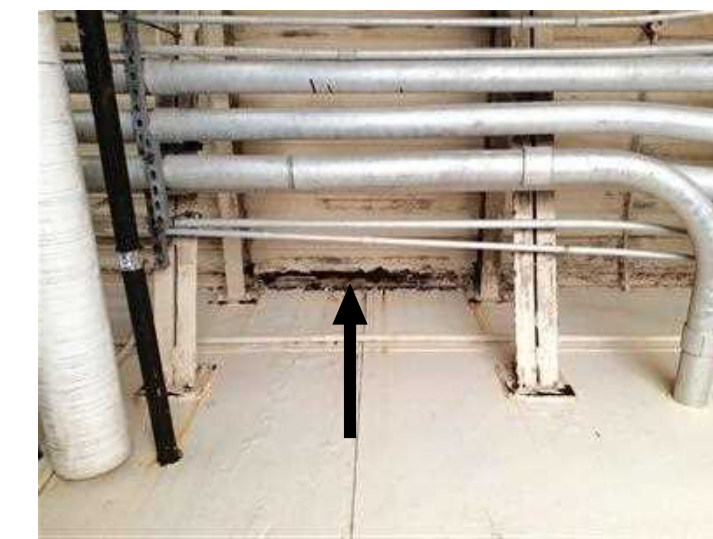
10e PHOTO
S-1.1 | S-1.9.A

DETERIORATED and RUSTED METAL DECKING (597 sf).

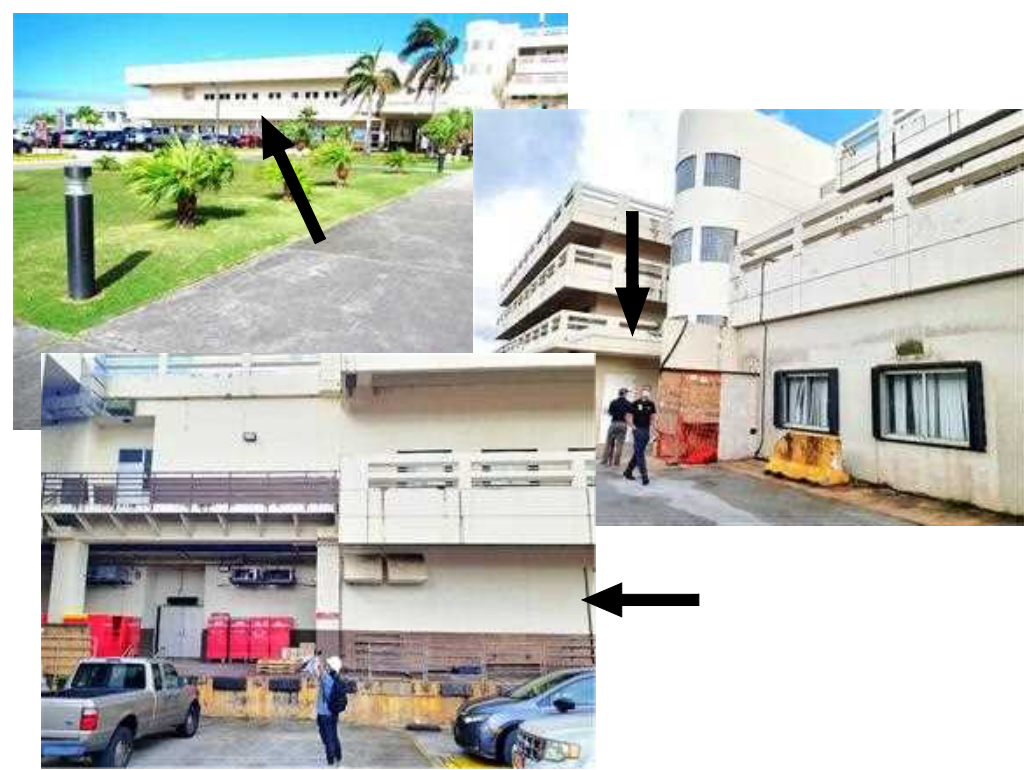
1e PHOTO
S-6.1 S-6.1.A

DETERIORATED WALLS, and PARAPET WALL PAINTS.

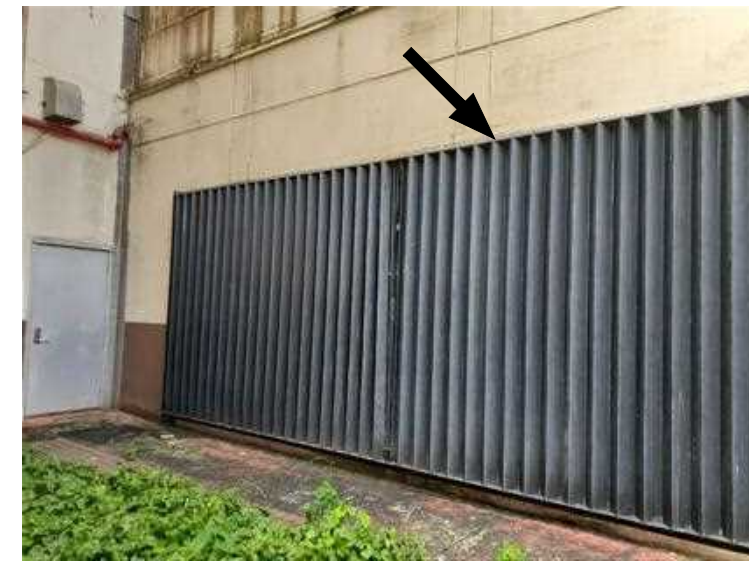
2e PHOTO
S-6.1 S-6.1.A

DETERIORATED WINDOW SHUTTERS

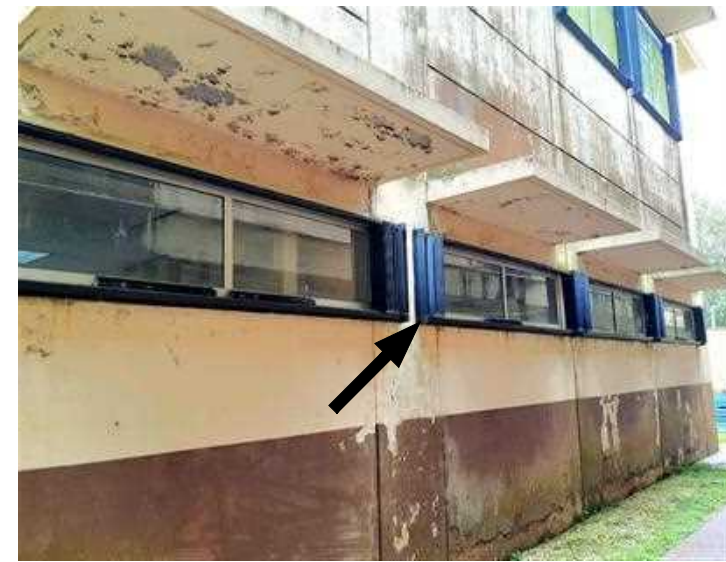
3e PHOTO
S-6.1 S-6.1.A

DETERIORATED WINDOW ACCORDION SHUTTERS

3	REMOVE EXISTING WINDOW ACCORDION SHUTTERS and ITS ACCESSORIES and REPLACE WITH NEW ALUMINUM ACCORDION SHUTTER, TYPICAL AT EXTERIOR CORRIDORS. REFER TO GMHA FOR COLOR SELECTION.			9	REMOVE EXISTING WINDOW LOUVERS and REPLACE WITH NEW TYPHOON PROOF WINDOW LOUVER, TYPICAL.	4,5,6 S-9.1 S-9.1
	4	REMOVE EXISTING DOOR HEAD BLOWER and REPLACE WITH NEW STAINLESS STEEL HOOD TO MATCH EXISTING, SEE MECHANICAL PLAN and DETAIL.					
	5	REMOVE EXISTING WALL EXHAUST HOOD and REPLACE WITH NEW STAINLESS STEEL HOOD TO MATCH EXISTING, SEE MECHANICAL PLAN and DETAIL.					
	6	REMOVE EXISTING WALL EXHAUST HOOD and REPLACE WITH NEW STAINLESS STEEL HOOD TO MATCH EXISTING, SEE MECHANICAL PLAN and DETAIL.

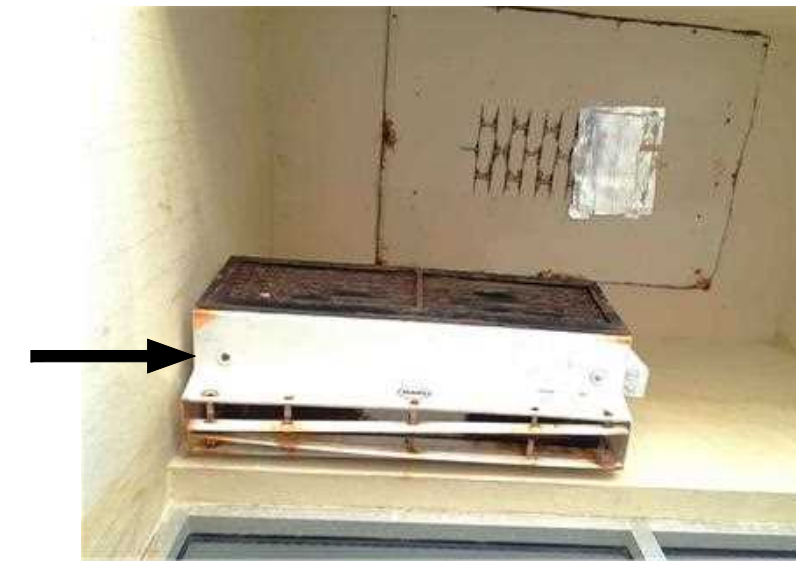
4e PHOTO
S-6.1 S-6.1.A

DETERIORATED DOOR HEAD BLOWER.

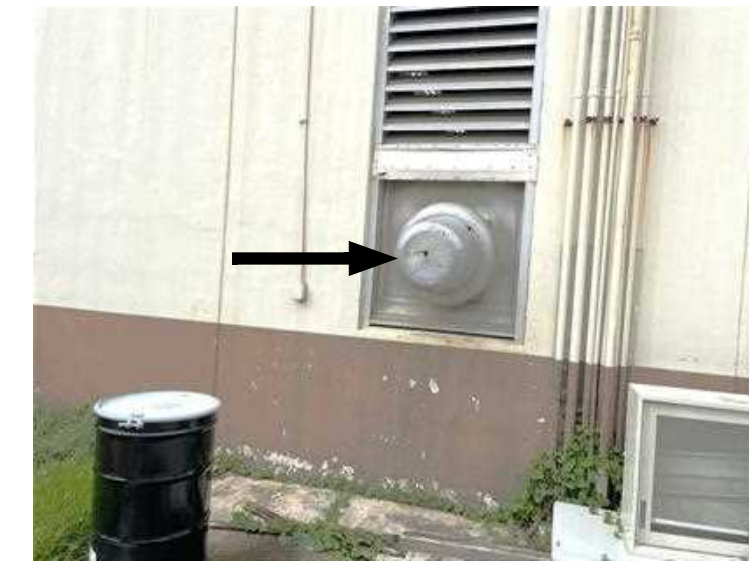
5e PHOTO
S-6.1 S-6.1.A

DETERIORATED WALL EXHAUST HOOD.

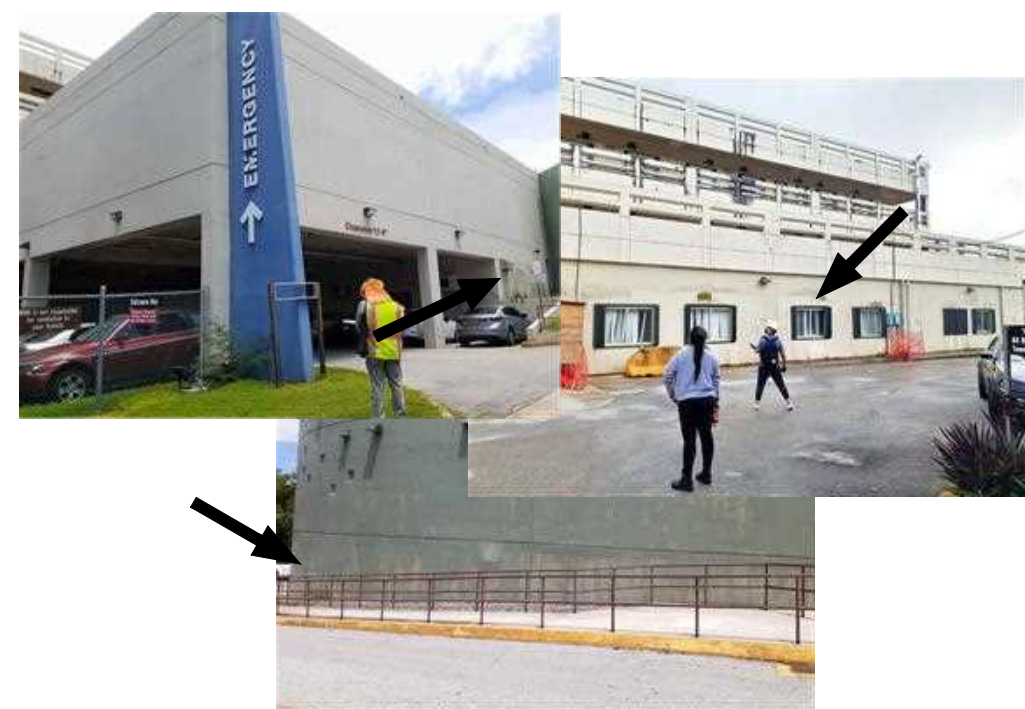
1e PHOTO
S-6.2 S-6.2.A

DETERIORATED WALL, and PARAPET WALL PAINTS.

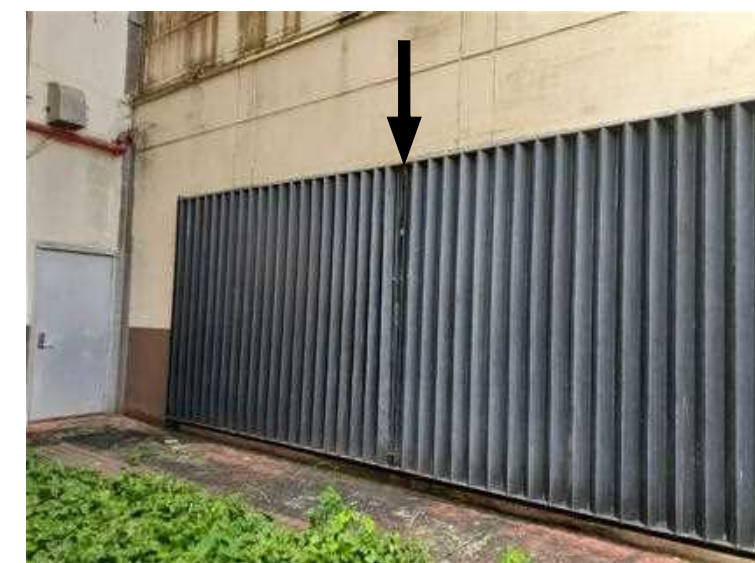
2e PHOTO
S-6.2 S-6.2.A

DETERIORATED WINDOW SHUTTERS

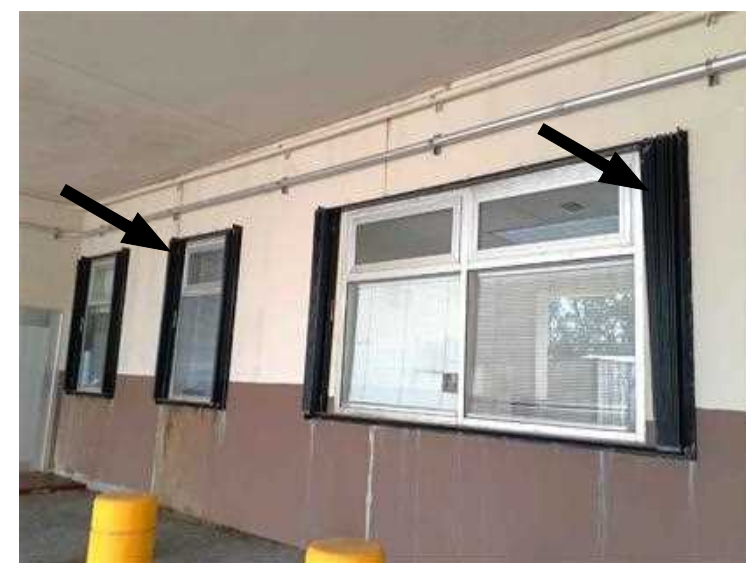
3e PHOTO
S-6.2 S-6.2.A

DETERIORATED WINDOW ACCORDION SHUTTERS

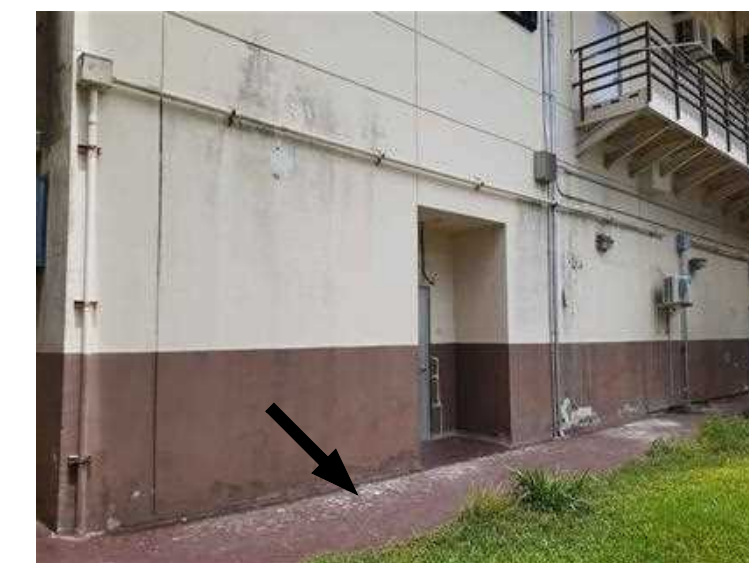
4e PHOTO
S-6.2 S-6.2.A

DETERIORATED ACCESS STEEL STAIRS.

4e S-6.2 S-6.2.A	DETERIORATED ACCESS STEEL STAIRS.	REMOVE EXISTING STEEL STAIRS & ITS ACCESSORIES and PROVIDE WITH NEW, SEE STAIR DETAILS.	1 S-10.1 S-10.1
	5e S-6.2 S-6.2.A	BIRDS DROPPINGS PRESENT ON BEAM, HOODS, PIPES, DUCT WORK, SHUTTER HEAD, ETC. FROM LIGHT TO HEAVILY INFESTED NARROW TO EXTRA WIDE AREAS.	PROVIDE STAINLESS STEEL ANTI BIRD SPIKES ON ALL LEDGES SUCH AS PIPES, SPRINKLER SYSTEMS, STEEL BEAMS, WINDOW SHUTTERS HEAD, HVAC EXHAUST HOODS, AC UNITS, ETC. and PVC AviAngle LEDGE SHIELD ON CONCRETE BEAM LEDGES. SEE SHEET S-9.1 FOR PVC AviAngle LEDGE SHIELD and ANTI BIRD SPIKES SPECIFICATIONS.	5 S-11.1 S-11.1
	6e S-6.2 S-6.2.A	DETERIORATED WALL EXHAUST HOOD.	REMOVE EXISTING WALL EXHAUST HOOD and REPLACE WITH NEW STAINLESS STEEL HOOD TO MATCH EXISTING, SEE MECHANICAL PLAN and DETAIL.

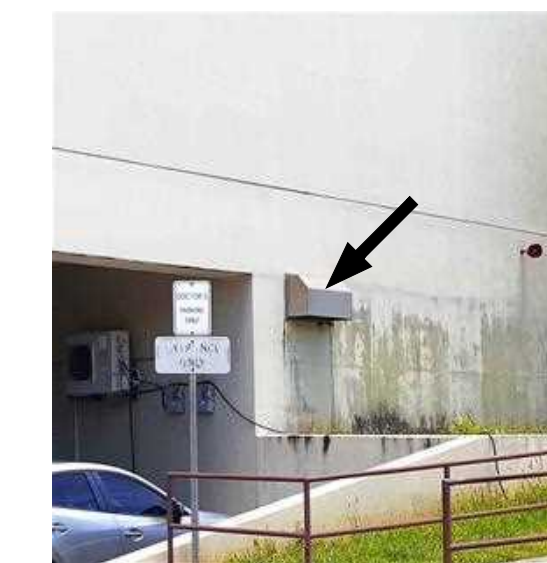
5e PHOTO
S-6.2 S-6.2.A

BIRDS DROPPINGS PRESENT ON BEAM, HOODS, PIPES, DUCT WORK, SHUTTER HEAD, ETC. FROM LIGHT TO HEAVILY INFESTED NARROW TO EXTRA WIDE AREAS.
