GMHA HOSPITAL ROOF AND ENVELOP UPGRADE PROJECT

PACKAGE A - 3RD & 4TH FLOOR ROOF AND ENVELOP (A,B, & E-WING)

GUAM MEMORIAL HOSPITAL AUTHORITY, TAMUNING, GUAM

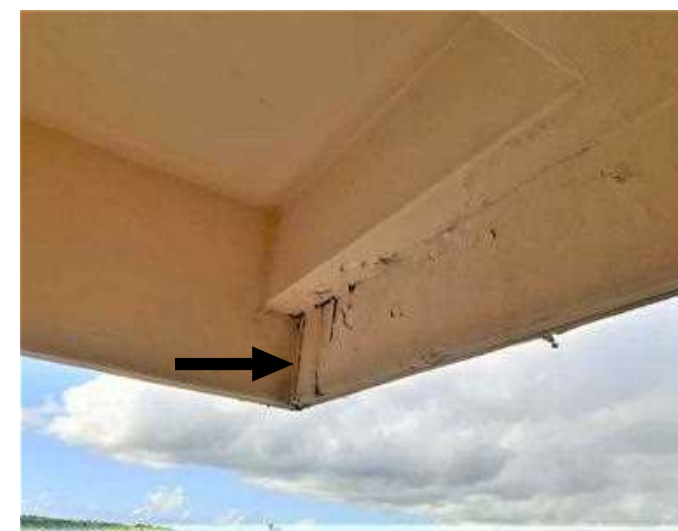
2e PHOTO
S-3.3 S-3.3.A

CONC FASCIA PALLS (9 Sf)

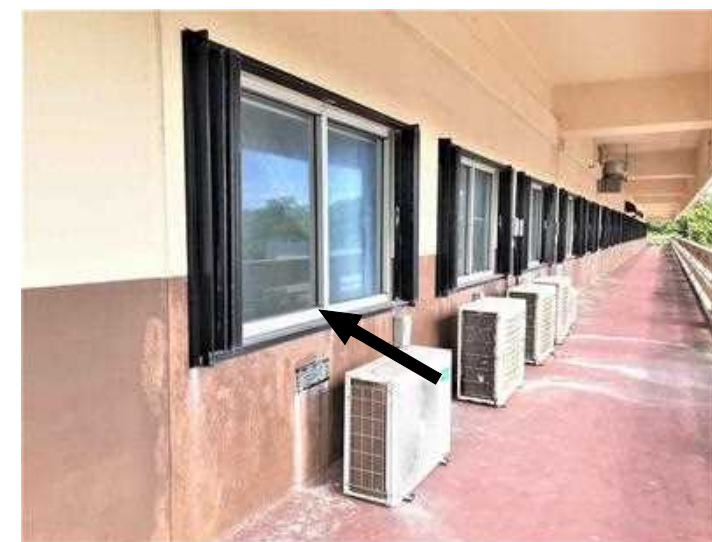
7e PHOTO
S-3.3 S-3.3.A

CONDENSATION AT WINDOWS (10 EA 6'x4')
DETERIORATED SEAL (2 EA 28"x48")

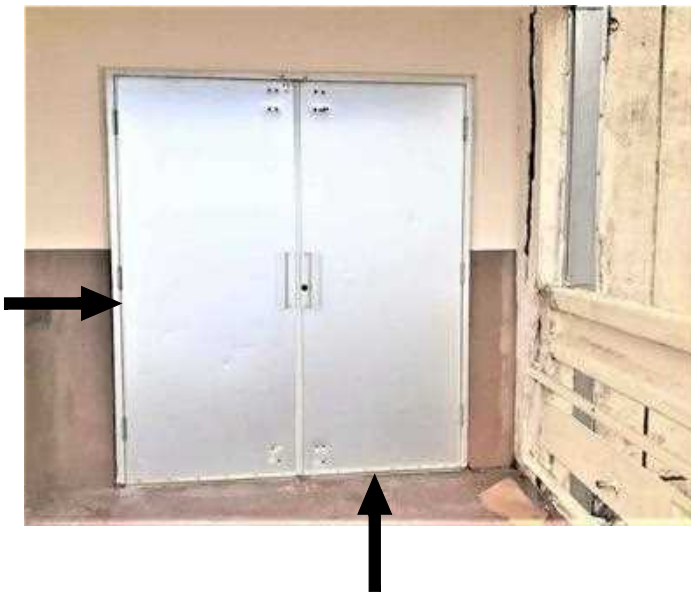
1e PHOTO
S-3.4 S-3.4.A

DETERIORATED DOOR SEALANT & SEAL (40 lf. SLNT), (28 lf. SEAL).

PHOTO KEY NOTES:		SCOPE OF REPAIR WORKS:		
WING	PHOTO No.	DAMAGED DESCRIPTION	REPAIR METHODS	DETAIL SHOWN
B - WING - 3RD FLOOR (EXTERIOR)	1e	DETERIORATED DOOR SEALANT & SEAL (40 lf SLNT) (28 lf SEAL).	REMOVE EXISTING DOOR SEAL / SEALANT AND REPLACE WITH NEW.	
	2e	DOOR THRESHOLD FAILED (6 lf).	REMOVE EXISTING DOOR THRESHOLD AND REPLACE WITH NEW	3 S-8.1 S-8.1
	3e	SEVERE CRACKS ON PILASTER WALL (13 lf).	GRIND TRACES OF CRACKS, CLEAN AND INJECT WITH EPOXY MORTAR, SEE DETAIL.	6 S-11.1 S-11.1
	4e	DETERIORATED PARAPET WALL PAINTS (1440 sf).	WATERBLAST TO CLEAN EXISTING PARAPET WALL AND PROVIDE NEW PAINT, PER GMHA FACILITY STANDARD.	
	5e	DETERIORATED CHAIN LINK & PIPE RAILING & ITS ACCESSORIES (158 sf).	REMOVE EXISTING CHAINLINK GUARD RAILS AND REPLACE WITH NEW. SEE DETAIL.	2,3 S-3.4 S-13.1
	6e	WALL MOUNTED EXHAUST HOOD RUSTED WITH BIRD DROPPING.	REMOVE EXIST WALL MOUNTED HOOD & REPLACE WITH NEW. REFER TO MECHANICAL DRAWINGS.	2A S-3.4 S-14.1

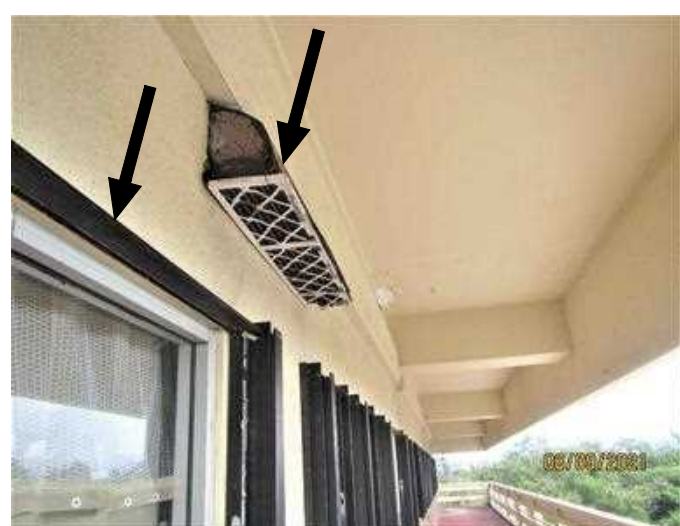
19e PHOTO
S-4.2 S-4.2.A

WINDOW SHUTTER HEAD AND EXHAUST HOOD

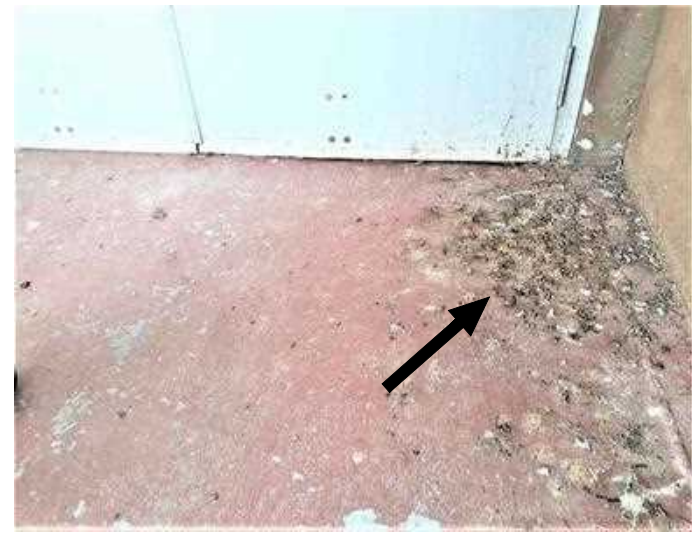
3e PHOTO
S-4.3 S-4.3.A

BIRDS DROPPINGS (40 Sf)(180 Sf)

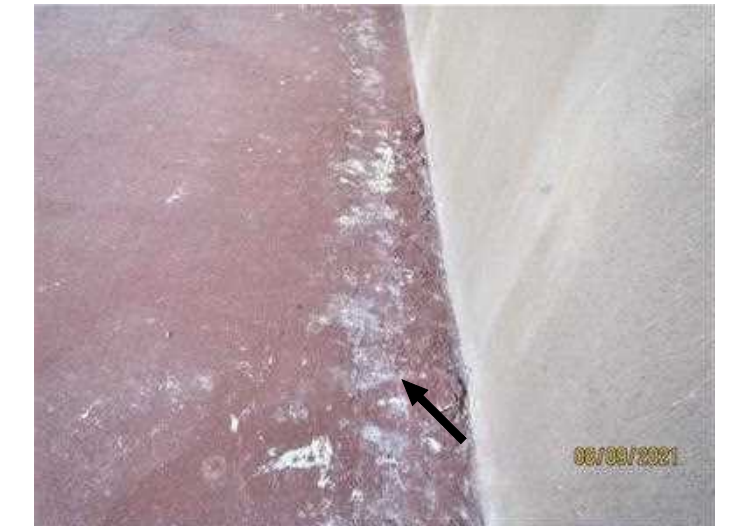
6e PHOTO
S-4.4 | S-4.4.A

BIRD DROPPINGS (135sf).

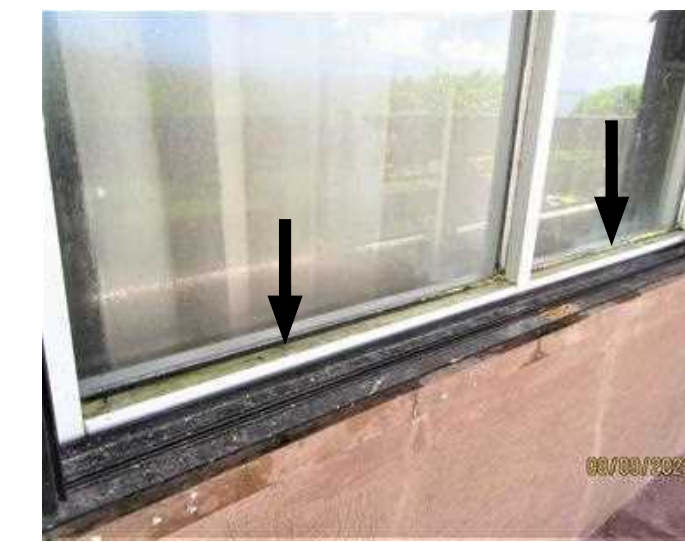
16e PHOTO
S-4.4 | S-4.4.A

MILDEW ON WINDOW SILL WITH GREEN ALGAE (TYP. - 20ea.).
