DRAWING INDEX

REV	DATE	BY	DESCRIPTION
GMHA NO. _____ GRANT ID NO. _____ CONTRACT NO. _____ PROJECT NO. _____		PROJECT: GMHA HOSPITAL AND ENVELOPE UPGRADE PROJECT	
DES. BY: kje DRN. BY: jl CHK. BY: rmca		CHIEF ENGR: - ENGR. SUP: - PROJ. ENGR: -	
I HEREBY CERTIFY THAT THIS PLAN WAS PREPARED BY ME OR UNDER MY DIRECT SUPERVISION DATE: 07-31-2024		CONTENTS: FIRST FLOOR PLAN _ A-WING: DAMAGED LOCATIONS, PHOTO KEY NOTES, SCOPE OF REPAIR WORKS, NOTES, and KEY PLAN	
DRAWING NO. S-1.2.1		SH. 07 OF 60

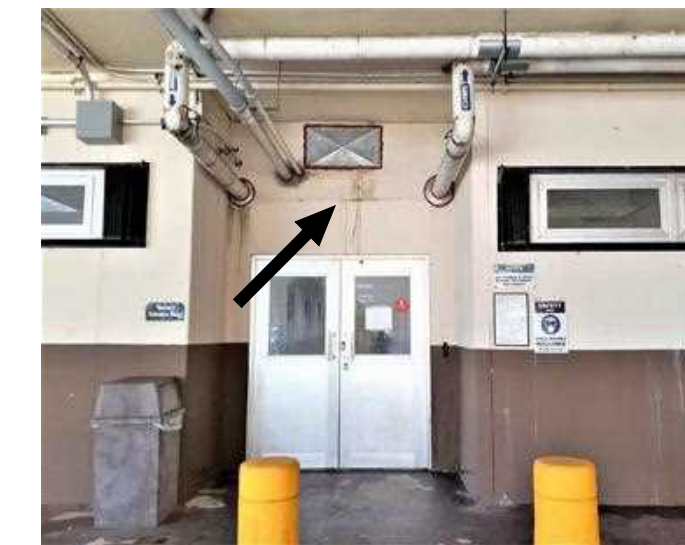
4e PHOTO
S-1.2 | S-1.2.A
STAINED WALL PAINT (±104 Sf).

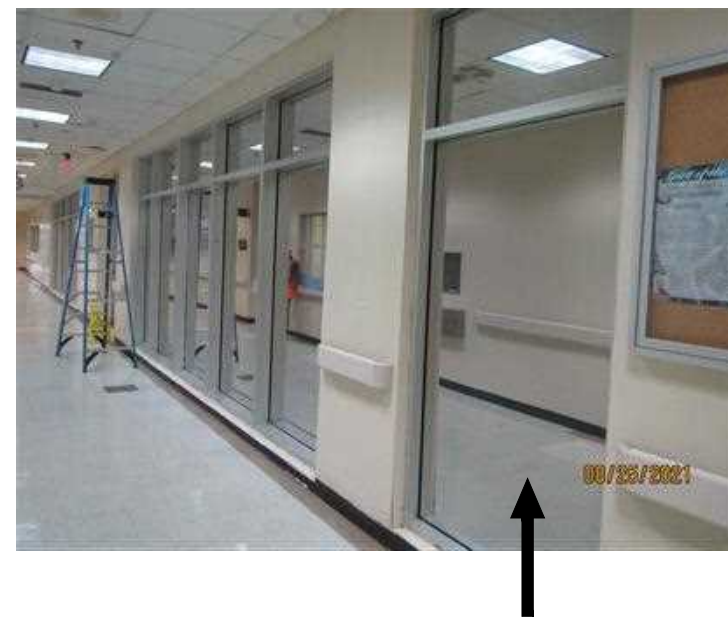
6e PHOTO
S-1.2 | S-1.2.A

6e S-1.2 S-1.2.A	DETERIORATED FIXED GLASS WINDOW CURTAIN WALL.	REMOVE FIXED GLASS WINDOW CURTAIN WALLS and ITS ACCESSORIES and REPLACE with NEW FIXED GLASS WINDOW.	1,2,3 S-9.1 S-9.1
	7e S-1.2 S-1.2.A	DETERIORATED WINDOW SHUTTERS.	REMOVE EXISTING WINDOW SHUTTERS and ITS ACCESSORIES and REPLACE WITH NEW EXTERIOR MOUNTED TYPHOON RATED INTERLOCKING ALUMINUM SLATS ROLL-UP SHUTTERS WITH MANUAL OPERATING SYSTEM. VERIFY WIDTH and HEIGHT OF EXISTING WALL OPENING.	4 S-11.1 S-11.1
	8e S-1.2 S-1.2.A	DETERIORATED WINDOW ACCORDION SHUTTERS	REMOVE EXISTING WINDOW ACCORDION SHUTTERS and ITS ACCESSORIES and REPLACE WITH NEW ALUMINUM ACCORDION SHUTTER, TYPICAL AT EXTERIOR CORRIDORS. REFER TO GMHA FOR COLOR SELECTION.	
	9e S-1.2 S-1.2.A	BIRDS DROPPINGS PRESENT ON BEAM, HOODS, PIPES, DUCT WORK, SHUTTER HEAD, ETC. FROM LIGHT TO HEAVILY INFESTED NARROW TO EXTRA WIDE AREAS.	PROVIDE STAINLESS STEEL ANTI BIRD SPIKES ON ALL LEDGES SUCH AS PIPES, SPRINKLER SYSTEMS, STEEL BEAMS, WINDOW SHUTTERS HEAD, HVAC EXHAUST HOODS, AC UNITS, ETC. and PVC AviAngle LEDGE SHIELD ON CONCRETE BEAM LEDGES. SEE SHEET S-9.1 FOR PVC AviAngle LEDGE SHIELD and ANTI BIRD SPIKES SPECIFICATIONS.	5 S-11.1 S-11.1

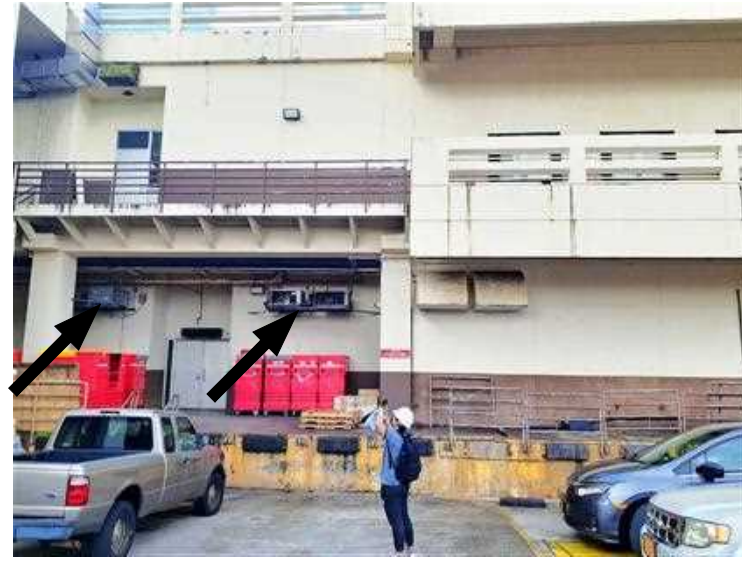
7e PHOTO
S-6.1 S-6.1.A

WING	PHOTO No.	DAMAGED DESCRIPTION
1st FLOOR (EXTERIOR) FRONT and LEFT ELEVATIONS	7e S-6.1 S-6.1.A	BIRDS DROPPINGS PRESENT ON BEAM, HOODS, PIPES, DUCT WORK, SHUTTER HEAD, ETC. FROM LIGHT TO HEAVILY INFESTED NARROW TO EXTRA WIDE AREAS.
	8e S-6.1 S-6.1.A	DETERIORATED DOOR HEAD BLOWER.
	9e S-6.1 S-6.1.A	DETERIORATED WINDOW LOUVERS, TYPICAL.

REPAIR METHODS	DETAIL SHOWN
PROVIDE STAINLESS STEEL ANTI BIRD SPIKES ON ALL LEDGES SUCH AS PIPES, SPRINKLER SYSTEMS, STEEL BEAMS, WINDOW SHUTTERS HEAD, HVAC EXHAUST HOODS, AC UNITS, ETC. and PVC AviAngle LEDGE SHIELD ON CONCRETE BEAM LEDGES. SEE SHEET S-9.1 FOR PVC AviAngle LEDGE SHIELD and ANTI BIRD SPIKES SPECIFICATIONS.	5 S-11.1 S-11.1
REMOVE EXISTING DOOR HEAD BLOWER and REPLACE WITH NEW STAINLESS STEEL HOOD TO MATCH EXISTING, SEE MECHANICAL PLAN and DETAIL.	
REMOVE EXISTING WINDOW LOUVERS and REPLACE WITH NEW TYPHOON PROOF WINDOW LOUVER, TYPICAL.	4,5,6 S-9.1 S-9.1
